Trees and redevelopment at Civic Square, Launceston.

Impact of proposed improvements.

Jerry Romanski
Arborist / Consultant
B.Sc (Hons), Ass. Dip. App. Sc. (Hort/Arb)

29 Winston Ave
SEVEN MILE BEACH TAS. 7170
m: 0419 363 011
e: arborist@jerryromanski.com
25/10/2016

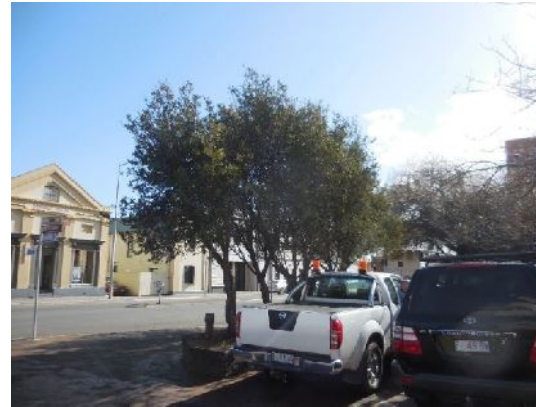
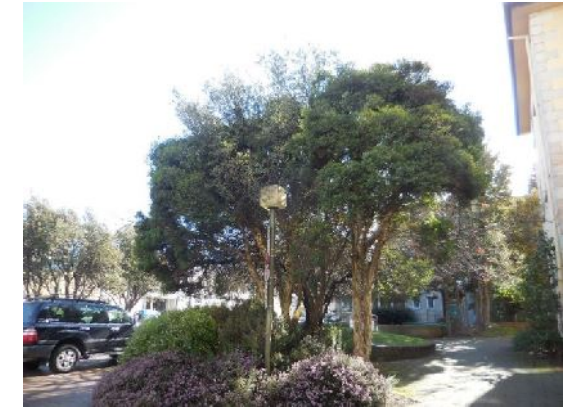
Fig. 1 The Callistemons (1) on the left and the mixed Melaleuca / Callistemon bed (3) on the right

- **The Callistemon and Melaleucas** (trees 1 and 3) have reached the threshold between maturity and senescence. The trees are currently in a good condition and have the potential to provide additional 10-15 years of landscape service, with declining aesthetics. The proposed hard landscape improvements would include the removal and replacement of the garden bed edging and can be expected to disturb roots likely to be growing along the brickwork. The works are expected to have a moderate impact on these individuals reducing their landscape service to less than 10 years. The works provide an opportunity to renew both the hard edging and the landscape planting, avoiding the inevitable disruption to the landscape as the trees decline in the foreseeable future.

ID	SPECIES	TREES	HGT	DBH	H/S	DEFECTS	COMMENTS	LIFE	RET	WORKS
1	Callistemon sp.	4	4	25	G/G	Minor or none noticed		10-25	Y	Consider early replacement – life may be reduced to less than 10 years due to root disturbance during infrastructure replacement.
2	Platanus Xacerifolia	1	10-14	48	F/G	Moderate size dead branches, Broken branches hanging in crown, Roots lifting brick bed surround on NW side	The poor condition of the upper crown of the plane may be due to a combination of exposure to drying north-west winds, reflection from the water feature, limited root volume and impact of highly chlorinated water from a potentially leaking water feature.	10-25	Y	Deadwood, formative prune, reduce over-extended branches. Assess / improve irrigation over the raised garden bed.

ID	SPECIES	TREES	HGT	DBH	H/S	DEFECTS	COMMENTS	LIFE	RET	WORKS
3	Melaleuca linariifolia	3	4	25	G/G	Bifurcation of stem	Also 2 Callistemon pallidus at this site	10- 25	Y	Consider early replacement – life may be reduced to less than 10 years due to root disturbance during infrastructure replacement.

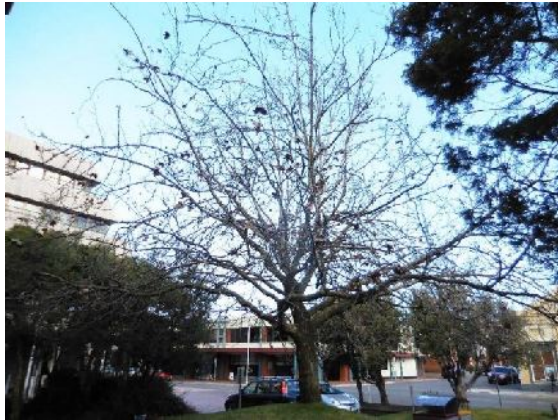
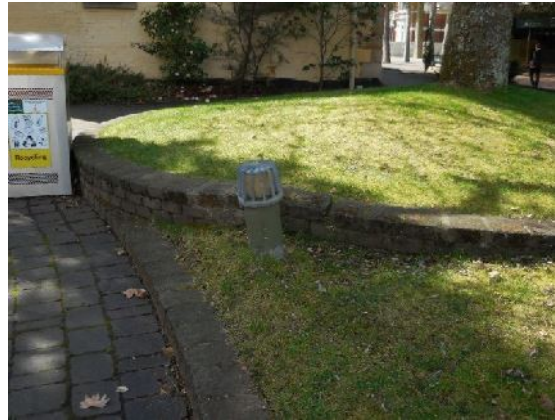
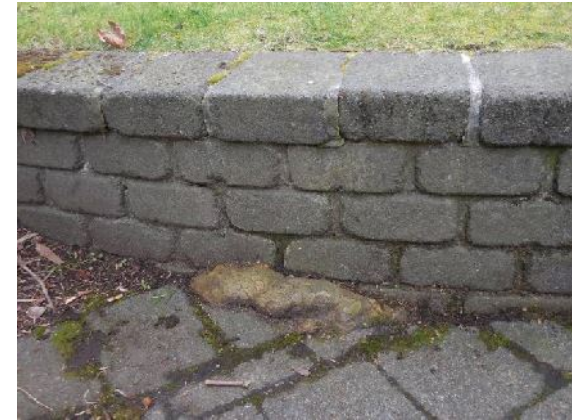
- **The London plane** (2) is generally structurally sound, but has not been performing well for some years. Tips of upper crown branches have died-back at times, with dry sections breaking out, but there are signs of periodic recovery as well. The tree has a broad spreading crown with considerable presence at this site and worthy of further maintenance (see Works above).

The circular brick edging is being lifted by large roots on the northern-western side, with another root poking out from below the brick retaining wall on the south eastern side (Fig. 2). Replacement of the brick edging will need to contend with large roots; some root pruning may be possible, but it is likely that the new installation will need to accommodate and provide for further expansion of the existing roots. Strategies for installation of the new edging in close proximity to large roots are best developed for individual situations, but may include bridging over roots, localised packing of roots with crushable material to enable hardscape installation and modification of edging alignment.

Fig 2. From left: the broad-spreading crown of the plane provides a strong landscape element and welcome shade over the summer; the garden edge and light are being displaced by large roots; a root squeezing below the south-eastern section of the low retaining wall.

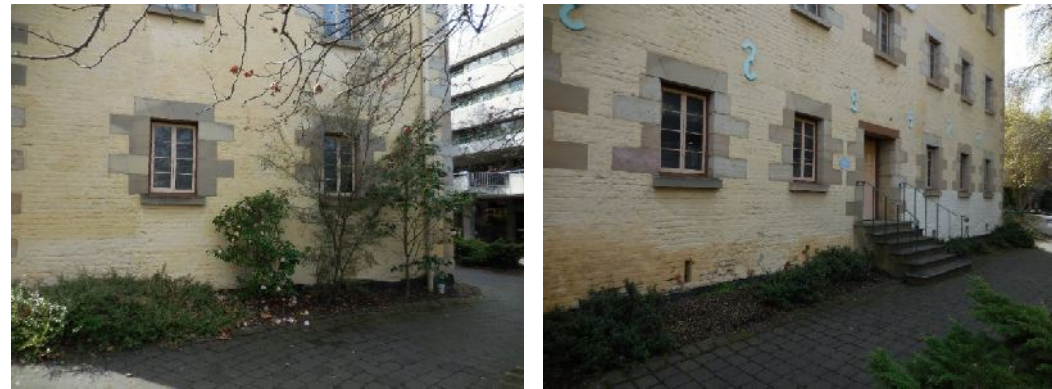
Fig 3. The western and southern side of Macquarie House.

- Building conservation measures necessitate the removal of the garden beds along the western and southern side of Macquarie House. The existing vegetation (4) consists predominantly of low growing shrubs and is not prominent in the immediate landscape (Fig. 3).

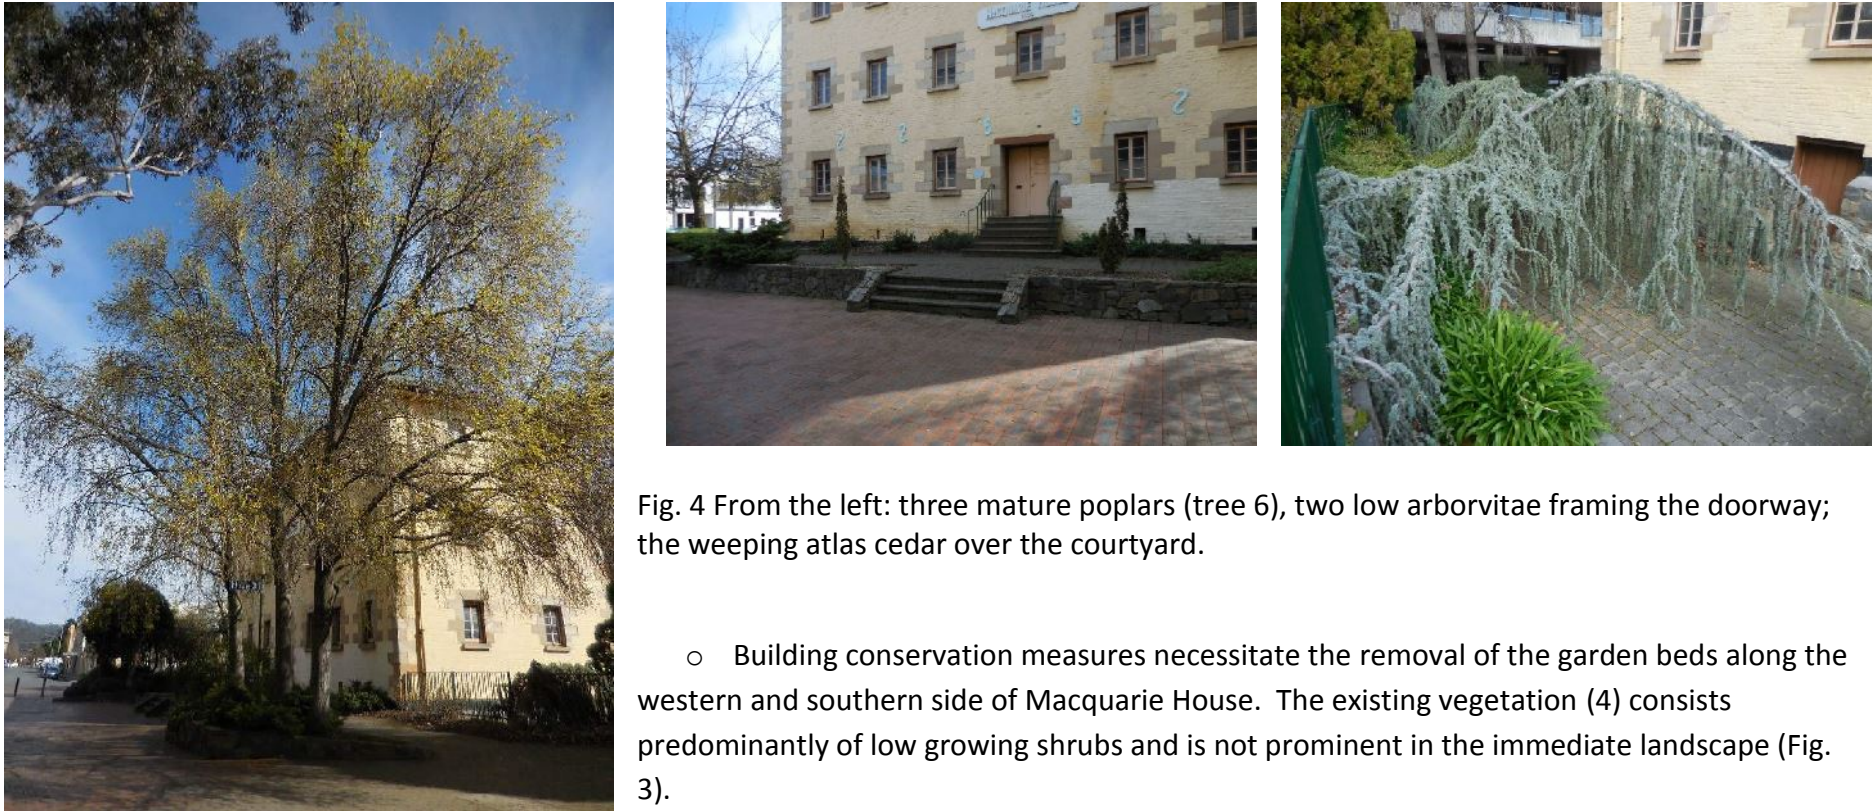
Fig. 4 From the left: three mature poplars (tree 6), two low arborvitae framing the doorway; the weeping atlas cedar over the courtyard.

- The 2 low **arborvitae** (5) framing the steps and doorway to Macquarie House are in poor condition (Fig 4, centre) . The trunk of one has been broken – the tree is not likely to ever develop an aesthetically pleasing form. Replacement of both small trees is recommended.

- The mature **Chinese poplars** (6) are doing well and are unlikely to be adversely affected by the proposed works. Care needs to be exercised when lifting and replacing the paving below the tree crowns. Movement of heavy machinery and storage of materials should be avoided within the TPZ – an area with approximately 4.6m radius from each trunk. Presence of an arborist for on-site advice during lifting of the pavement in this area is recommended.

- Location of the **weeping atlas cedar** (7) is unfortunate. The tree remains healthy but its weeping crown clearly interferes with the utility of the courtyard (Fig 4, right). Maintenance of the low cedar crown is not compatible with public utility of the courtyard. Removal of the tree is essential to progress the vision for this space.

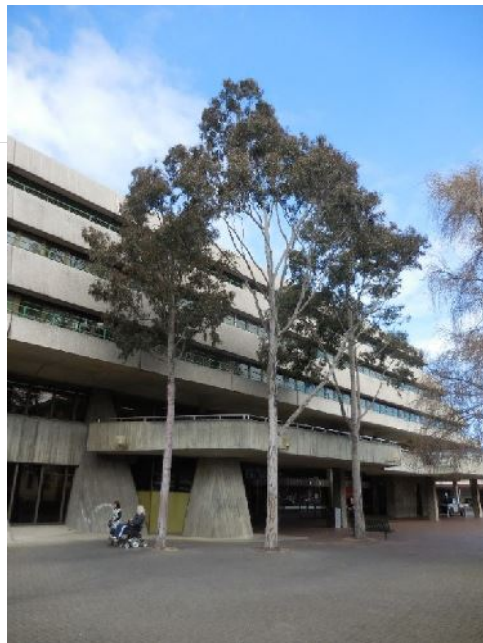
It is unfortunate that a number of trees growing at Civic Square, including the 3 mature spotted gums in front of the Henty House, have been planted inside upturned concrete pipe sections. Tree roots soon begin to circle inside the pipes and rely on the pressure between the roots and the concrete surface rather than radial root extension for stability in the ground. There are local examples of failures by trees growing inside pipe surrounds (pers. comm. Tony Long, UTAS, Launceston, 2016).

Most of the gums’ roots do not radiate more than 2 m away from the trunks and those that do are of a small diameter. Despite their considerable height, the 3 gums are still quite young and their crowns are expected to grow higher and broader, elevating the potential for wind throw.

Using currently available information, the risk of harm associated with the trees is estimated at 1 in 300,000, in the tolerable range, but could be as high as 1 in 100,000 with multiple targets during events at Civic Square. The risk of injury is expected to increase with further crown development and may reach an unacceptable level (≤ 1 in 10,000) within 5 years. Tree failure is likely to occur in strong winds with little warning.

The proposed pavement renewal provides an opportunity for replacement of the inappropriately planted gums. A root space for in-ground trees could be created in this area using structural cells. The in-ground installation could be paved over to achieve a trafficable surface. Use of in-ground structural cells provides a non-compacted soil volume that encourages root growth and greatly reduces the potential for root damage to paved surfaces and infrastructure. An installation approximately 3m wide x 4.8m long x 1.1m deep would provide adequate volume for a medium sized tree. A contiguous installation could be used to create a shared root space large enough for 3 – 5 replacement trees. More information about structural cell systems can be found at:

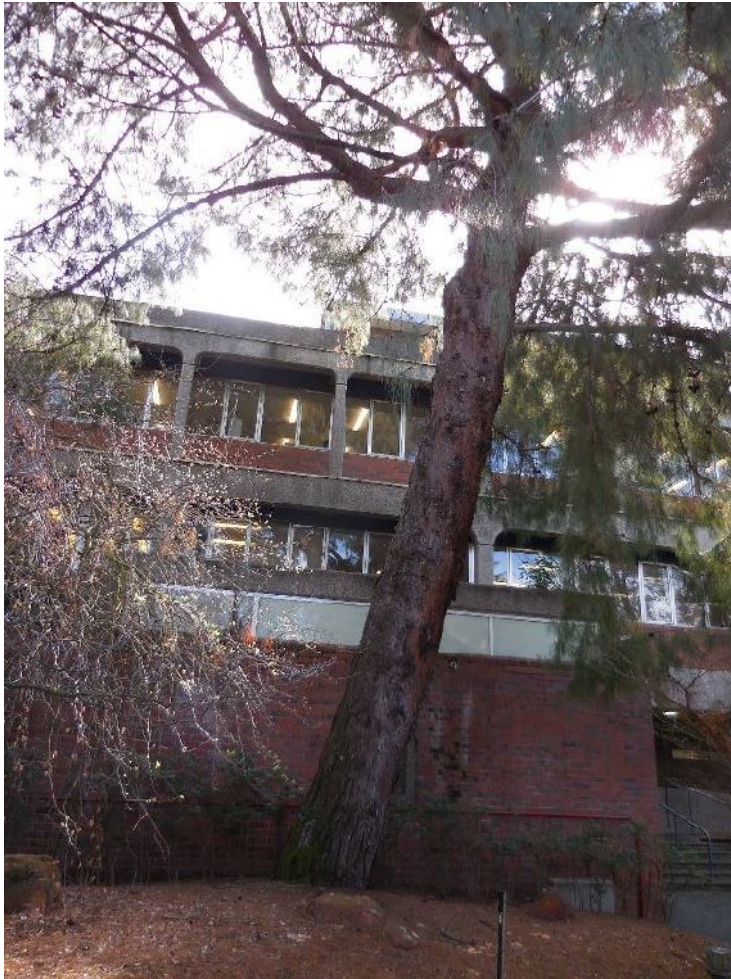
Fig. 4 The leaning pine.

- Trunks of a large **pine** (13) and **cypress** (11) growing along the northern periphery of the Japanese garden lean heavily (fig. 4). Installation of lean monitoring markers and periodic revision would provide valuable data about the trees' possible slow subsidence.

Greatest tilt recorded for the pine - 0.25°
 Direction of tilt - West
 Range of tilt - low,

Tilt is within expected limits of stability at wind speeds of at least 40km/h

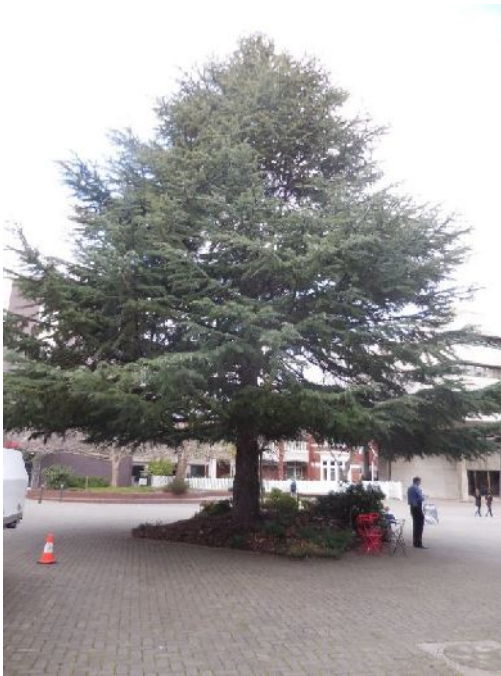
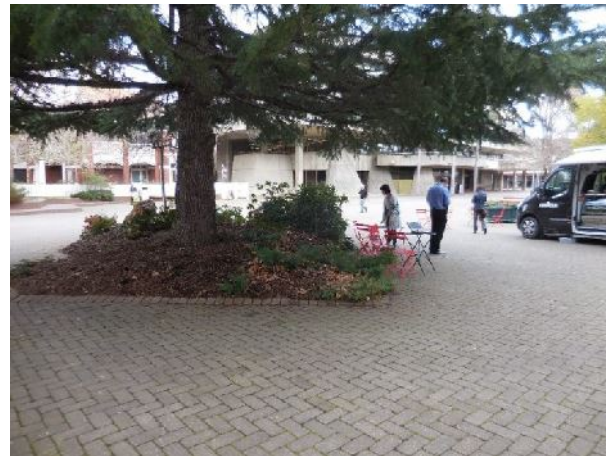
The construction of a stage is proposed in the area to the north-west of the **cedar** (15), between the tree and the terraces (see Appendix 1). The stage finished surface would be approximately 400mm above the exiting paving in this area. It is likely that cedar roots are currently growing below the existing paving and capping of this area with fill and new infrastructure could dramatically reduce water availability to the exiting roots, leading to a decline in the tree's condition and longevity.

The tree's structural root (SRZ) is calculated to have a radius of 2.8m and a recommended tree protection zone (TPZ) should extend to 7.2m radius from the trunk. Pavement replacement and construction of the stage are likely to encroach over the SRZ and TPZ. Design of the stage and edge seating and methods of paving renewal need to be sensitive to the expected presence of large and fine roots below the footprint of

the proposed works. Key considerations are: i) physical damage to large roots (greater than 75mm in diameter), ii) capping of the root zone reducing infiltration of water and air essential to root function.

While I believe that the proposed development is possible, despite the close proximity of the works to the large cedar (Fig. 5). Appropriate design that minimises root damage and maintains a viable root zone providing air and water infiltration is essential to the long-term viability of the cedar. The stage could be built entirely on pier footings with infill wall edging, or over rock fill supplemented with irrigation below the finished surface. Similarly, the edge seating could be constructed between pier footings, with the footings hand dug or hydro-excavated to avoid damage to large roots. Pedestrian access over the garden bed itself could be facilitated by a deck constructed over piers, with supplementary irrigation ensuring adequate soil moisture over this important section of the root zone.

Fig. 5 The cedar (left) and paving between the tree and terraces (right), currently used by the mobile café van. The tree's roots are expected to extend below the existing paving – design and construction methodology for the proposed improvements will need to be sensitive to the long-term viability of this space as a root zone.

Input of an arborist during the construction design stage for improvements in this area and on-site advice during early stages of construction is recommended.

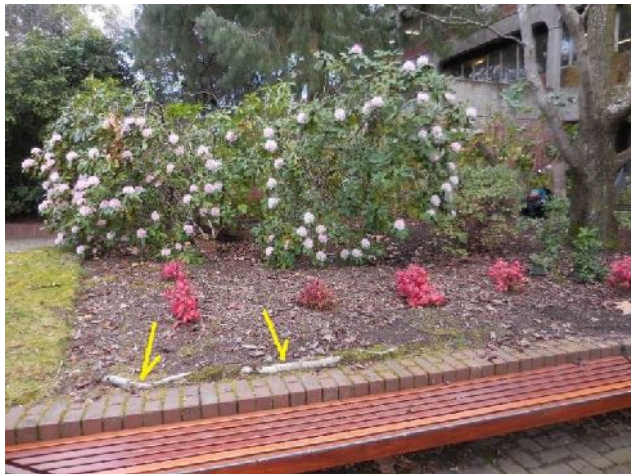
○ The Liquidambar (16) is healthy and typically for this species displays a robust root system. A large root is readily visible extending along the bed surface and beside the brick retaining wall (Fig. 6 and 7). Replacement of the brick edging and reduction of the south-westerly extension of the garden bed will substantially impact on structural roots of this tree. Works in this area, including the necessary removal of 2 myrtle beech trees (see comments below) provide an opportunity for succession planting of a young Liquidambar beside the existing mature specimen.

Fig. 6 Large Liquidambar root along the brick garden retaining wall.

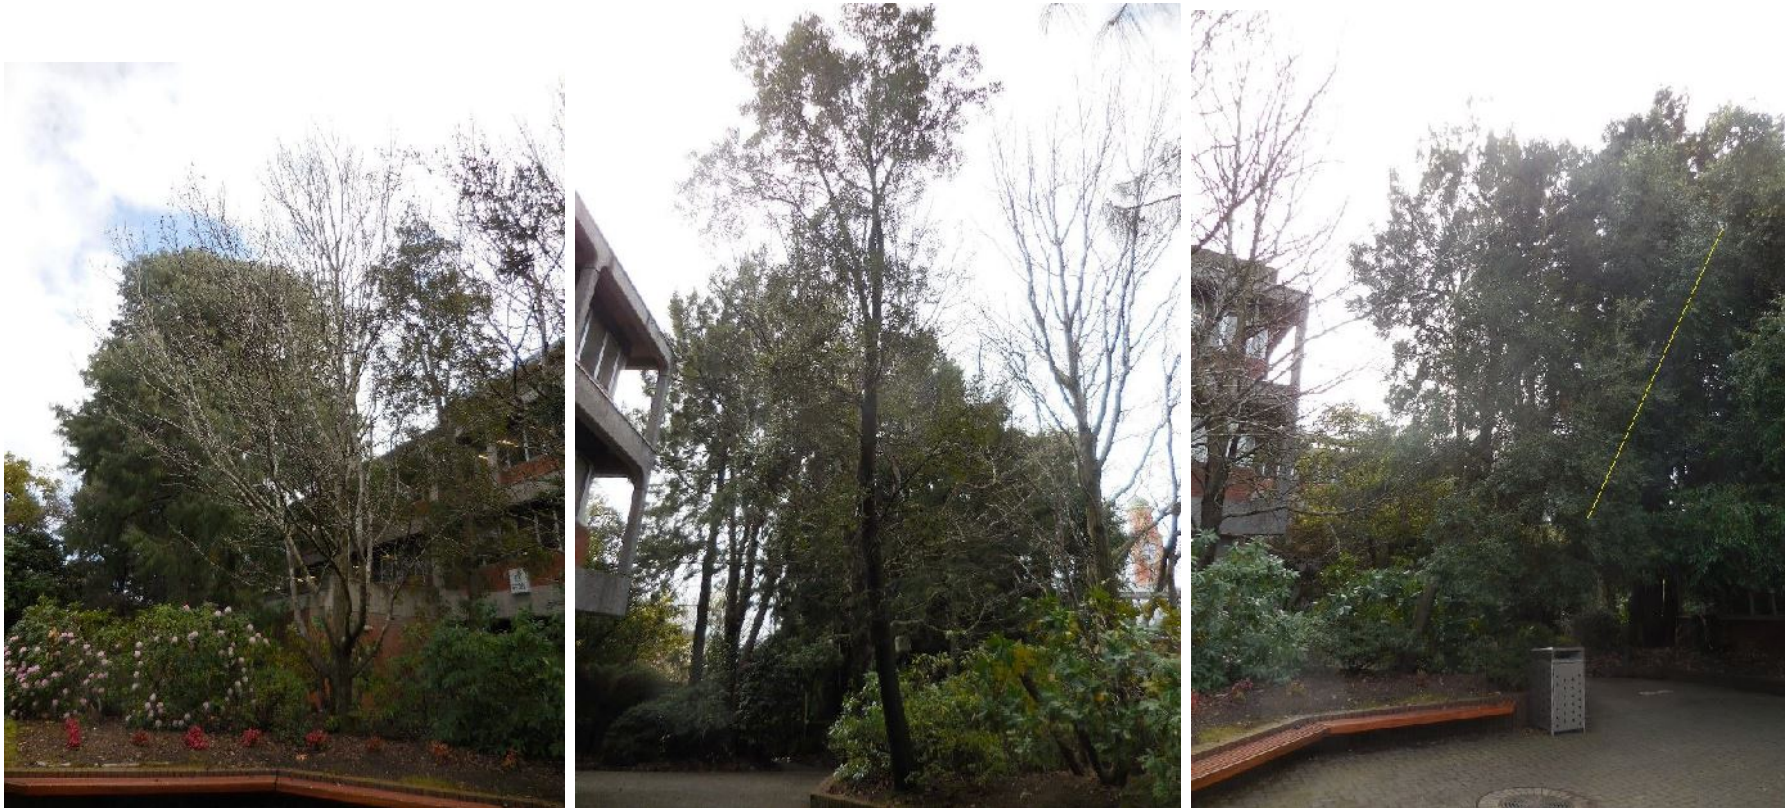
- The 2 myrtle **beech trees** (17 and 18) provide a tall evergreen element within the raised garden bed. Both display a strong lean (Fig. 7) and sounding of the bed surface suggests a considerable lifting of the tension section of the root plate away from the underlying substrate. Slow subsidence of the trees is expected, but more importantly, the trees now have an increased potential for failure at ground level. Early removal of the trees is recommended.

Fig. 7 Left – Liquidambar (16); Centre – myrtle beech (17) leaning toward the building; Right – myrtle beech (18) leaning over the path.

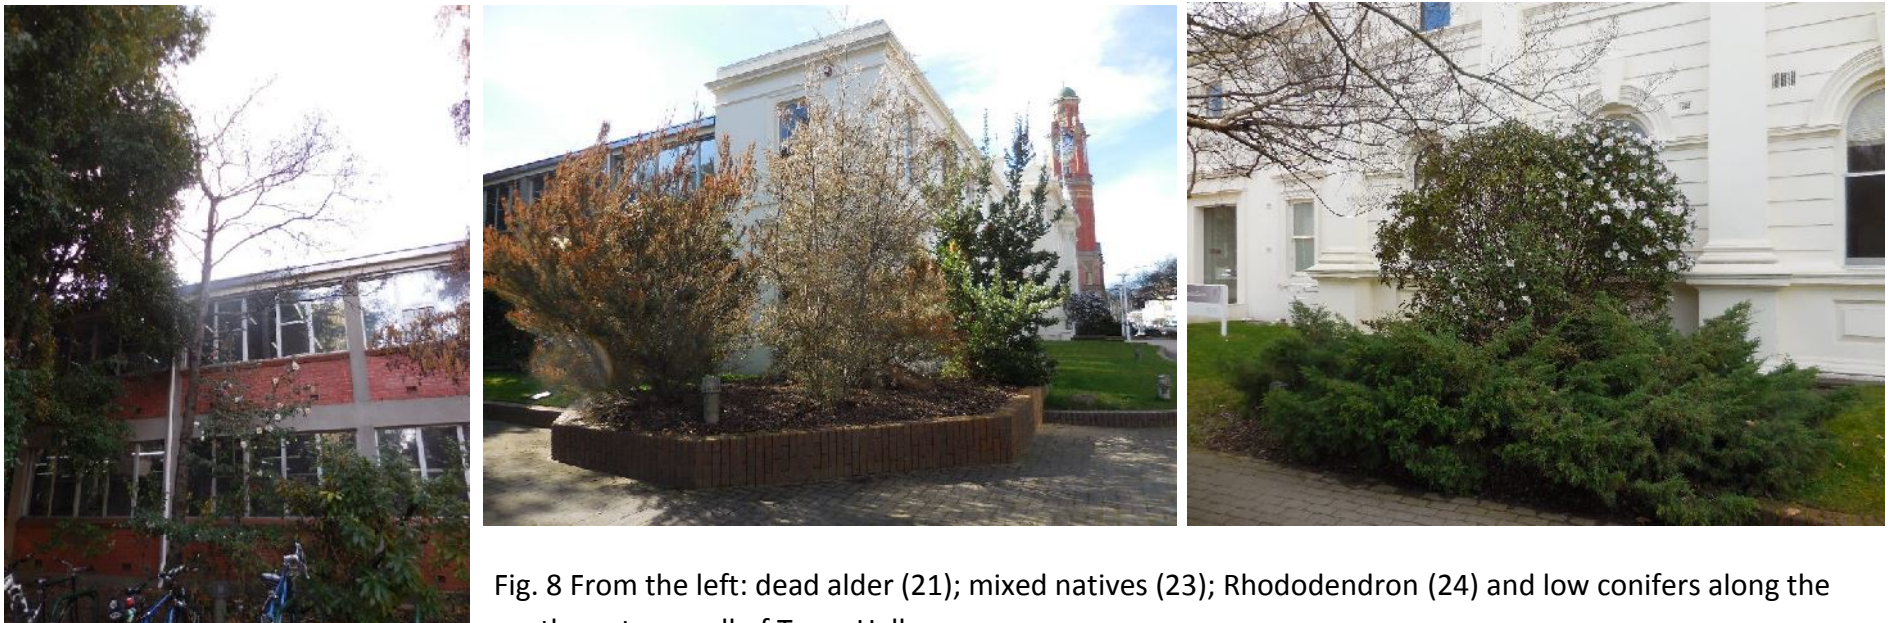
- Tree 21, **common alder** (21) has died (Fig. 8). Replacement of this tree is not essential due to close proximity of already established large trees.
- As part of landscape renewal, the **natives** (23) growing near the south-western corner of Town Hall are proposed to be replaced with species more complementary to the predominantly exotic planting theme of Civic Square.
- The bed (24) extending along the south-eastern wall of Town Hall is proposed to be replaced with paving to reduce soil moisture levels near and over the building footings.

Fig. 8 From the left: dead alder (21); mixed natives (23); Rhododendron (24) and low conifers along the south-eastern wall of Town Hall.

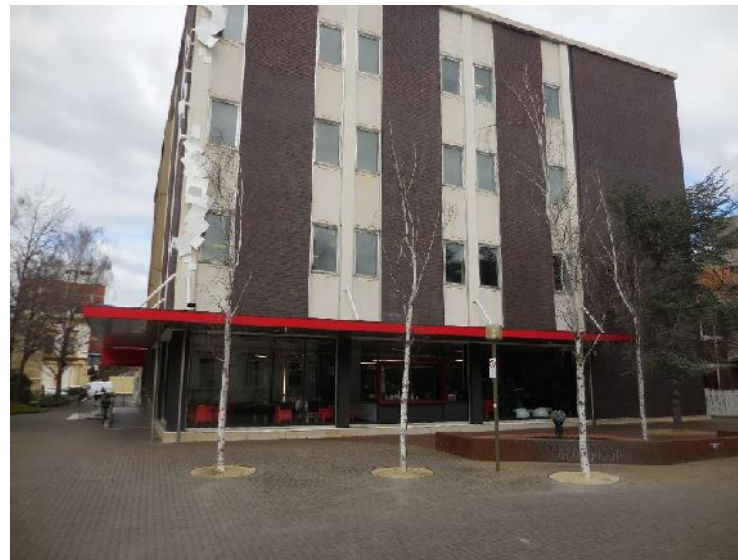
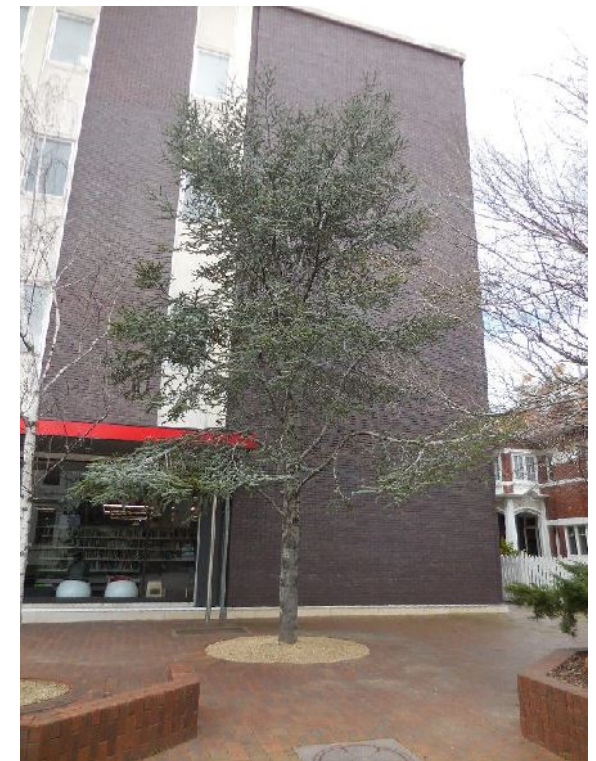
- The mature **atlas cedar** (30) and 4 **birches** (31) currently growing in the ground in front of LINC have been planted in upturned concrete pipes. This practice creates inherent root defects, as discussed for the spotted gums growing in front of the Henty House. Trees planted this way can be expected to have a much reduced landscape life. In fact, the birches are already in poor condition. The currently proposed infrastructure improvements at Civic Square include the development of a raised seating area in front of LINC that could be complemented with sunken tree wells housing moderate size trees growing in crates or a more extensive structural cell installation with in-ground trees. Maples (*Acer* sp.) would be suitable for either in ground or planter cultivation in this space, providing welcome shade over the summer and plenty of light during the winter.

Fig. 9 The poor performing birches and cedar growing in concrete pipes in front of LINC.

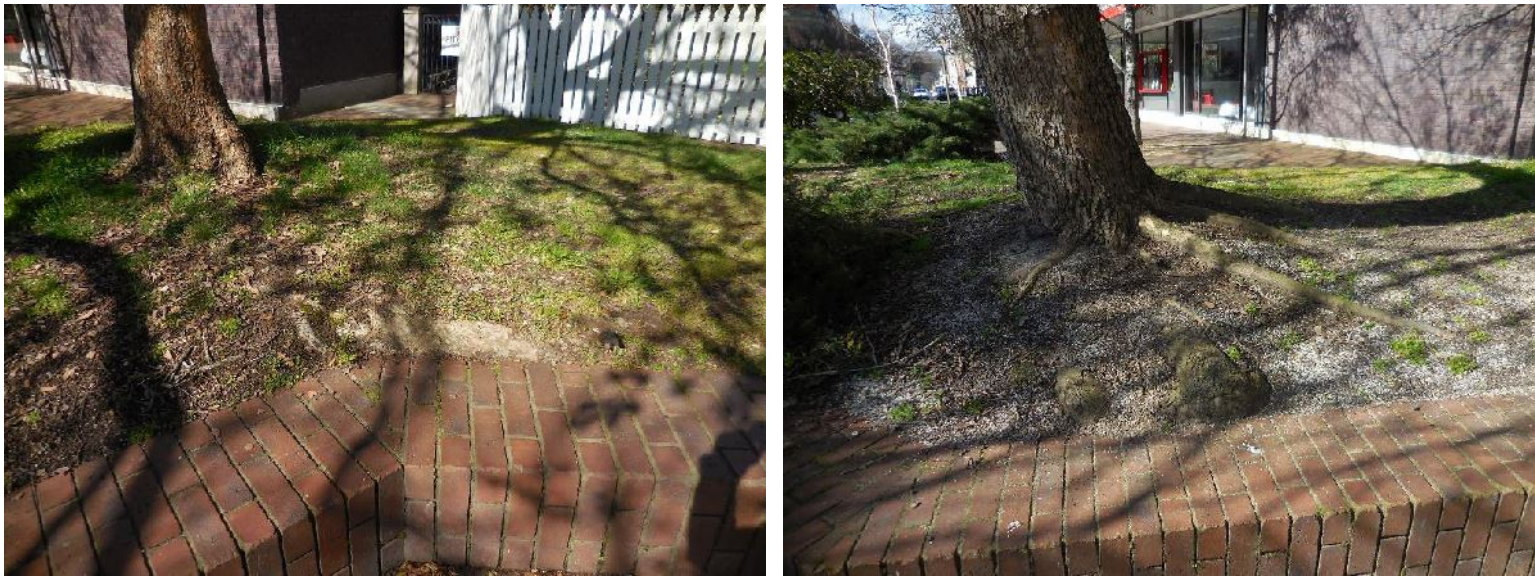
- Roots of the Chinese elms and plane (27, 28 and 29) growing in the raised bed beside LINC can be expected to have large roots in close proximity to the bed edging. Take care when replacing the edging. (Fig. 10).

Fig. 10 Roots near the surface and garden edging.

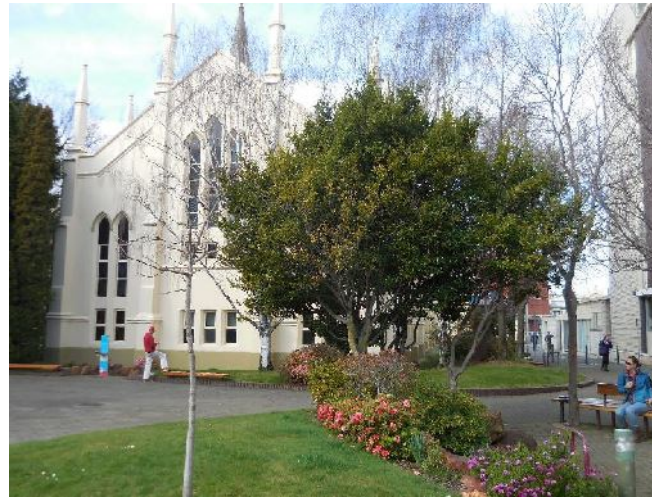
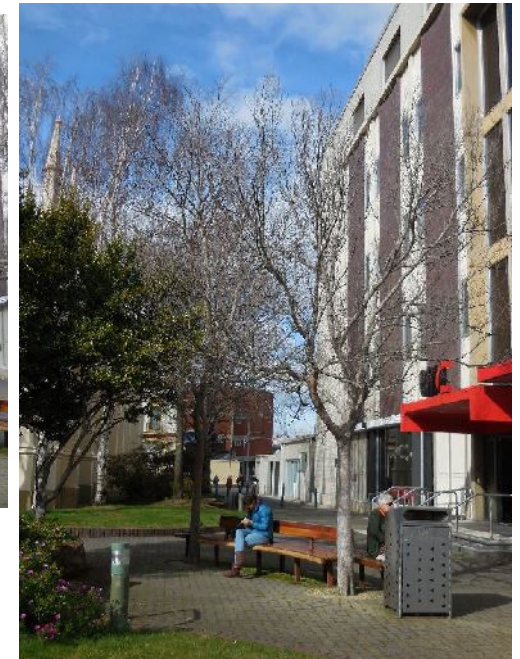
- This area will be dominated by the new the Playspace – a space for families and friends to gather, relax and play. Construction of the Playspace will require the removal of an existing garden bed to the south-east of LINC and 5 small trees there (32 and 33) (Fig. 11).
- Two **Chinese elms** (34) growing between the garden bed and LINC have been planted in upturned pipes. The trees are not performing well. The northern of the 2 trees in particular is in poor condition. Both elms would need to be removed to create space for the Playspace (Fig. 11).

Fig. 11 The Chinese elms (34) (left) and trees 32 and 33 (right) will need to be removed for the new Playspace.

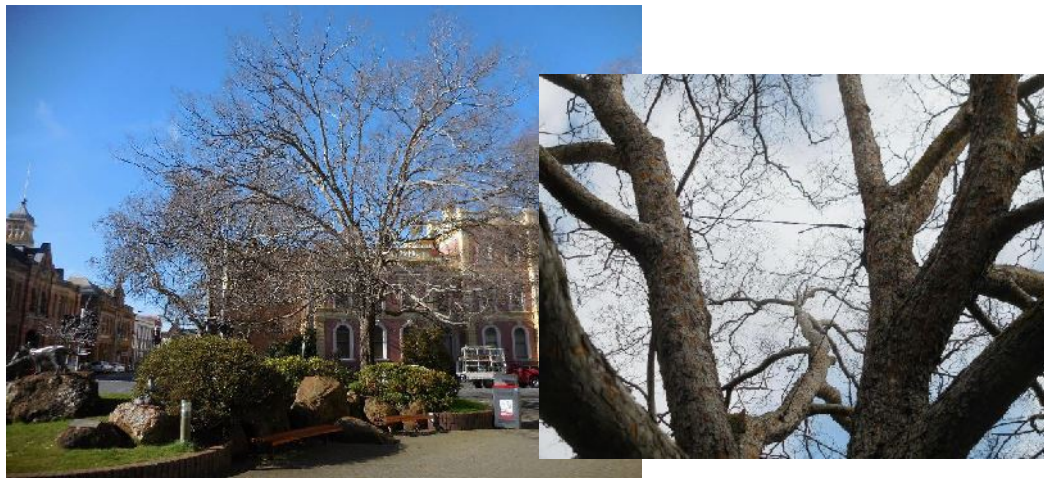
Elm (35) (Fig. 12) is growing in a raised bed that will be refurbished with new edging and seating. The elm crown has been braced in the past. The bracing cable needs to be inspected and the termination clamps replaced (see Works in table above). The proposed Playspace will cap a section of the tree's potential root zone. Ensure that adequate irrigation is supplied to the garden bed to offset the potential loss of this root zone section.

Fig. 12 Elm 35 is to be retained.

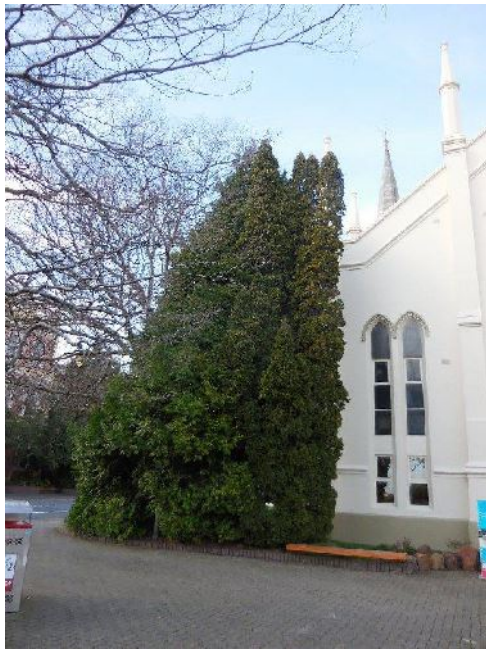
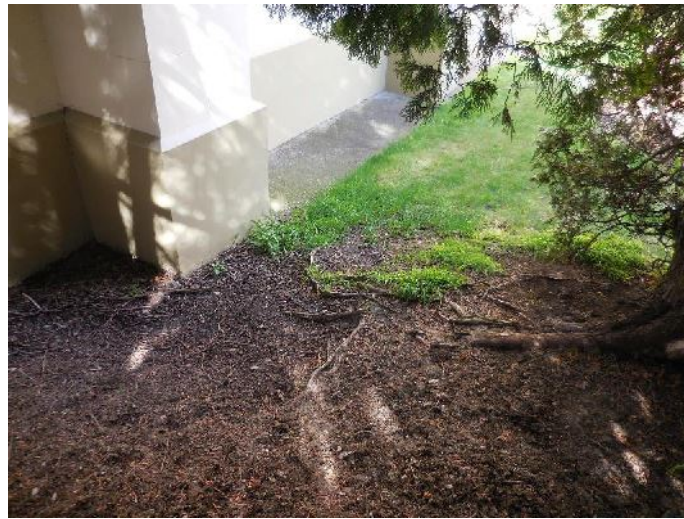
Fig. 13 Conifers 36 and 37 by the church corner.

The 2 **Thuya** (36 and 37) growing beside the north-eastern corner of the church are poorly located for long-term maintenance in the landscape (Fig. 13). The trees are growing within 1m of the church footings. Branches of the southern tree are rubbing on the church wall. Attachments of the numerous leaders that make up the crown of the northern tree include bark at their attachment and are being held together by a loop of rope.

Removal of these trees would greatly improve passive surveillance of the Playspace.

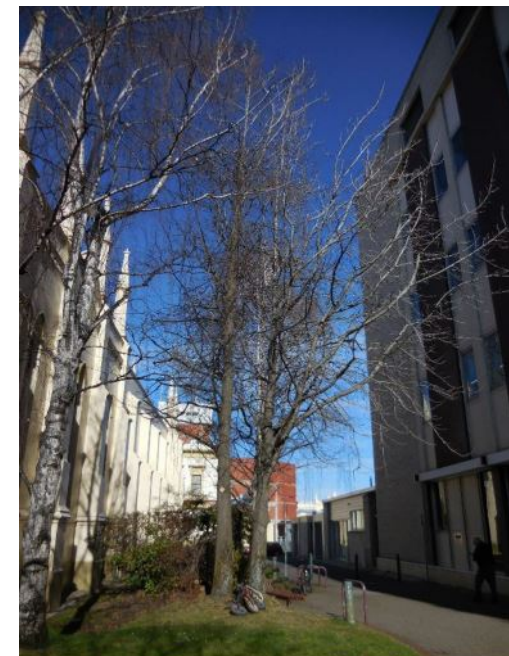
Fig. 13 Roots of **Liquidambars** (39) are pushing on the existing bed edging. Take not to damage the roots when replacing the edging.
