# Launceston Flood Authority

## Annual Report 2019

Report for the period ending 30 June 2019

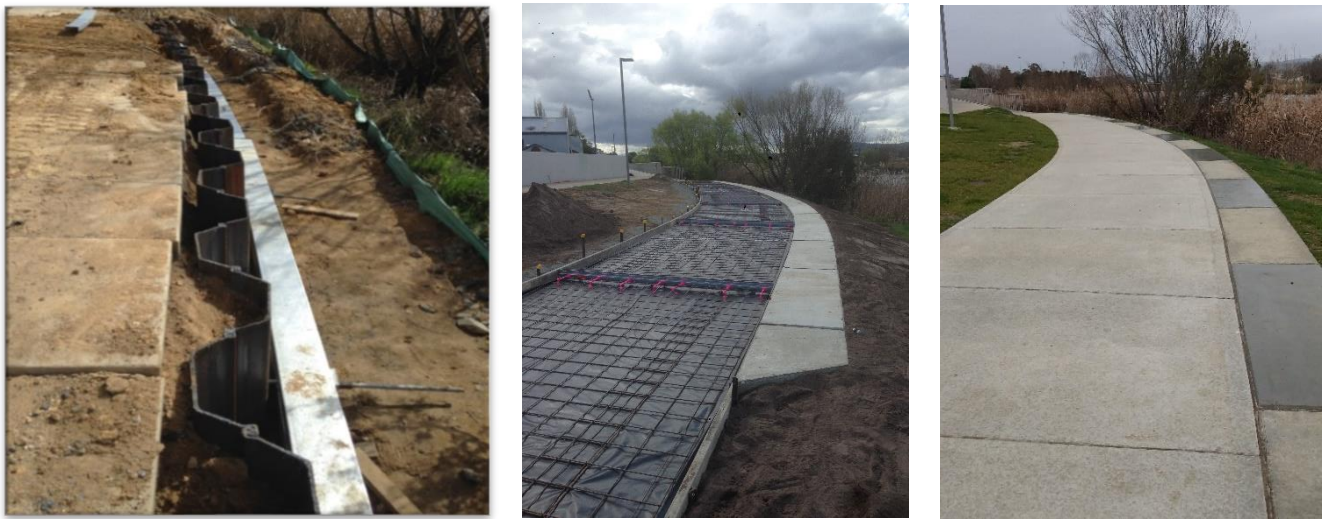
North Esk River stabilisation works with steel piling and tie rods anchoring north of Black Bridge were successfully completed by December 2018. This was followed with reinstatement with reinforced concrete slabs and grass seeding. Movement monitoring is ongoing.

Figure 1. Invermay Levee Stabilisation with steel piling and tie rods, October 2018

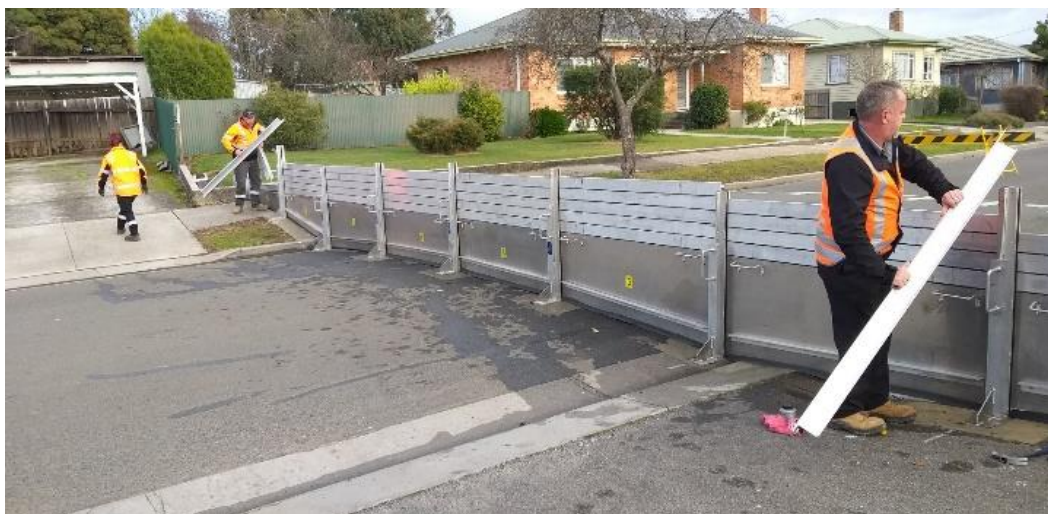
Final completion of the new Newstead Levee was achieved in July 2019. Figure 2 below shows test installation of the new floodgate in Hart Street which forms part of the flood protection system.

Figure 2. Newstead Levee floodgate test installation, July 2019

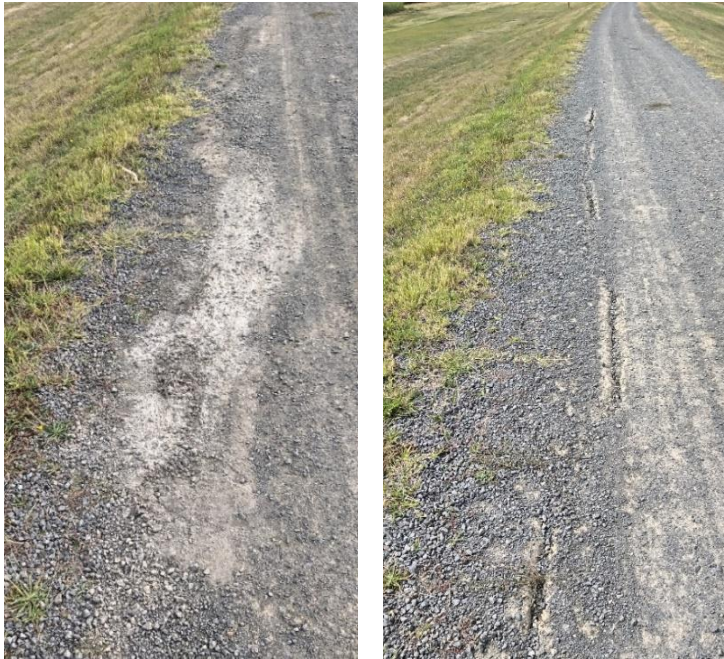
Figure 4. Photos of crack repairs with bentonite slurry Invermay Levee, March 2019

Shrinkage cracks usually appear during very hot and dry summer periods especially in areas with poor soils as in Invermay; we will increase surveillance in those areas and intervene when necessary. The medium to long-term plan is to add topsoil to identified sections so as to improve the quality of grass coverage. Where the settlement is in excess of 30cm we will find the cause and rectify by adding a clay layer before the topsoil and grass seeding.

At the end of summer 2018, we filled shallow longitudinal cracks on the gravel footpath on Invermay Levee between Churchill Park and Heritage Forest, with sloppy bentonite slurry as recommended by Pitt & Sherry's geotechnical engineer as shown in Figure 4 below.

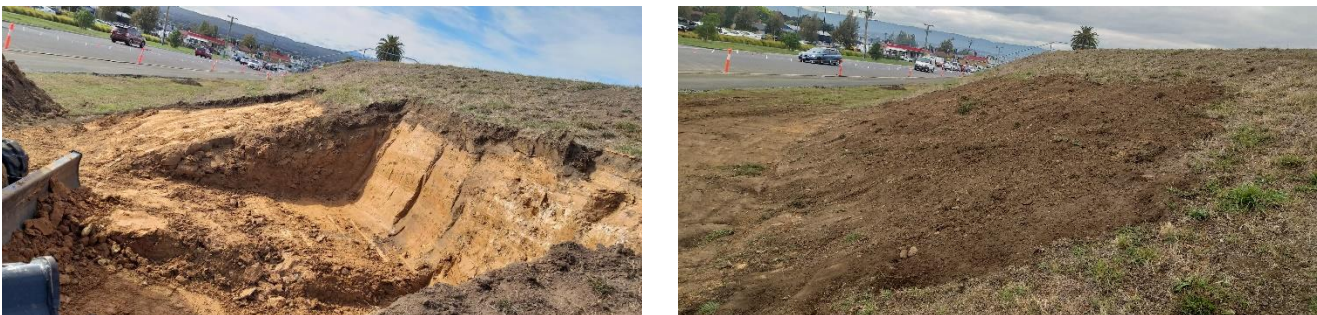
Figure 5. Photos of crack repairs and reinstatement on Kings Wharf Levee, April 2019

We repaired some localised cracks in the Kings Wharf Levee opposite the North Esk Rowing Club by digging out and backfilling in layers with new clay before covering with topsoil and grass seeding. For details see Figure 5 below.

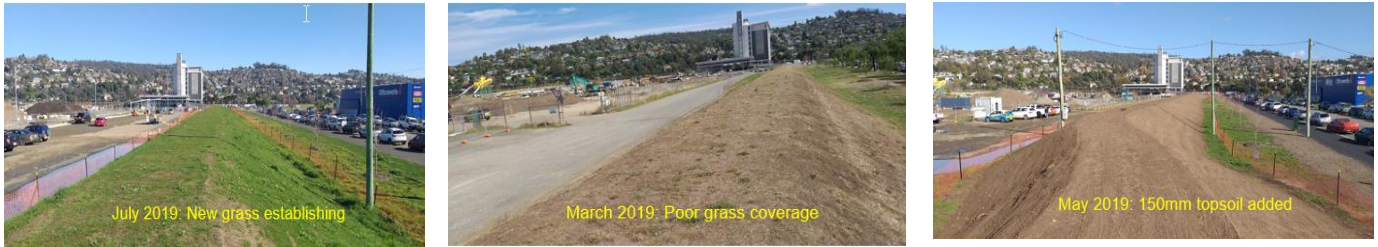
We also carried out repairs to improve grass coverage along bare sections of the earthen levees. Good grass coverage protects the levee from general wear and tear, as well as insulating the underlying clay material from drying out and shrinking in hot temperatures. A good sward of grass acts to protect the soil from eroding should overtopping occur during extreme flood events.

Figure 6. Photos of grass repairs on Kings Wharf Levee, March to July 2019

In autumn we added topsoil and trialed a new hardy grass variety on the Kings Wharf Levee between Goderich Street and Tarooma Street. This was in anticipation of the opening of the new Riverbend Park public facility and potential for increased wear and tear from high pedestrian traffic, that is likely to result in more frequent superficial maintenance on this section alongside Lindsay Street.

Figure 6 shows progressive work to improve grass coverage on the Kings Wharf Levee. We will continue with these improvements on all the levees within our affordable budget.

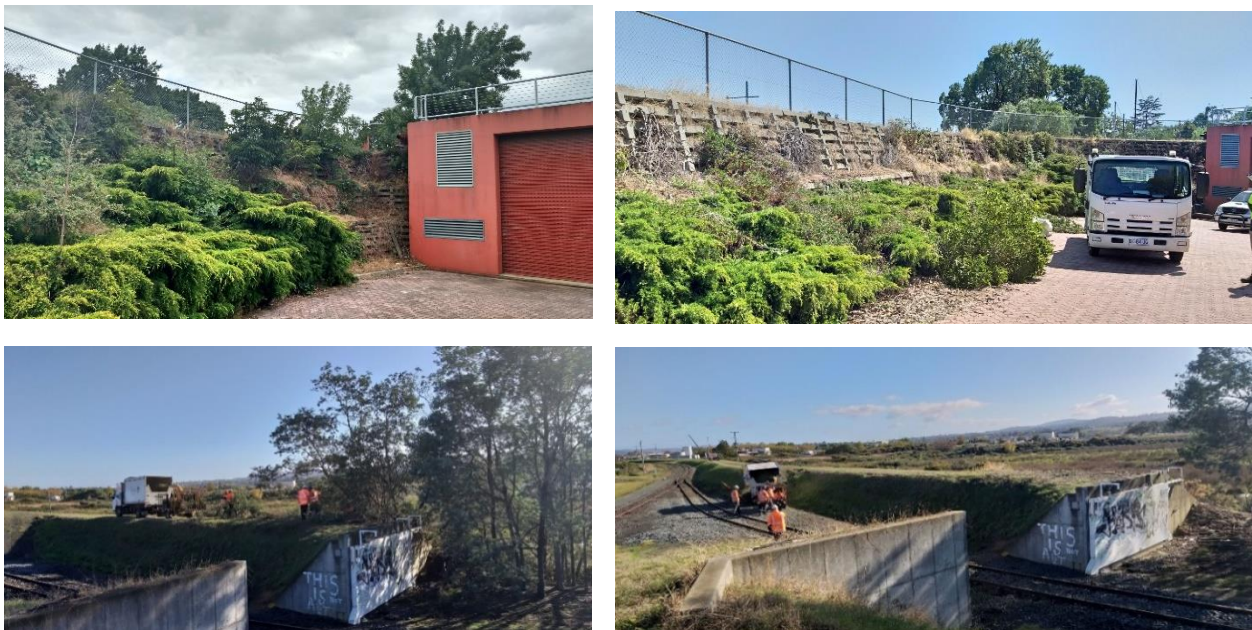
Unwanted and invasive vegetation hinders operational access and visual inspection of levee elements, as well as providing habitat for animal burrowing detrimental to an earthen levee. Decaying tree roots in the levee embankment can act as flood flow paths and a root ball from an overblown tree could initiate a potential breach in the levee. Last summer we removed unwanted trees from various locations on the levees. These were:

- Paterson Levee - difficulties with visual inspection of crib wall at Margaret Street Sewage Pump Station.
- East Launceston Levee near East Tamar Junction rail yard - trees hindered access, gate opening and promoted rabbit burrowing in earthen levee.
- City Levee - south-east side of Charles Street Bridge and Tamar Street Bridge, tree blow over risk mitigation.
- Kings Wharf Levee - sprayed blackberries in stone wall on landside batter, Kings Wharf Road.
- Invermay Levee near Churchill Park - removed self-setting gum trees from destabilising rock revetment in riverside batter.

Figure 7. Photos of tree and bush clearing on levees, March and May 2019

Figure 7 shows before and after photos of some of the clearance of unwanted vegetation done on levees this year.

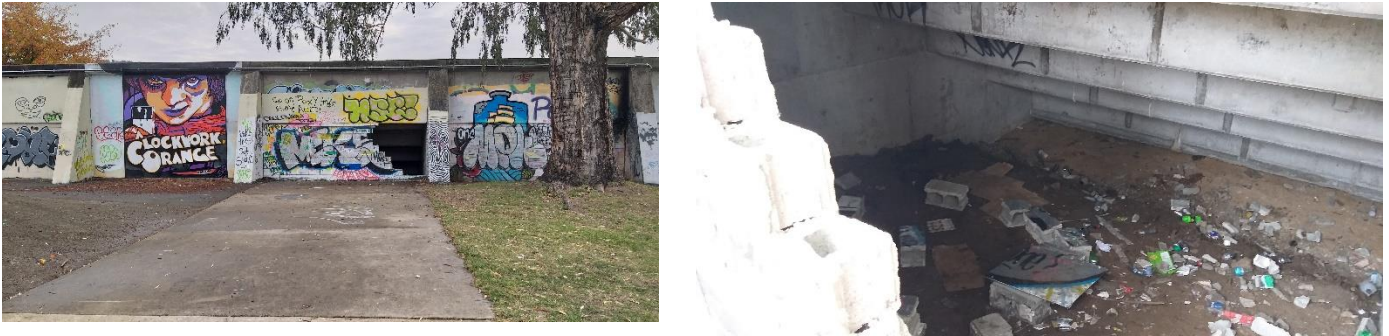
- Repair broken stainless steel cables on elevated public walkway behind QV Museum Inveresk on Invermay Levee (approximately \$2,000 annually),
- Cleanse graffiti on floodwalls and wingwalls on City, Invermay, East Launceston Levees and regatta side of Training Levee (approximately \$2,500 annually),
- Replace with steel panel demolished besser block walls on Training Levee in skate park (two panels replaced, \$2,000 per panel). This may continue as it is a popular gathering area for youths.

Figure 8 shows a vandalised wall at the back of the Training Levee.

Figure 8. Photos of vandalised besser block wall panel, May 2019

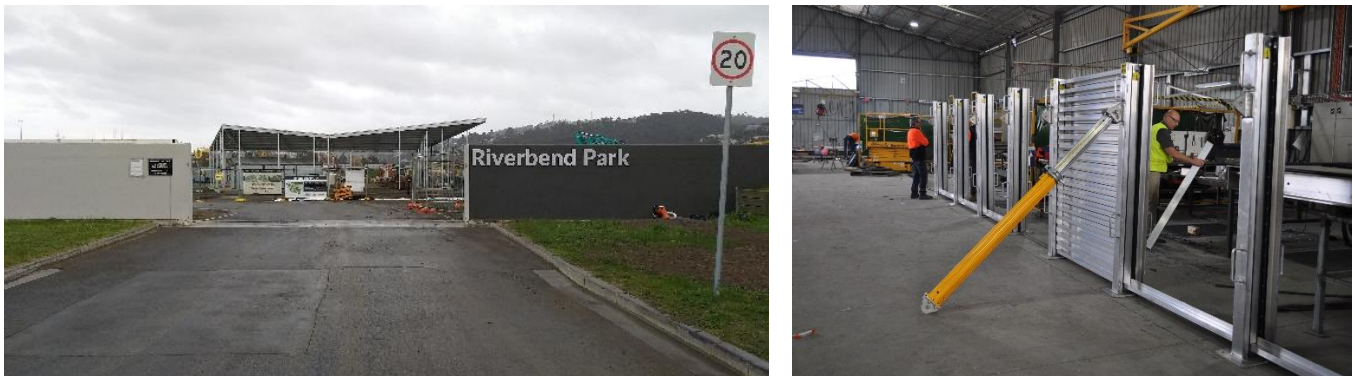
Figure 9 shows the current floodgate at the entrance to Riverbend Park, which is proposed to be widened and renewed with an alternative Bauer gate system.

Figure 9. Photos of existing Tarooma St sliding floodgate and new Bauer gate

A new floodgate system has been manufactured and is currently stored at the Remount Depot in Mowbray; a permanent storage facility will be constructed at the time of installation expected in October 2019. There will be need to modify the existing levee during civil works, to accommodate a wider floodgate and access to Riverbend Park.

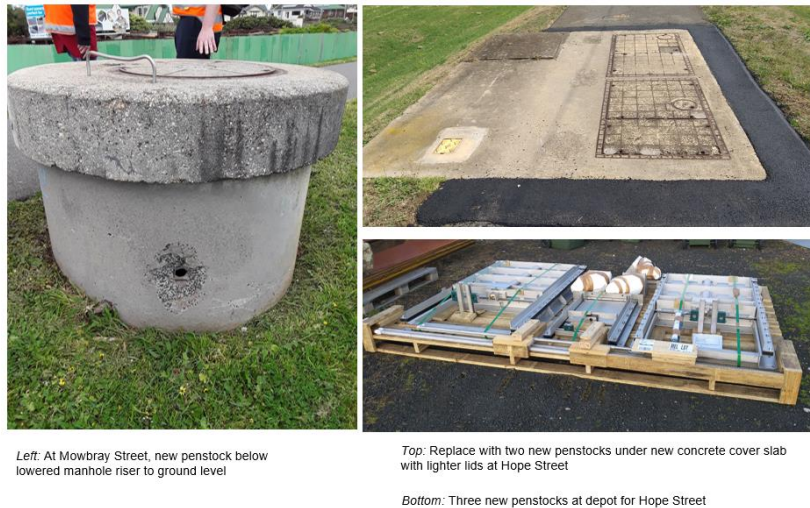
Figure 10. Photo of planned renewal works on Mowbray Levee in summer 2019

Three new penstock gates have been procured to replace the old ones at the western end of Hope Street and Mowbray Street. Details of new installation planned for summer 2019 (Figure 10) are as follows:

- Replace aging cast iron penstocks with new stainless steel penstock gate valves, below-ground.
- Replace rectangular concrete slab and heavy concrete-filled lids with lighter terra firma access covers incorporating safety cages to improve operational and public safety.
- Lower to ground level damaged raised manhole riser to facilitate safer access to below-ground penstocks.
