Launceston City Council - Albert Hall Renewal Project Recommended Works (rev.1)

Document produced on 16th December 2020

Client: Launceston City Council
Project: Albert Hall Renewal Project

CONDITION REPORT – AREA #1

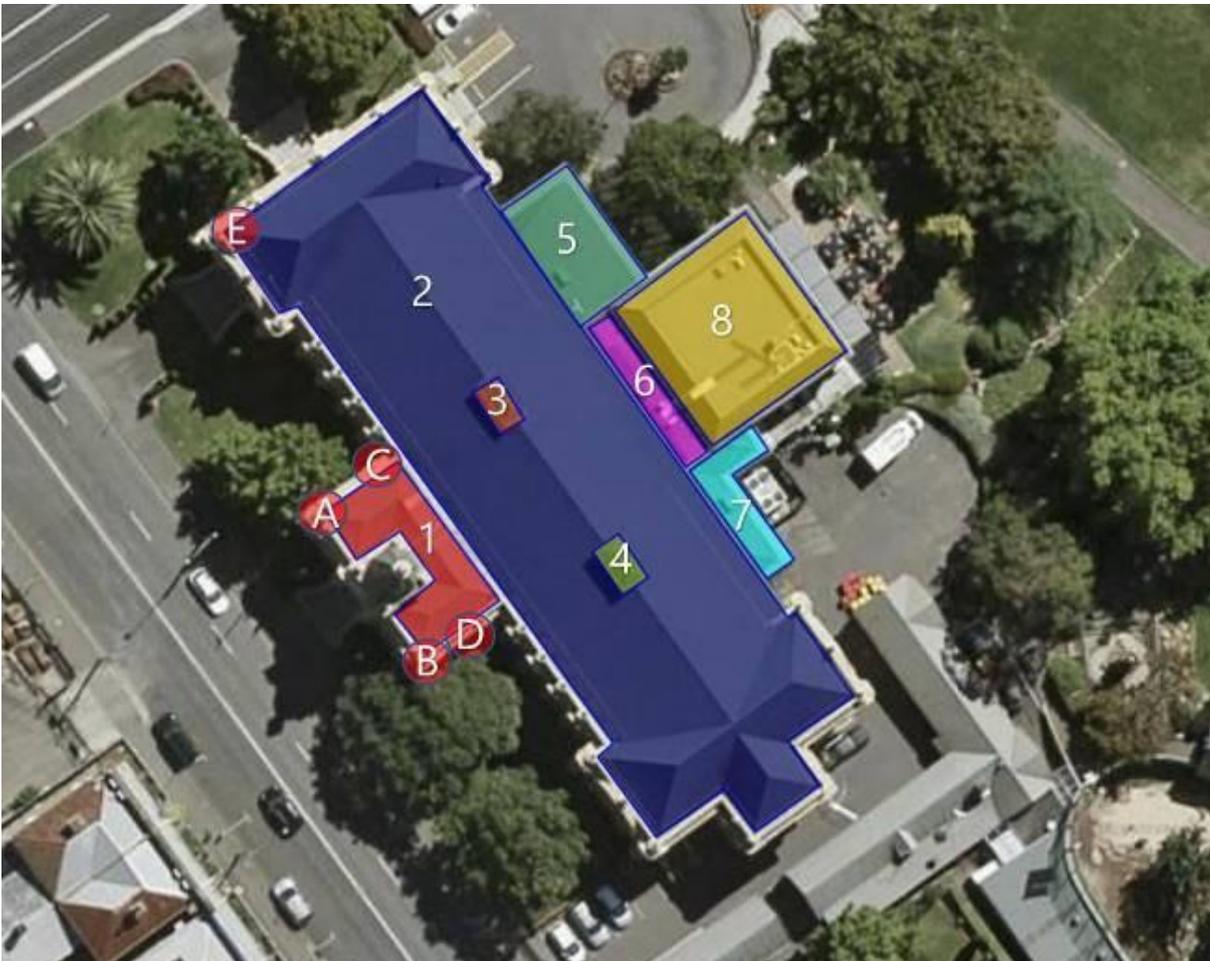
This report covers the roofing, gutters, flashings and other associated roof items on the Albert Hall located at 47 Tamar St, Launceston. For ease of identification, the building and this report have been split into eight (8) areas. There are also five leaks that are causing visible damage to the interior of the building noted as areas (A,B,C,D & E) as outlined in the map below. The overall condition of the roof seems in reasonable condition and potentially the best solution is to repair/replace areas that have the potential of causing water ingress within the building rather than a full replacement. The roof cladding profile (Trimdek) is unusual to see on heritage buildings and is more suited to less frequently traversed areas such as warehouses. Trimdek cladding is easily damaged when stepping on the ribs of the profile. The report outlines the most important maintenance and repairs to bring the roof up to scratch. It also lists the repairs that in our opinion improve the longevity of the existing roof cladding by addressing any preventable further deterioration.

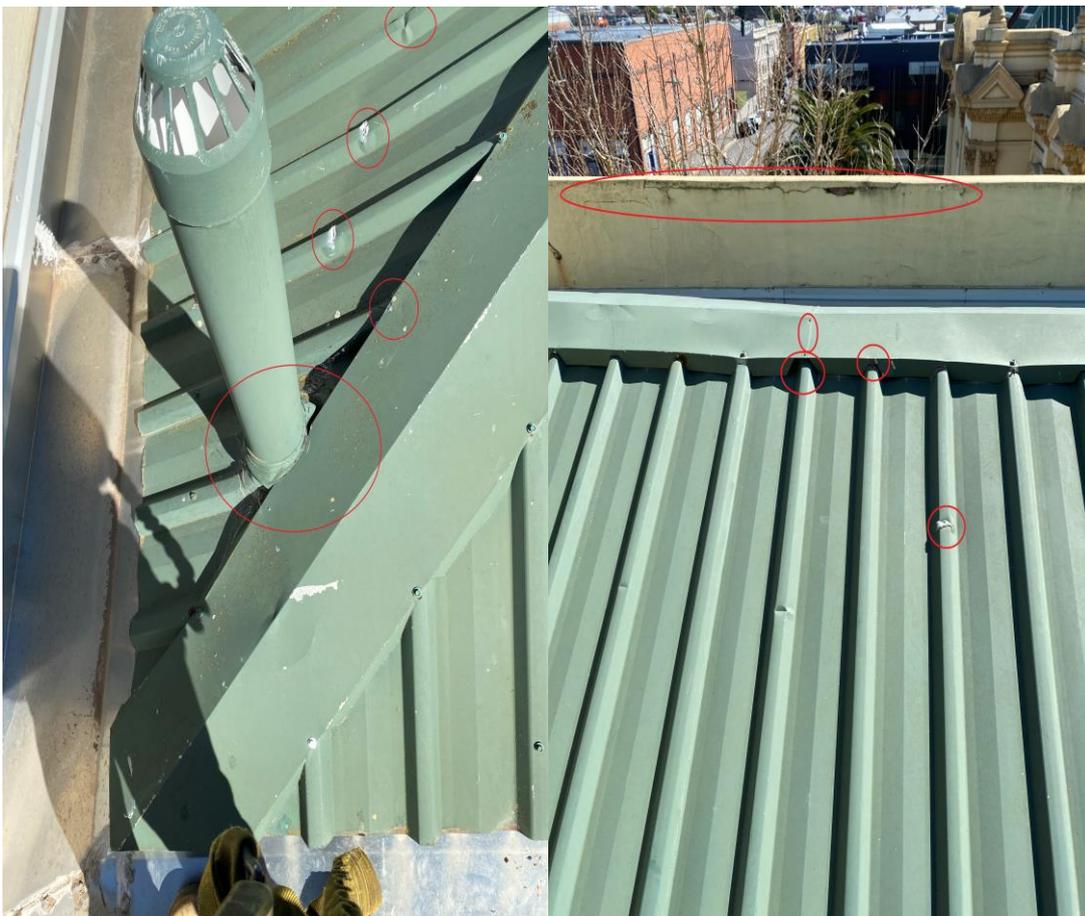
The roof cladding in this area is in very poor condition with many dents, holes and previous Band-Aid repairs.

The following options should be considered:

- A. In our opinion replacing this section of roof would be the best option for this area.
- B. Repairing this roof would require capping all existing dents and holes and adjusting the sheeting to lap correctly and re-screwing back down with new screws.

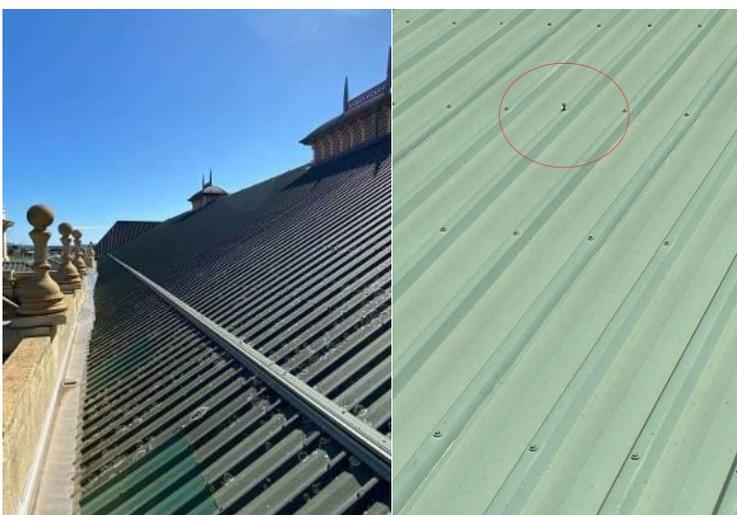
The roof cladding in this area is in an acceptable condition however there are lapped areas where the gutter has been replaced and patches in some other areas throughout. In our inspection several loose screws could be seen on most elevations of the roof and some of the screws seem to be corroded.

In our opinion replacing this section of roof would be the ultimate assurance that there is no potential for further leaks for this area however there is scope to gain a possible 10-15 years of life if some preventative maintenance takes place.

- Replace roof screws as required.
- Replace some of the poorly lapped sheeting.
- Patch dents and holes throughout.
- High pressure wash areas with a large amount of lichen and re-paint.
- Water testing may be necessary during the repairs especially with leak E.

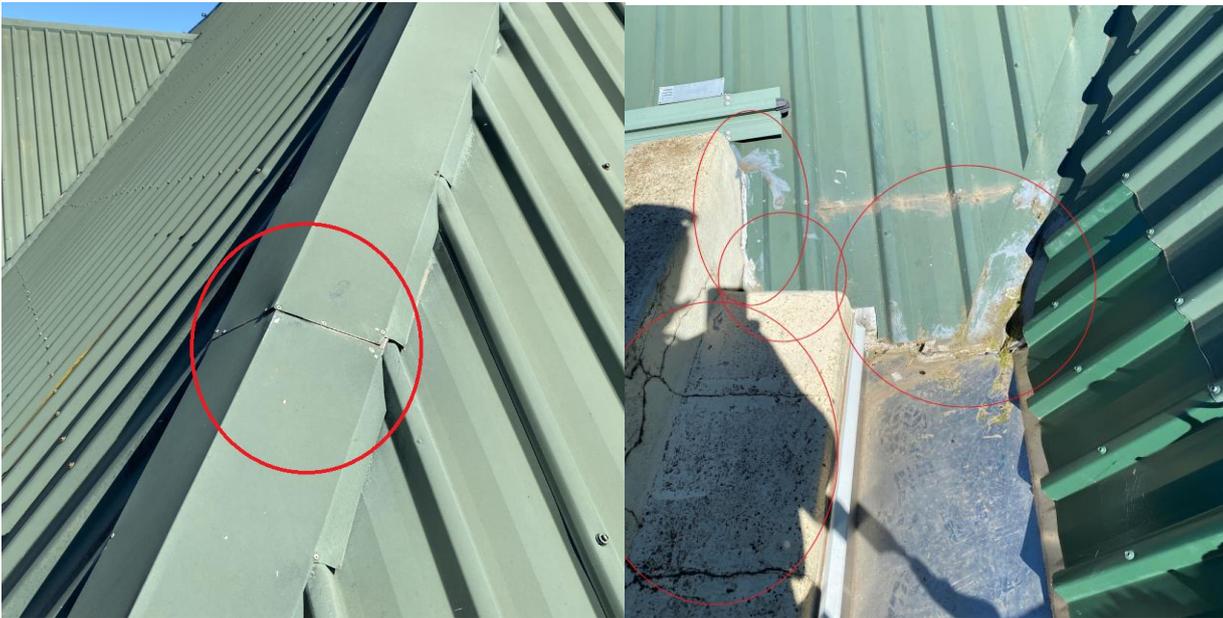
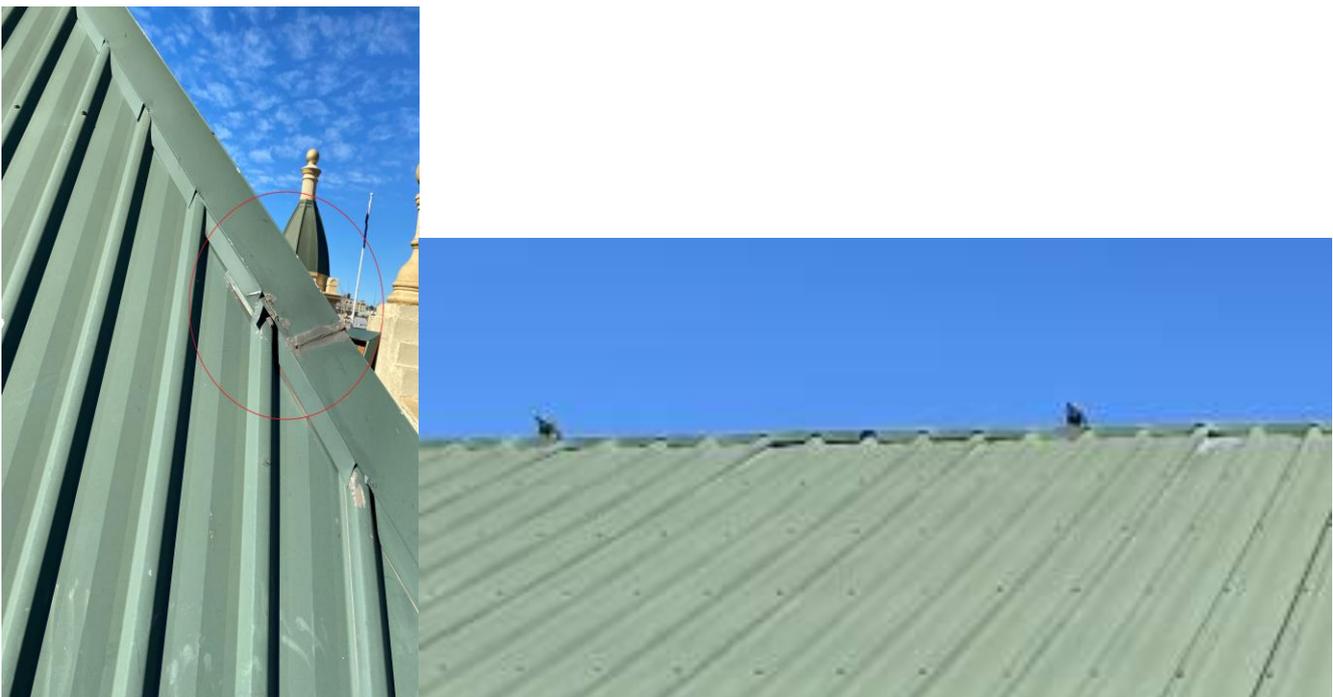
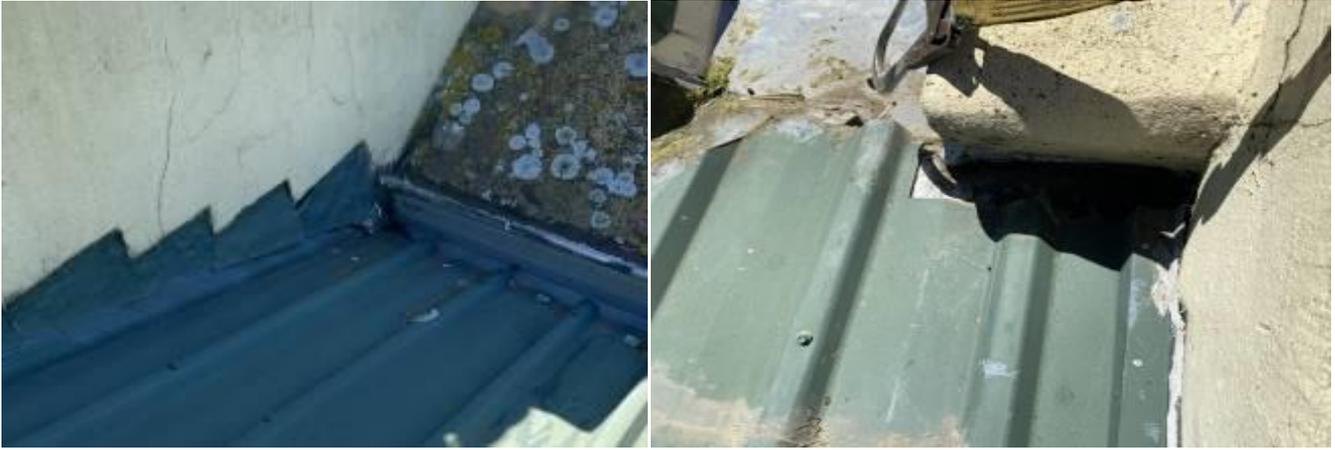
2.2 - FLASHINGS & CAPPINGS

The overall condition of the flashings and capping's in area #2 are in reasonable condition.

The following maintenance tasks are required to rectify this item:

- Replace/repair existing ridge capping's throughout. If repairing using correct fixings on each rib of the cladding would be required to ensure the two metals are stitched together.
- Additional flashings to intersection of parapet wall, valley and roof/box gutter on the north eastern side of the steep roof.
- Re-fix lead apron reglets to parapet wall.

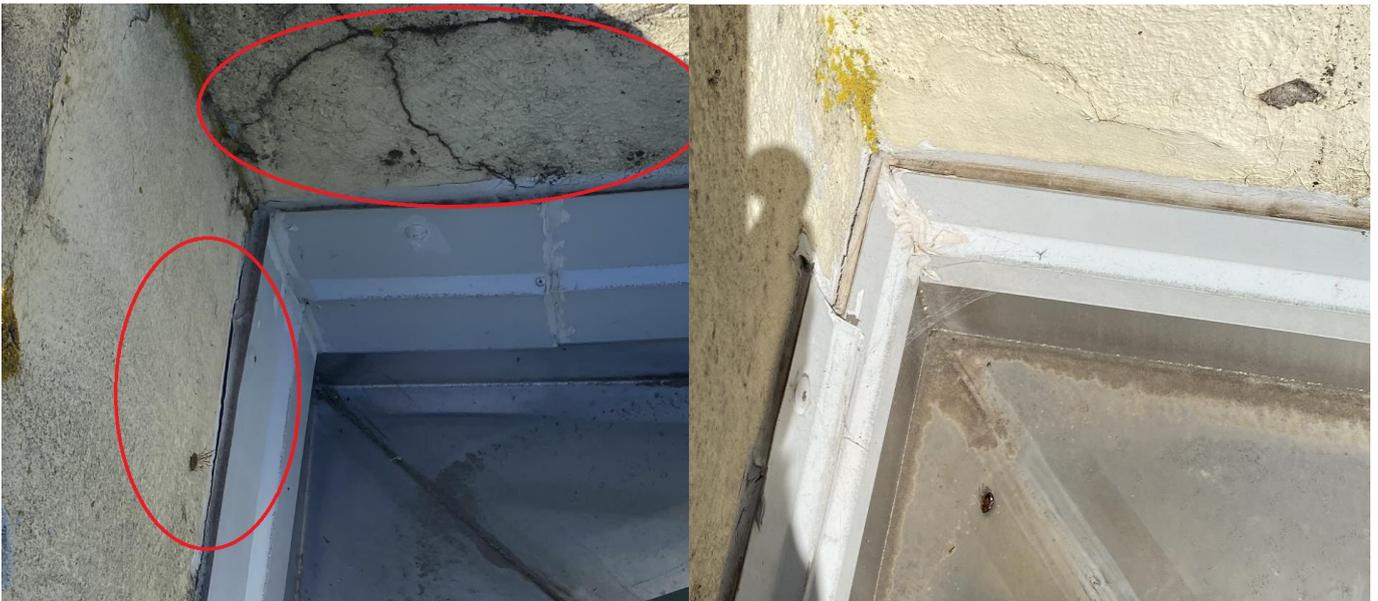
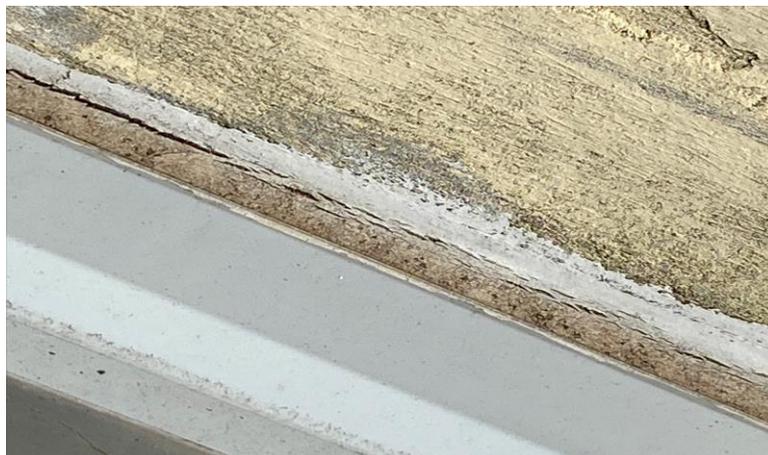
2.3 – PARAPETS

The overall condition of the parapets is poor with cracks in some areas.

The seal on top of the reglets has deteriorated in some areas causing large visible cracks that could cause water ingress.

The following maintenance tasks are required to rectify these items:

- Repairs to cracks in parapet walls.
- Re-seal reglet intersection with parapet wall.

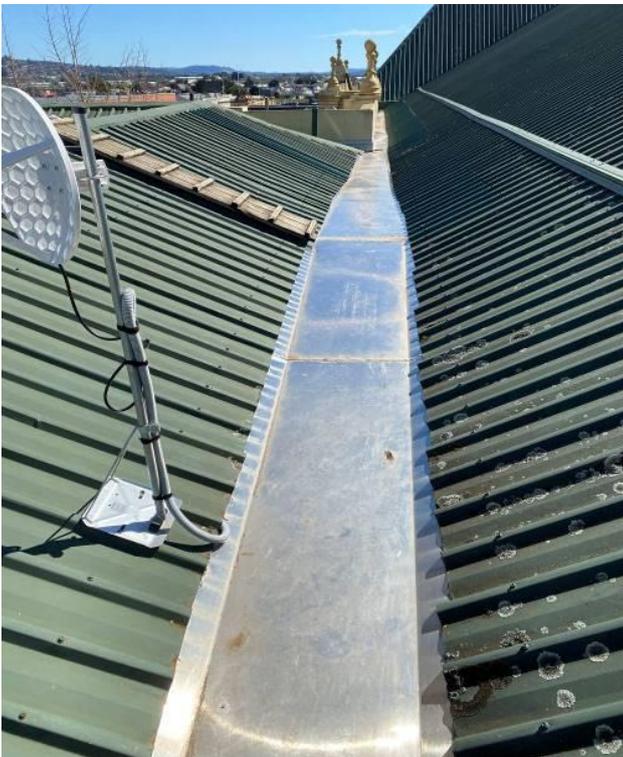
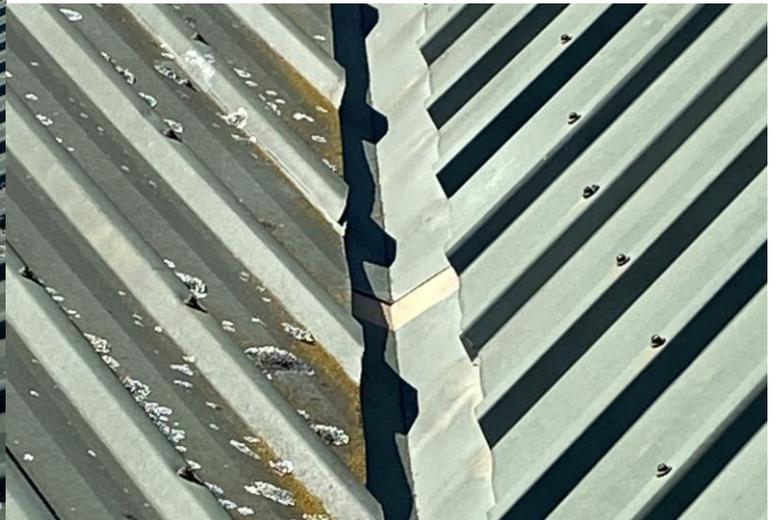
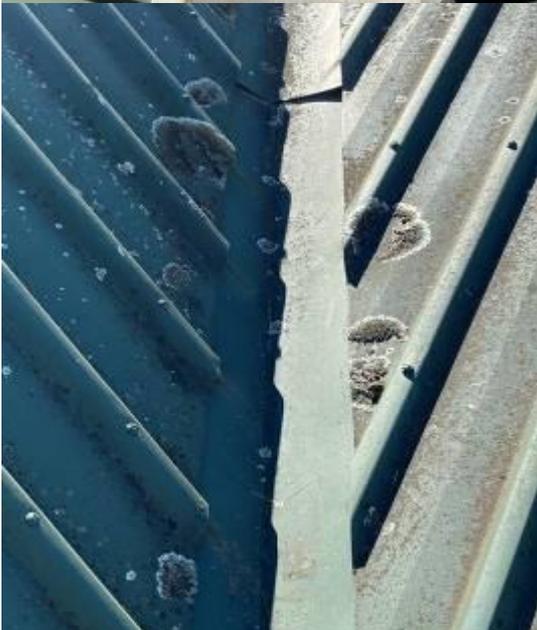
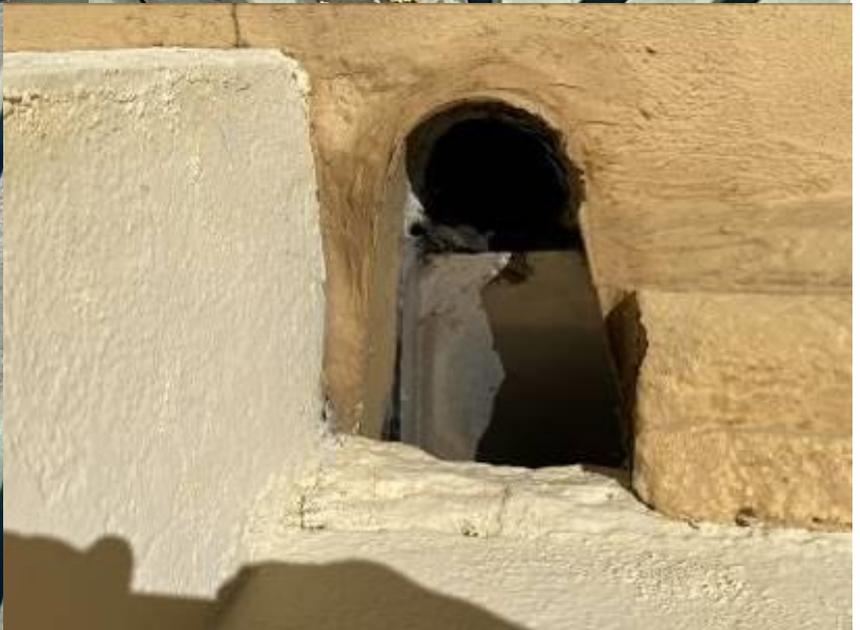
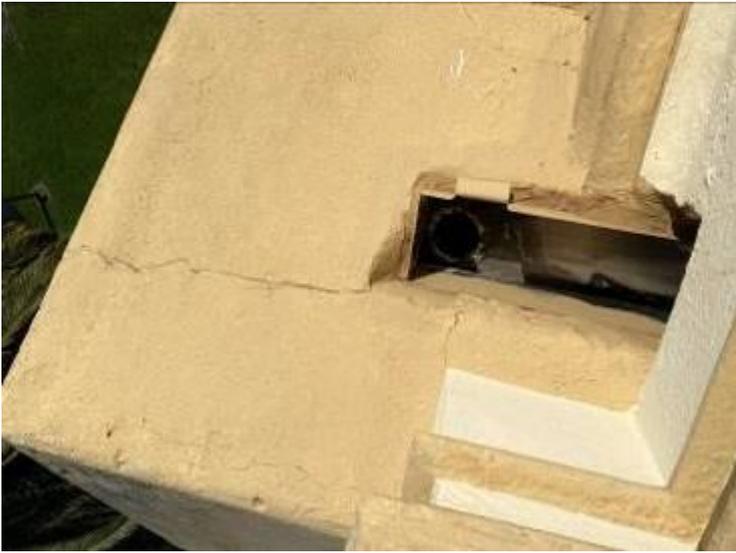
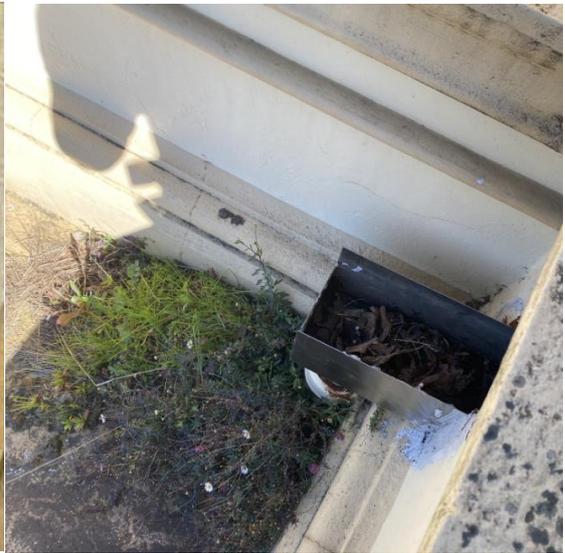
2.4 – GUTTERS

The box gutters are in good condition as they are stainless steel and were only replaced in the last 10 years however it would be diligent to clean back the joints and over seal them as the silicone deteriorates with time.

The outlets that run through the parapet walls require re-sealing on the façade side of the parapet wall. This could be the possible cause of leak E on the locality plan. A rainhead with overflow would be a solution to the downpipe outlets but may require further design input from a hydraulic engineer. The valley gutters on the North West and South West have slipped on the joints. The steep 50 degree pitch is also a concern with the flow of water into the valleys gaining momentum and hitting the turn up on the back of the 30 degree sides. This could cause the water to flow over the back on the 30 degree side of the valley and may be an ongoing issue that may be resolved with some re-designing. The eaves gutters also seem to be in acceptable condition on the eastern elevation.

The following maintenance tasks are required to rectify these items:

- Replace valleys. Re-design valley gutter profile.
- Clean back the joints and over seal all box gutter joints.
- Rainheads with overflows at outlet locations.

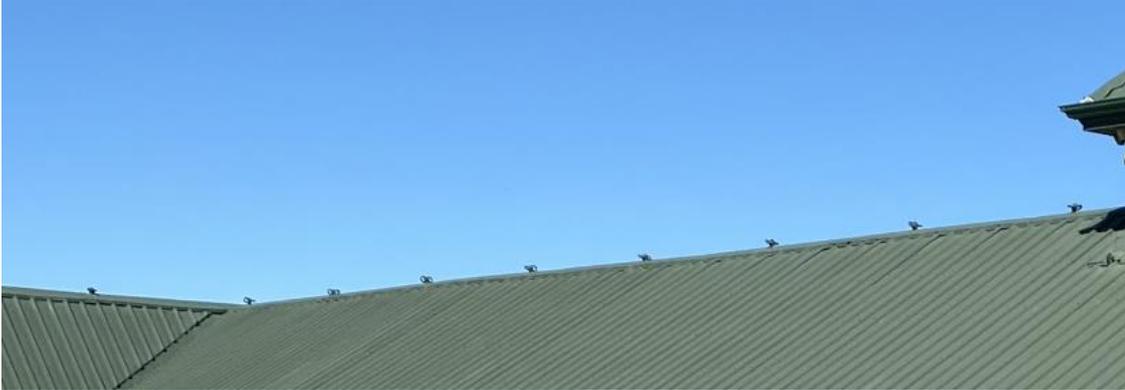
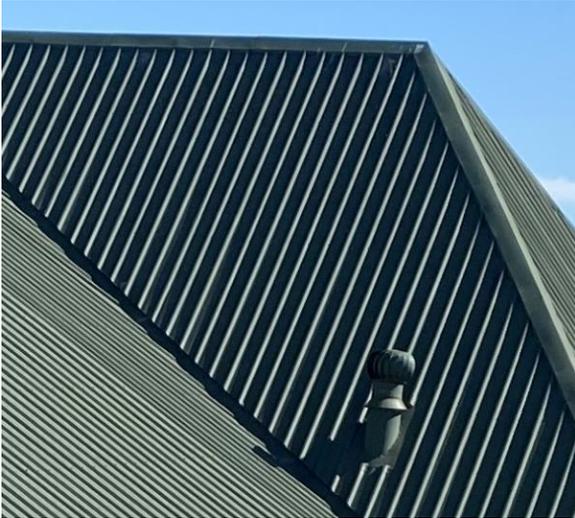
2.7 – PENETRATIONS

The top ridge has some anchor penetrations along the north south direction that have caused leaks in the past. These penetrations are just cut through the ridge and don't have Dektites to provide an appropriate seal.

The following maintenance tasks are required to rectify these items:

- Install rubber Dektites to ridge anchor penetrations.

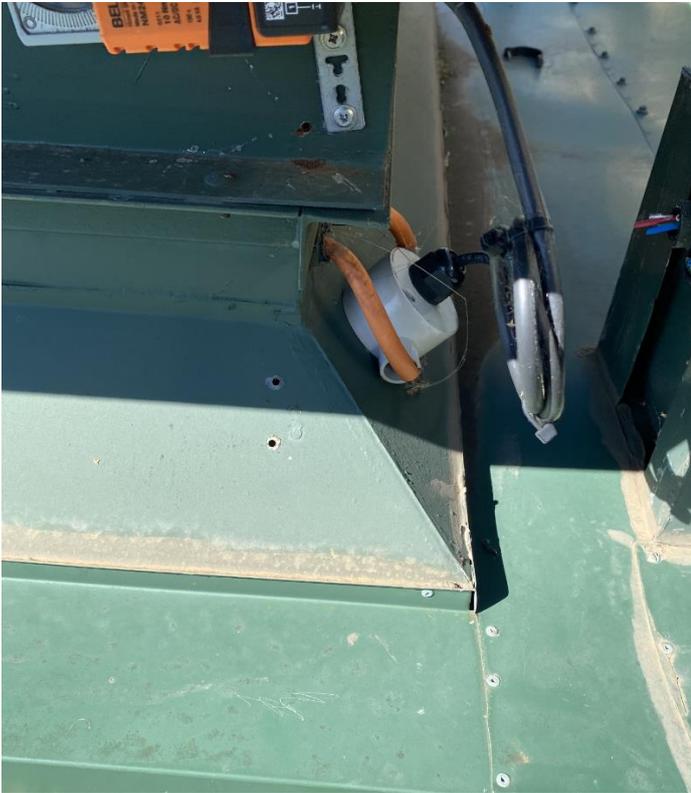
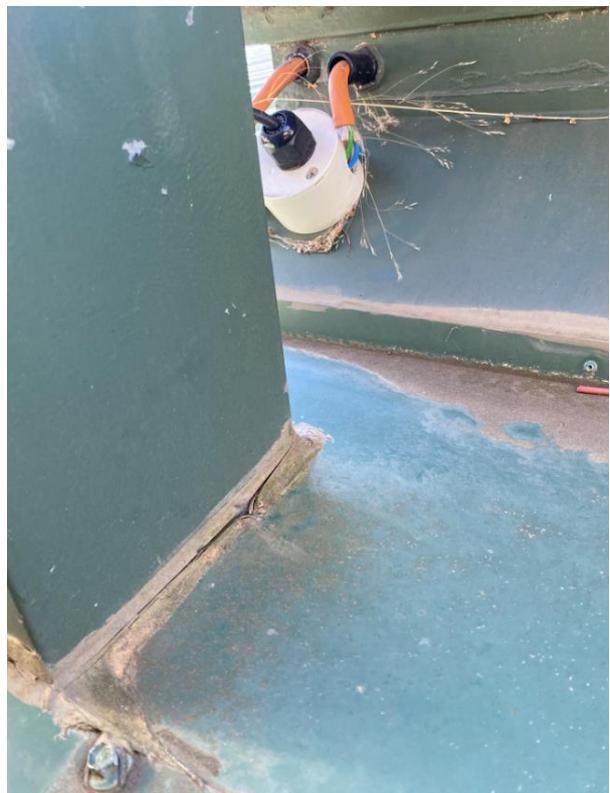
The mechanical roof penetrations have some gaps and cracks.

The following maintenance tasks are required to rectify these items:

- Replace existing trays and aprons around penetration.

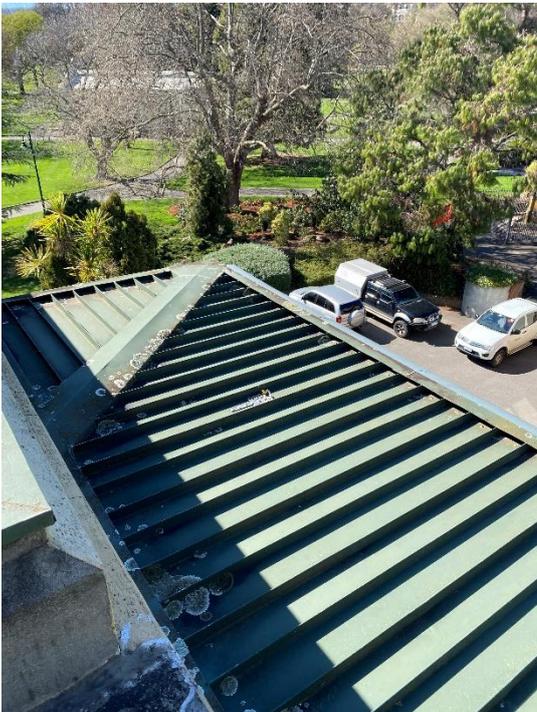
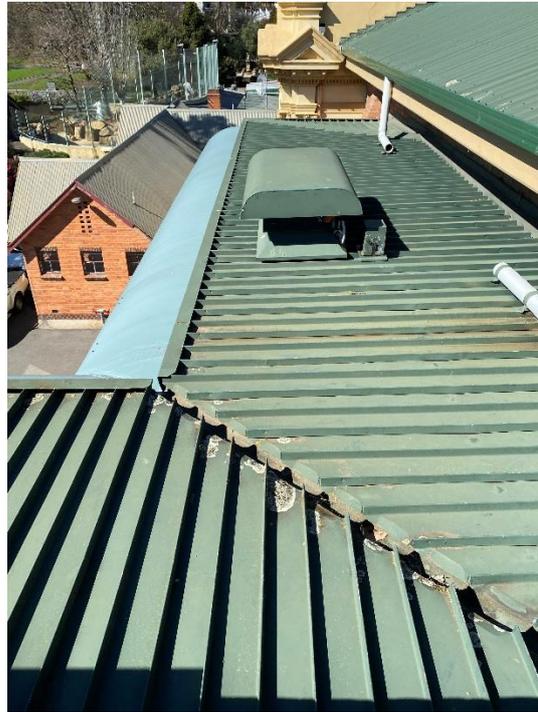
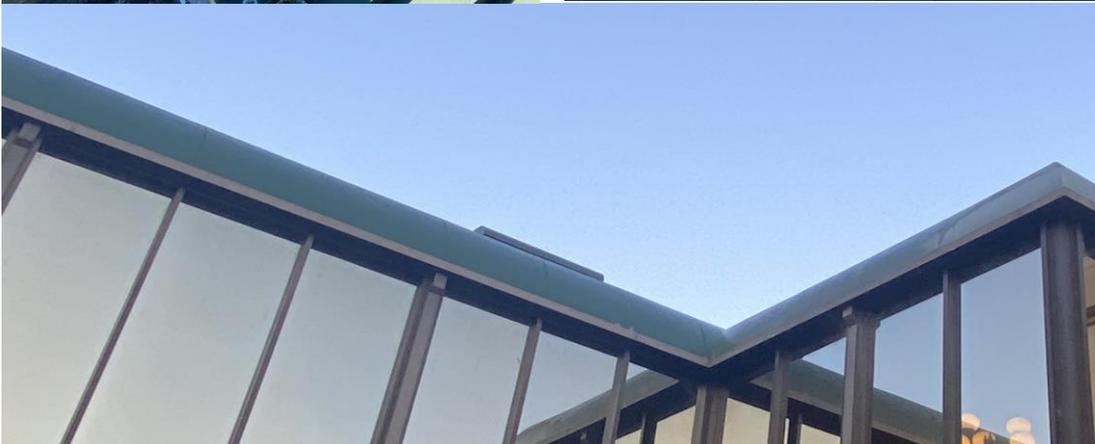
The roof cladding appears to be in good condition with no visible deep corrosion or holes.

The following maintenance tasks are required to rectify these items:

- This roof could use a clean to remove lichen followed by a new coat of paint.

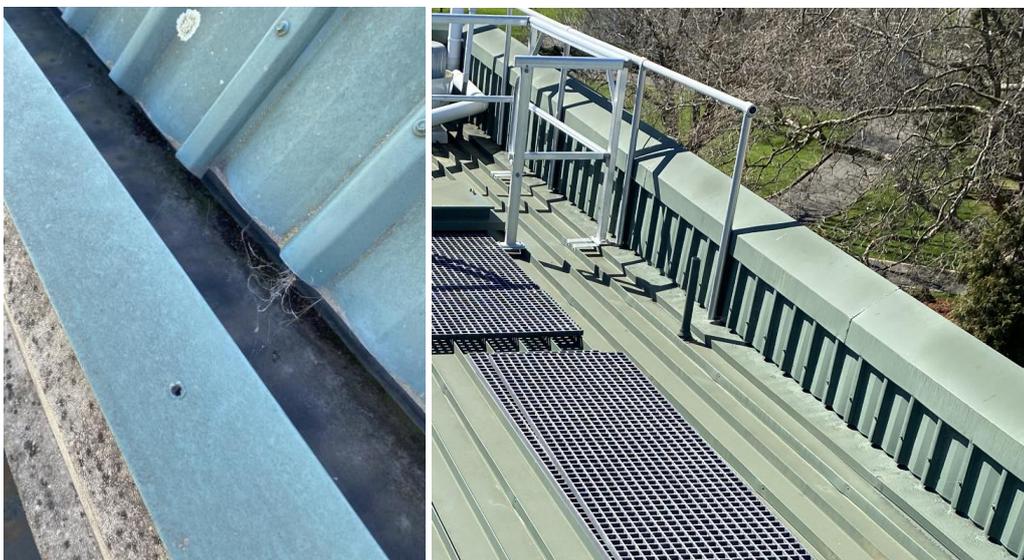
8.2 - FLASHINGS & CAPPINGS

The parapet capping has some missing fixings and is coming a little loose in the areas that were examined. The aprons are in good condition.

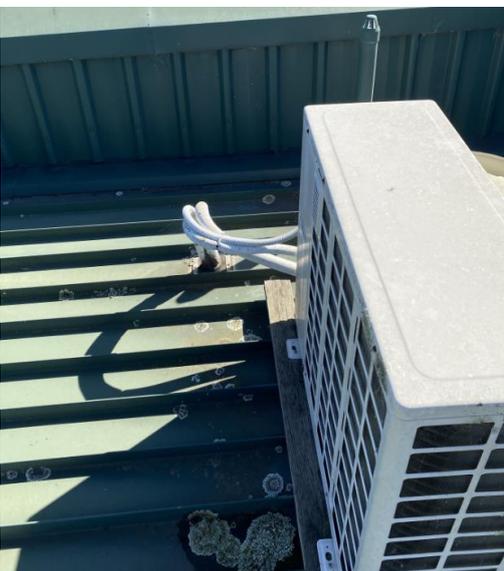
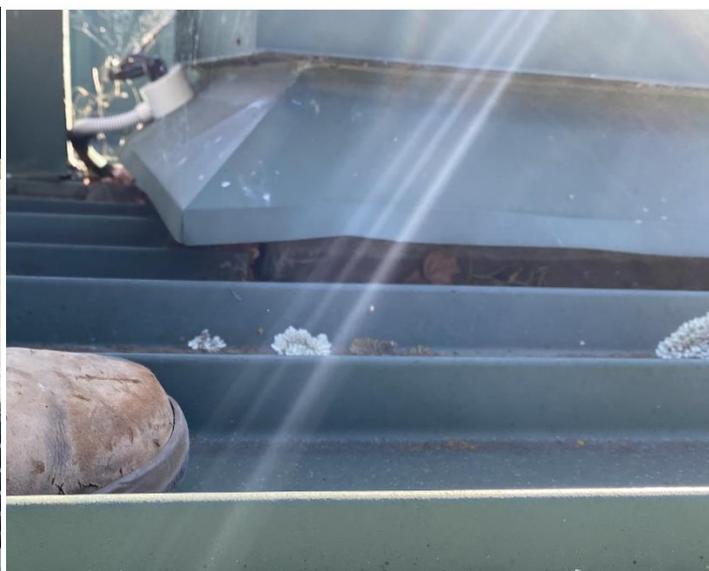
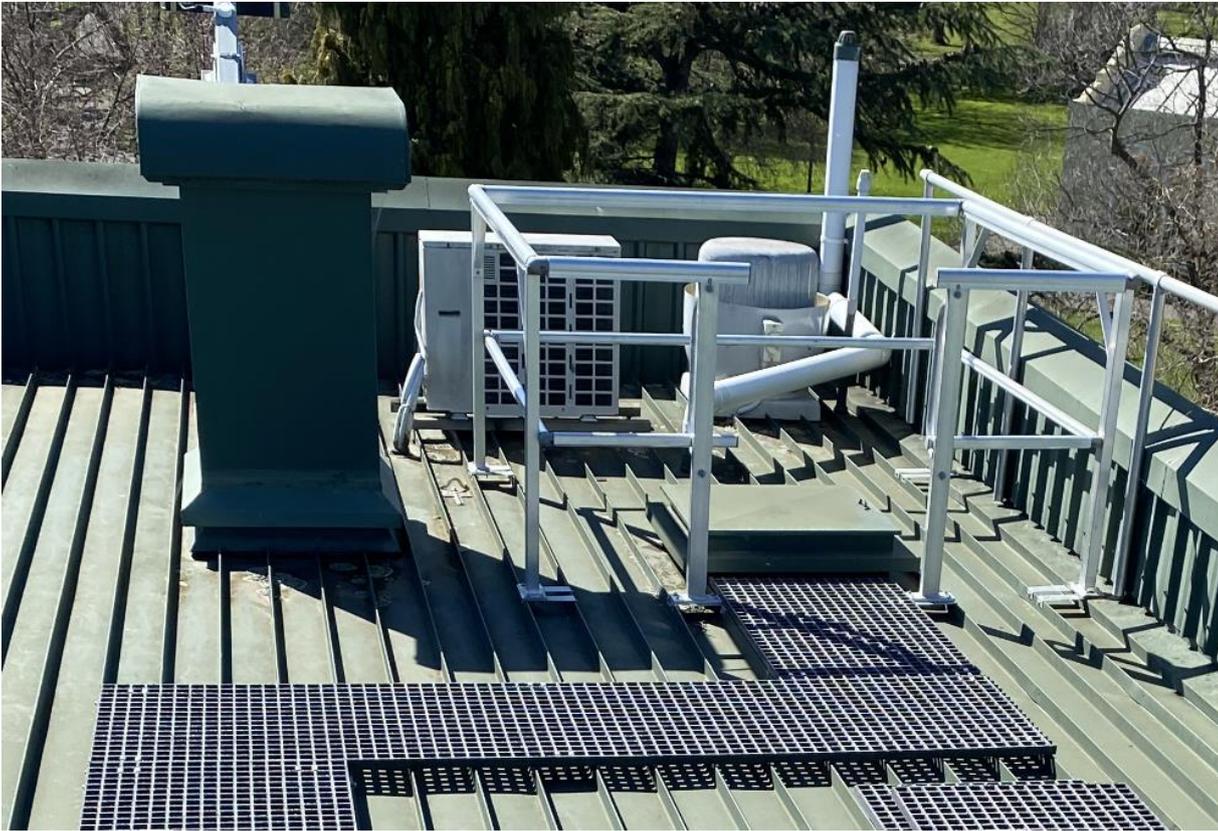
The old method of using soaker flashings on penetrations is seldom used these days due to their tendency to leak.

The following maintenance tasks are required to rectify these items:

- Determine if the ducts and AC are still in use and Install new trays, aprons and Dekites around penetrations.
