**RE: Development Application DA0490/2017 (City of Launceston) for 27 Benvenue Road, St Leonards**

# REPORT

For DARREN & LEEANA WRIGLEY

# Structural Survey (Boundary Wall)

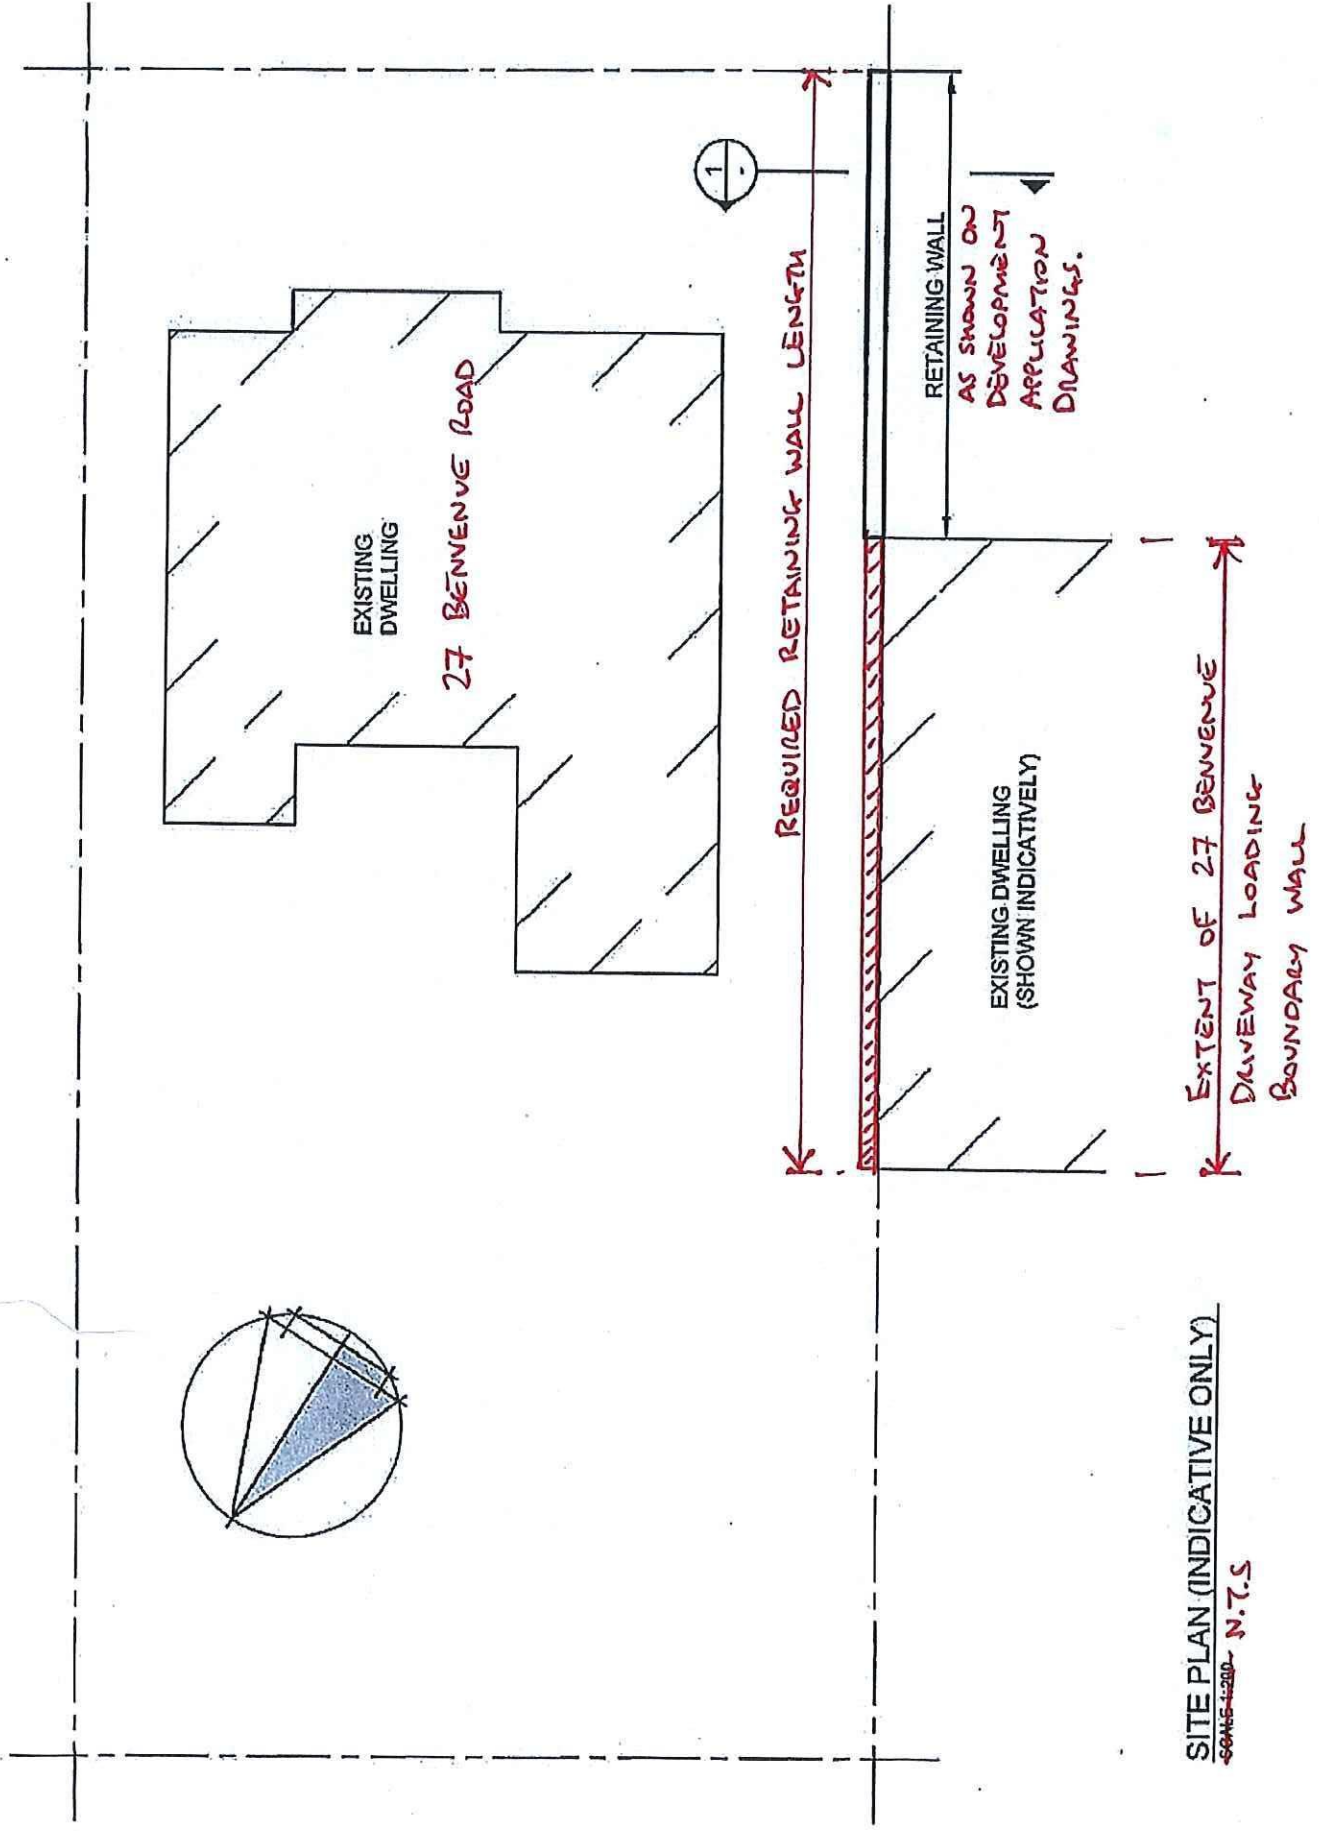
Skol

We believe, from a structural perspective, that the retaining wall shown on the development application, should be extended to retain the full extent of the concrete driveway, as shown on the attached sketch SK01, so as not to load the boundary wall.

RETAINING WALL AS SHOWN ON DEVELOPMENT APPLICATION DRAWINGS.

EXTENT OF 27 BENVENUE DRIVEWAY LOADING BOUNDARY WALL

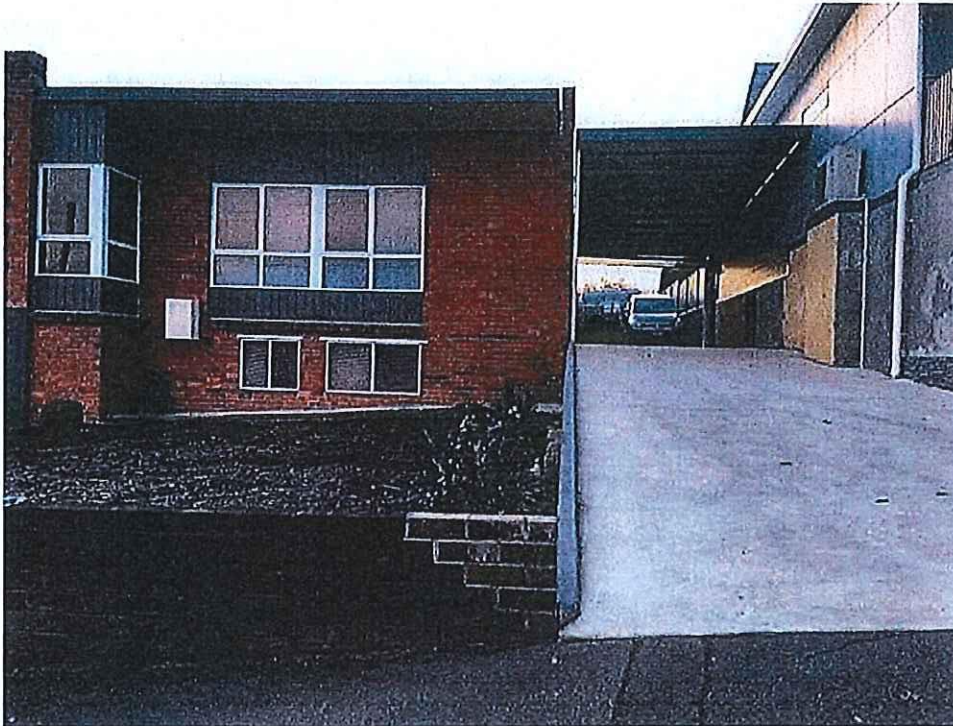
Photo 1 - Photo looking north west along the property boundary. on the left, 27 Benvenue Road on the right - note new concrete driveway and carport.

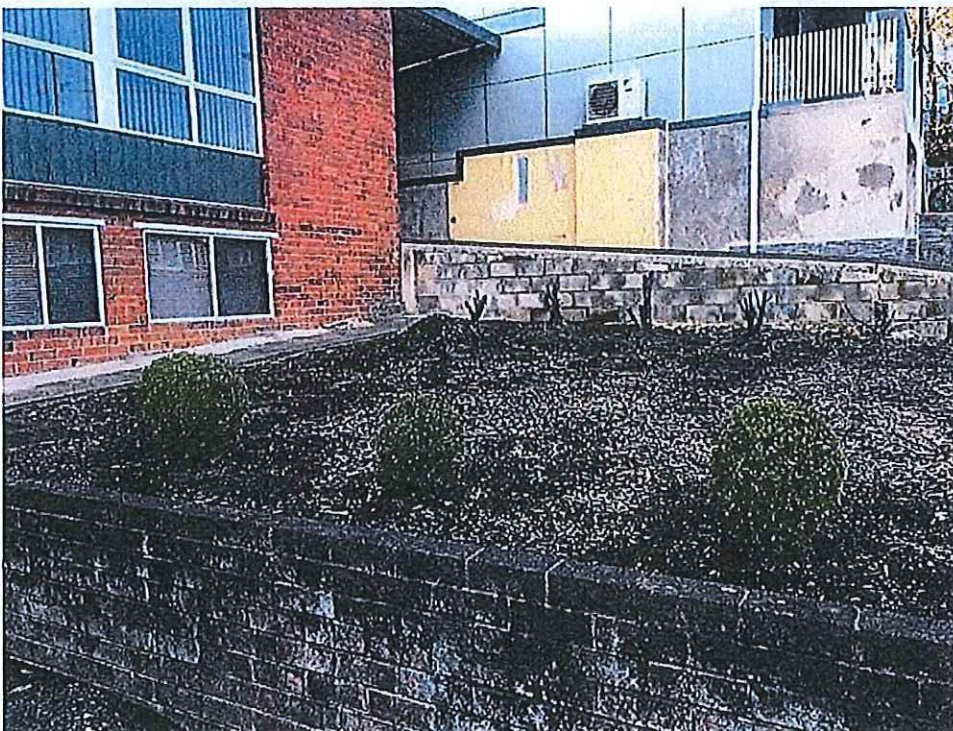
Photo 2 - Photo looking north from driveway. Note concrete block driveway retaining wall for 27 Benvenue Road.

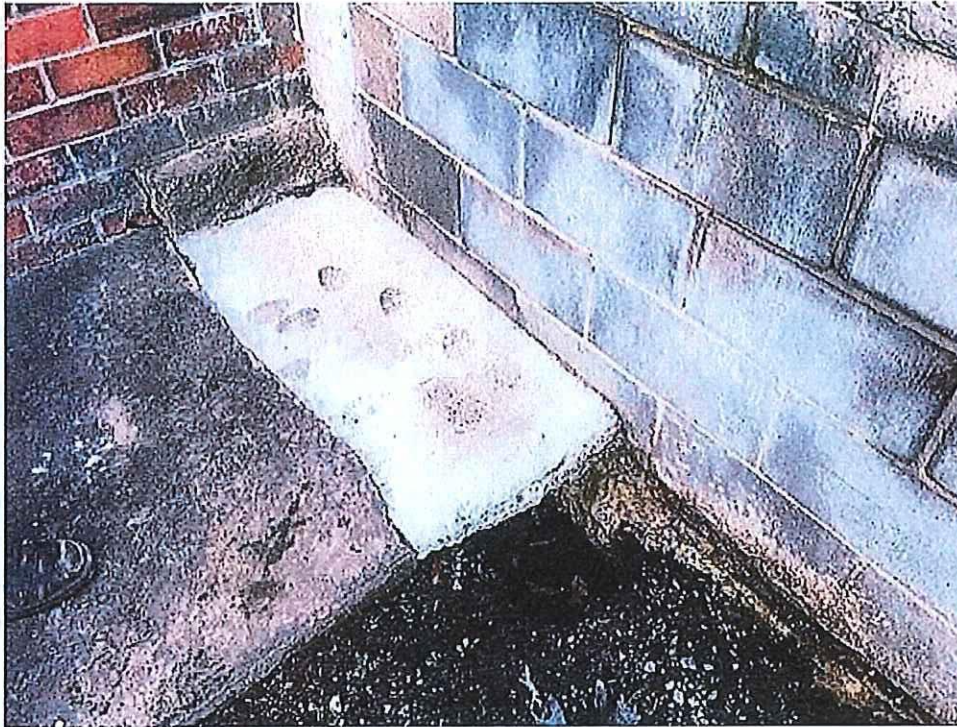
Photo 5 - Photo showing intersection of boundary retaining wall and brick wall. Note concrete works performed as part of construction works for 27 Benvenue Road.

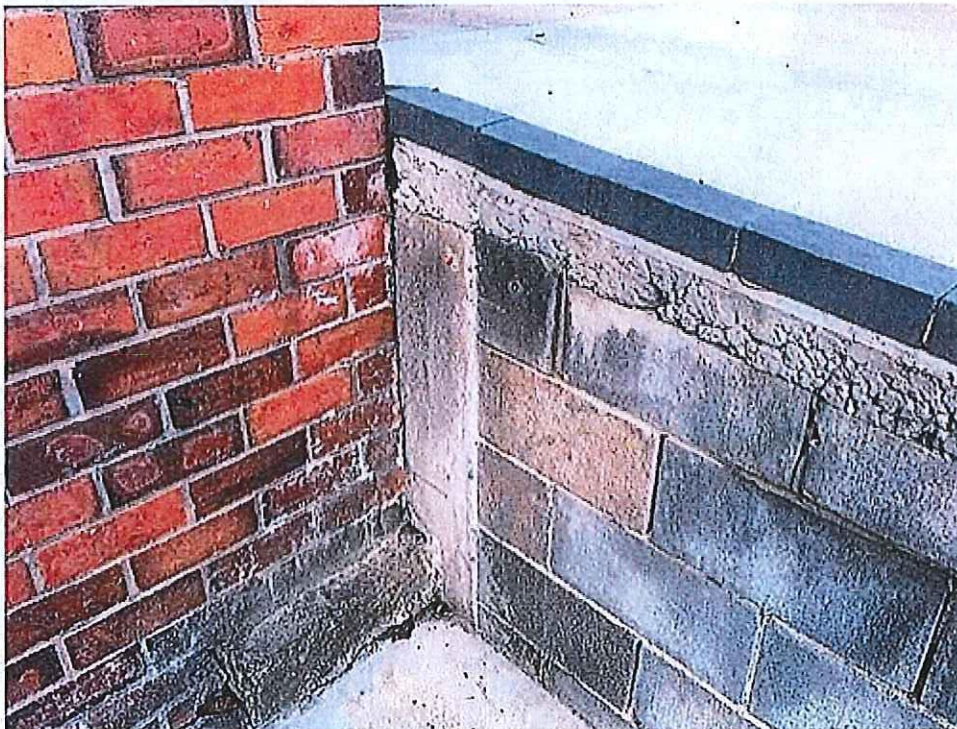
Photo 6 - Photo showing intersection of boundary retaining wall and brick wall. Note concrete works performed as part of construction works for 27 Benvenue Road.

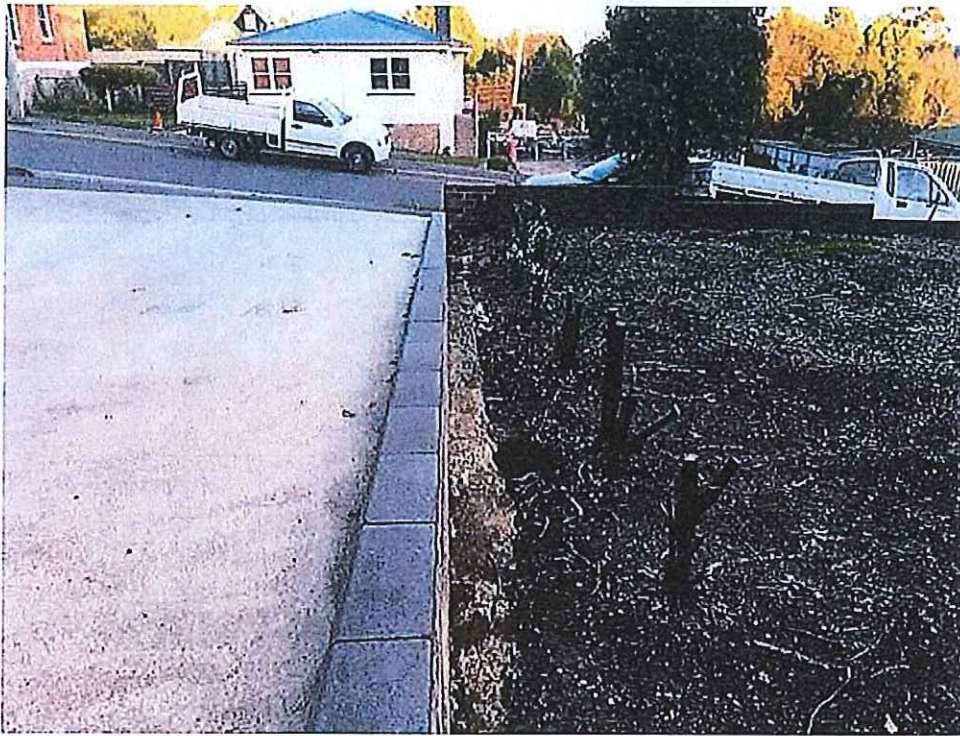
Photo 9 - Photo looking south east along property boundary retaining wall. Note paved kerb against boundary wall.

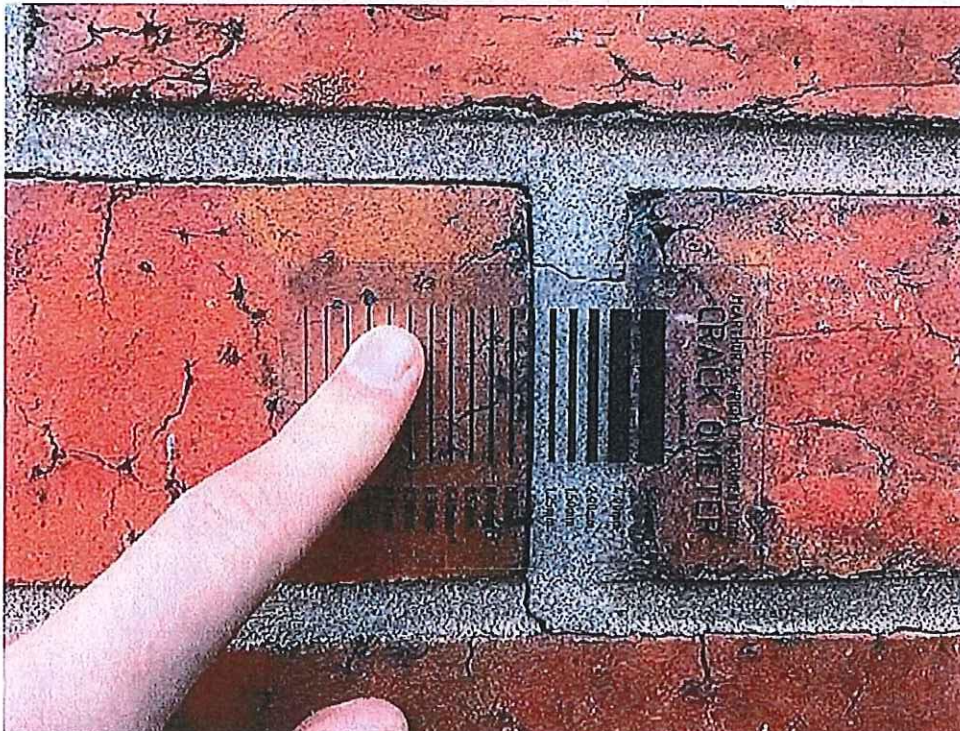
The house was observed to have some external cracking in the brickwork at three locations. Cracks in these locations were measured. The largest crack was approximately 2 mm wide, but otherwise the cracks were generally less than 1.00 mm (refer Photos 10-15 & 21 in Appendix A and Appendix B for locations).

Photo 10 - Example of 'fresh' cracking to south east (front) wall, note location in Appendix B - crack width noted as 1.0 mm.

4. Should repair works to the noted damage at \_\_\_\_\_ be required, we suggest that making good to the cracking be by re-pointing brickwork or where cracking has occurred within the brick by injection of an approved filler.

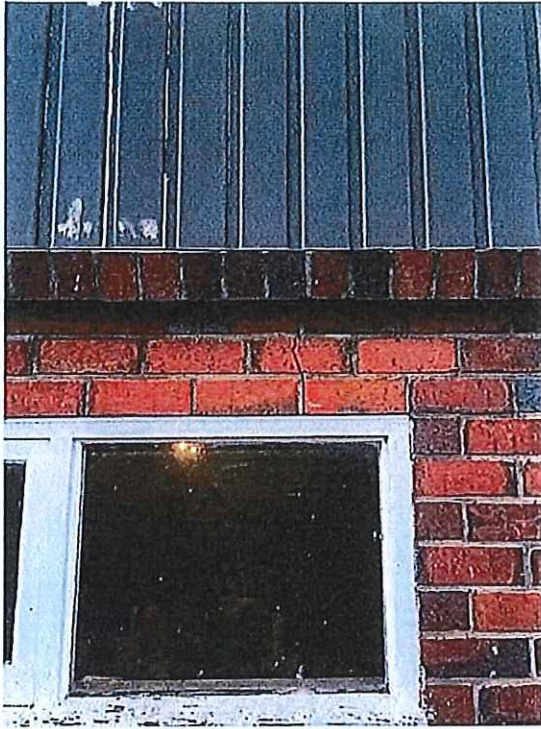
Photo 14 - General view of south west face at location of crack shown in Photo 13 and movement to timber cladding.

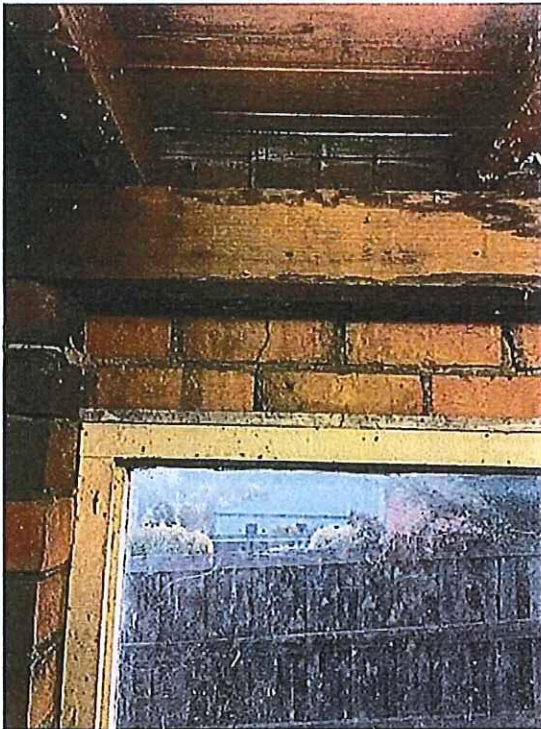
Photo 15 - Internal view of Photo 14. Note crack.

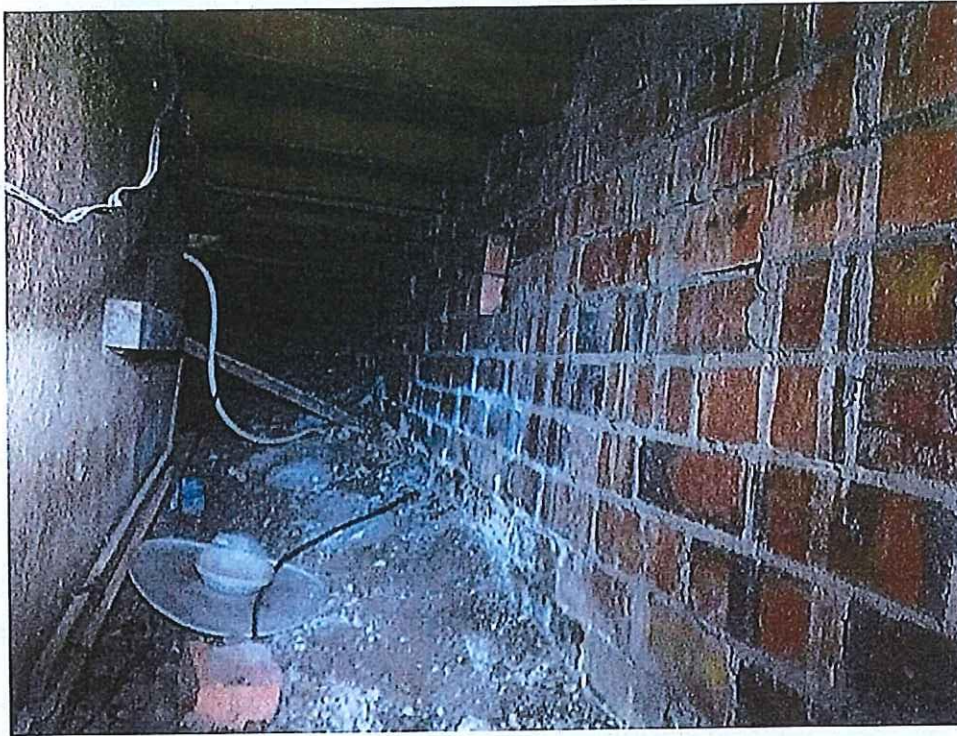
Mr. & Mrs. Wrigley supplied the attached (refer Appendix C) *Protek* report *Structural Survey (Boundary Wall)*, including drawing 5269-0001. This drawing shows the assumed existing situation and also a proposed engineered retaining wall solution. We generally concur with the *Protek* drawing and report, other than that no engaged piers along the boundary wall were noted and that floor joists not bearers were present in the location shown, with these being supported in a recess in the inside skin of brickwork (refer Photo 19 in Appendix A).

Photo 19 - Subfloor area looking north east along boundary wall (neighbouring concrete drive constructed to right of photo against this wall)

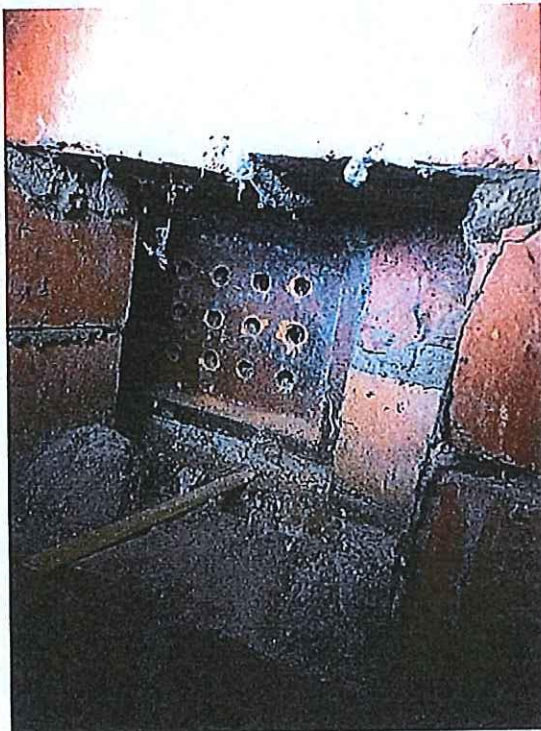
We also note, as per our attached report, that there appears to be sub-floor ventilation on the boundary wall that has been covered by the 27 Benvenue Road driveway works.

During inspection of the sub-floor area, it was noted that sub-floor ventilation on the boundary wall has been covered as part of the construction works at 27 Benvenue Road (refer Photo 20 in Appendix A). It was also noted that a block retaining wall within the sub-floor storage area showed signs of movement (see Photo 17 in Appendix A).

Photo 20 - Sub-floor ventilation on north east boundary wall which has been blocked by construction of neighbouring driveway.

2. Confirm 27 Benvenue Road driveway construction by way of Council records, investigation by a suitably qualified Engineer or proof of construction by other means. Noting that the driveway should have been designed and built, if permitted by Council, so that no load is transferred to the neighbouring property and also so as not to affect any existing sub-floor ventilation.

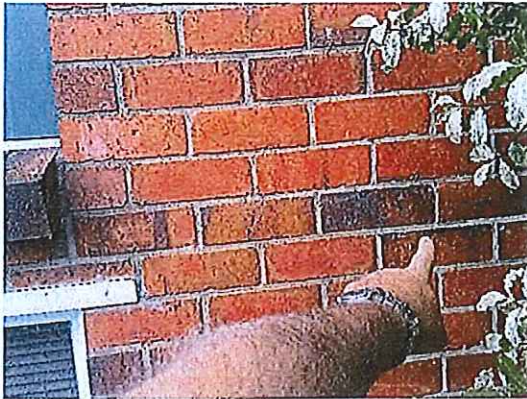
Photo 7 – horizontal cracking extends back to near the window on this front elevation.

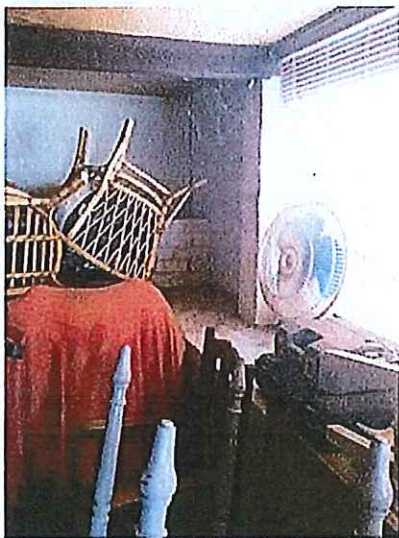
Photo 8 – typical construction in the rooms under the dwelling adjacent to the front south eastern corner where fine cracking has been noted.

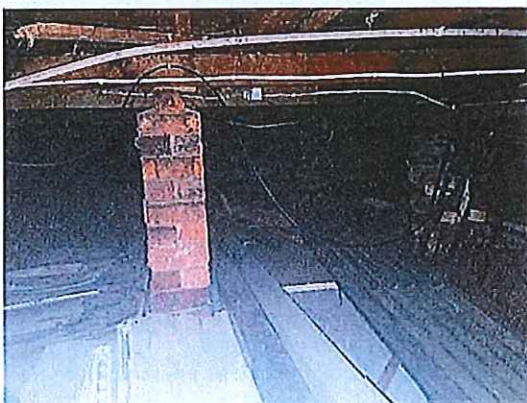
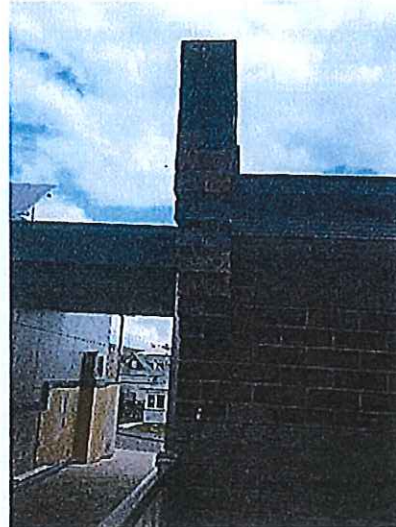
Photo 9 – view looking south along the boundary wall and showing the carport of the neighbouring property

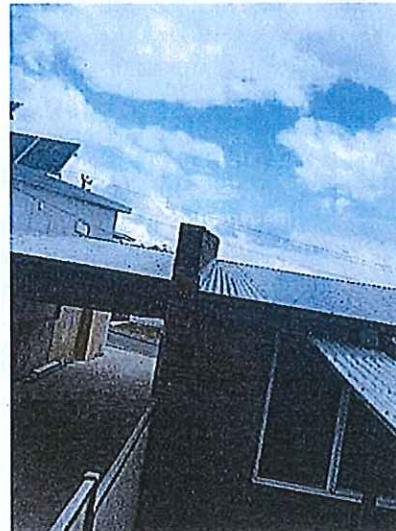
Photo 9 – alternative view of photo 10

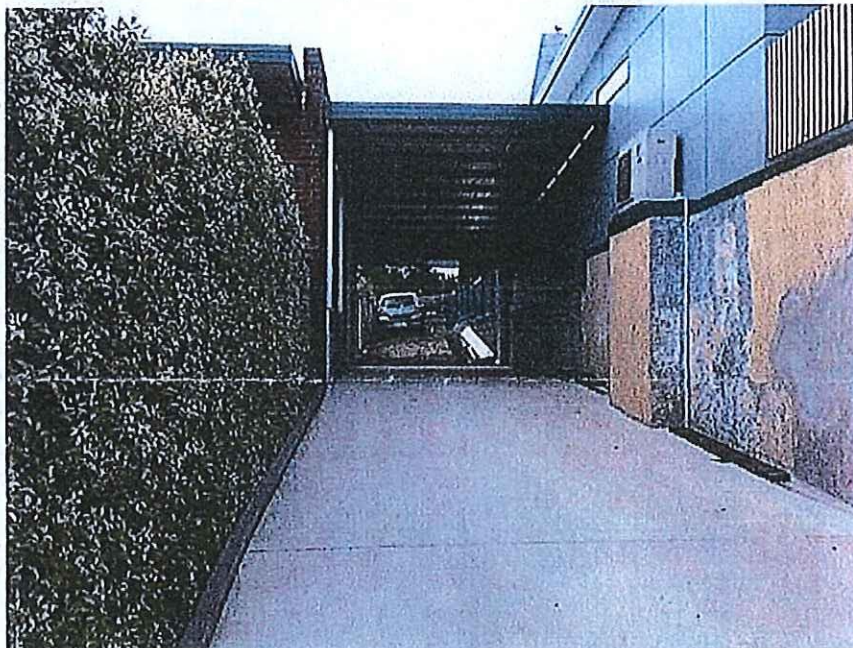
**Photo #1 - Carport and concrete driveway at 27 Benvenue Road.**
