ARBORICULTURAL ASSESSMENT

Theatre Annexe Poplars – UTAS Inveresk

21st June 2019

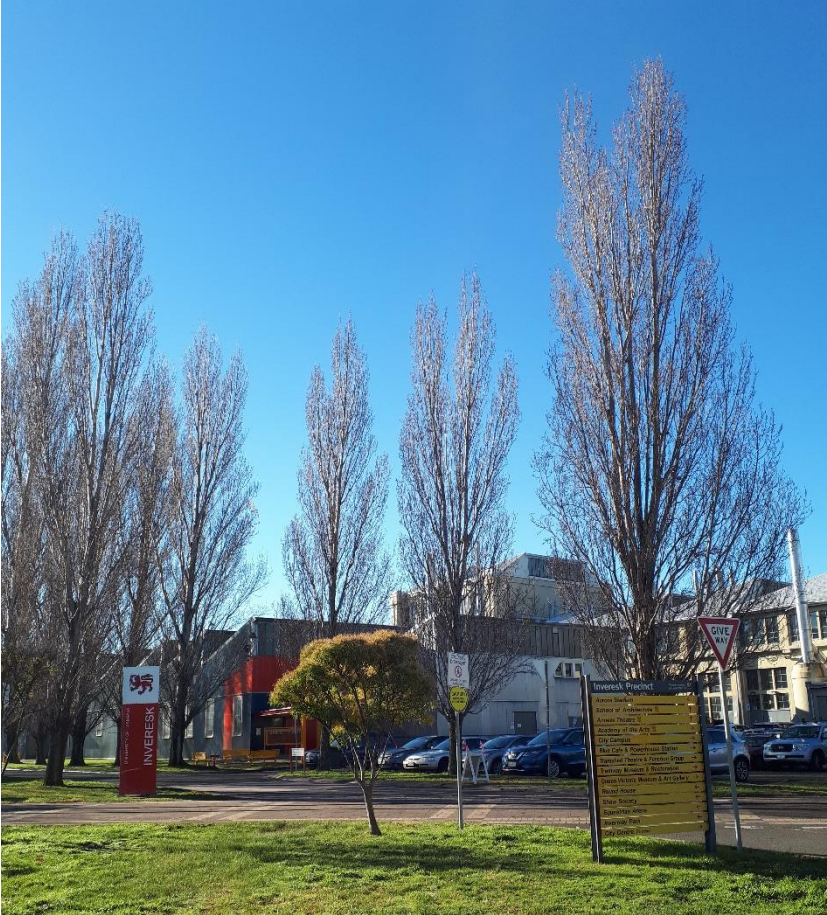
Although I have not seen the engineering drawings for the proposed works, I suggest that trees 1 – 4 may be significantly impacted due to the proximity of the proposed building and Indigenous cultural garden.

Lombardy poplar can be challenging to manage in a confined area due to their advantageous root system. It is already evident how the roots are breaking the concrete kerbs and bitumen roads. This is likely to continue and may impact the new elements of the proposed design. Further compounding this is the many suckers that will develop where these roots reach the upper soil profile. Unfortunately, there is no herbicides that are registered to control this issue.

Trees 1 - 4 (right to left). All trees are bounded by hard surfaces which are beginning to crack as a result of large root systems.

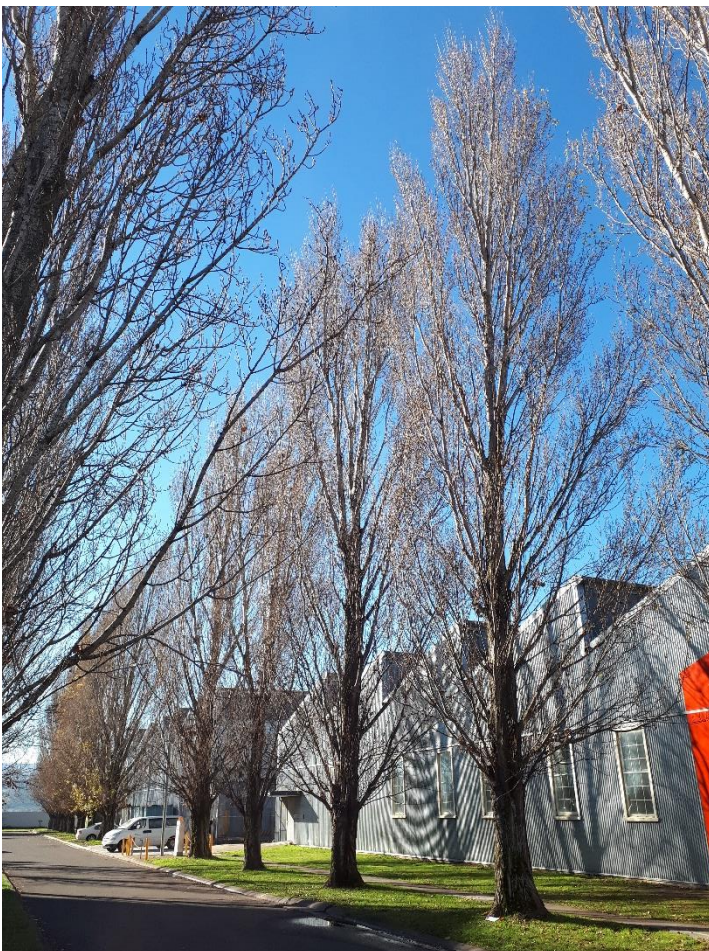
Debris accumulation in the saw tooth gutters has been raised as an issue, particularly trees 5 – 8. As the trees are only 7m from the building and extend approximately 15m above the roofline, it is likely that this issue will continue. As the building(s) are located on the leeward side of the trees, the greatest amount of foliage will continue to dump on these structures. Although the trees could be reduced in size to limit this, the heading cuts would be quickly compromised by decay, dramatically reducing their landscape life expectancy.

Trees 5 - 8 (foreground to background). Note the distance to, and height above the building. Due to the design of the gutter system, there are no practical solutions to avoid their constant blocking with tree debris in Autumn.

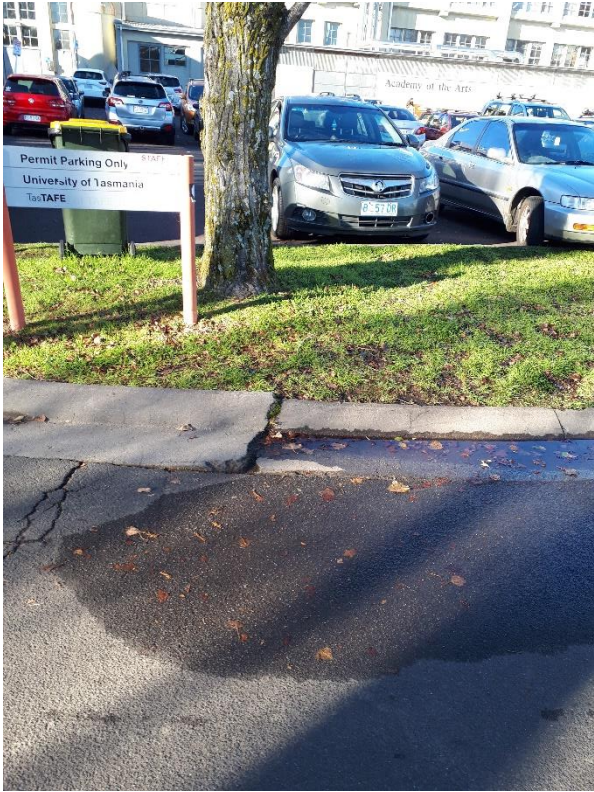
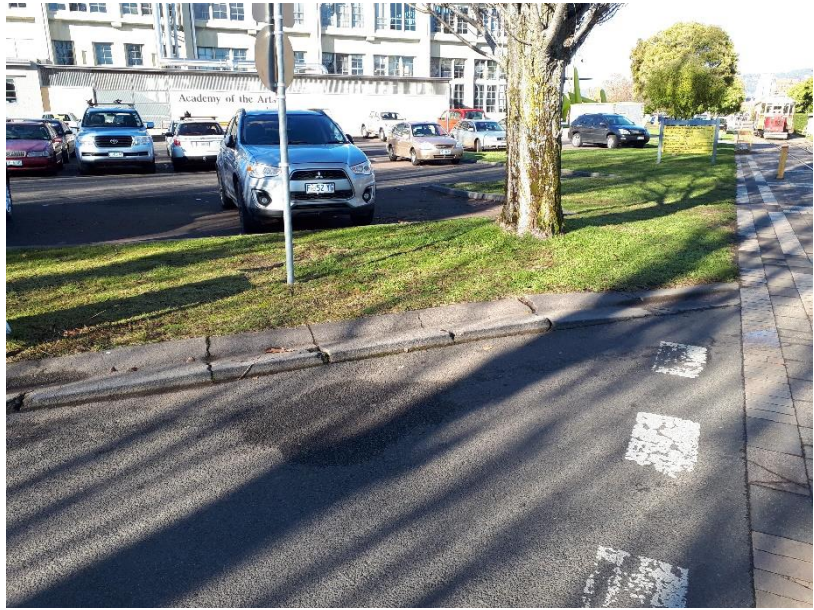
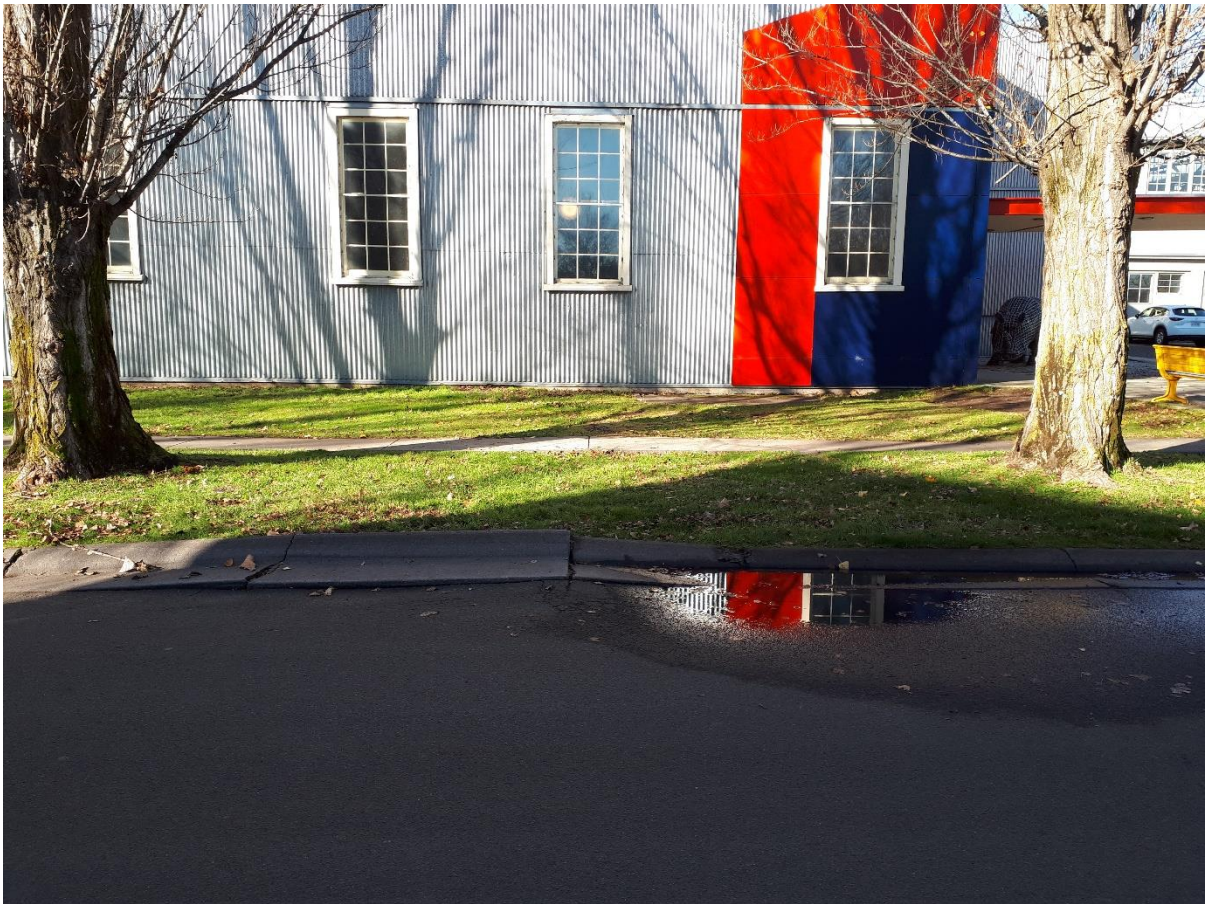
The damage that has occurred through root development - tree 3 (top left) Tree 1 (top right). Between tree 5 and 6 (above).
