Launceston Flood Authority

Annual Report 2019

Report for the period ending 30 June 2019

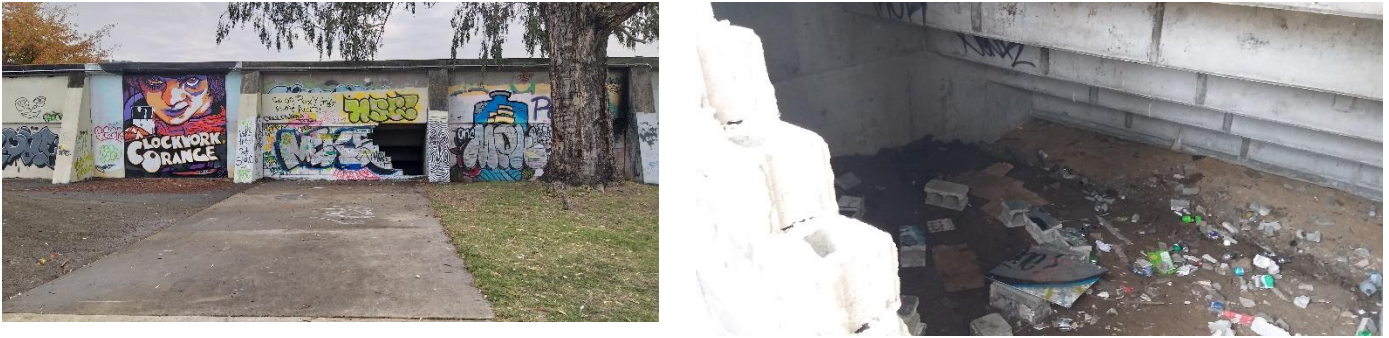
- Repair broken stainless steel cables on elevated public walkway behind QV Museum Inveresk on Invermay Levee (approximately \$2,000 annually),
- Cleanse graffiti on floodwalls and wingwalls on City, Invermay, East Launceston Levees and regatta side of Training Levee (approximately \$2,500 annually),
- Replace with steel panel demolished besser block walls on Training Levee in skate park (two panels replaced, \$2,000 per panel). This may continue as it is a popular gathering area for youths.

Figure 8 shows a vandalised wall at the back of the Training Levee.

Figure 8. Photos of vandalised besser block wall panel, May 2019

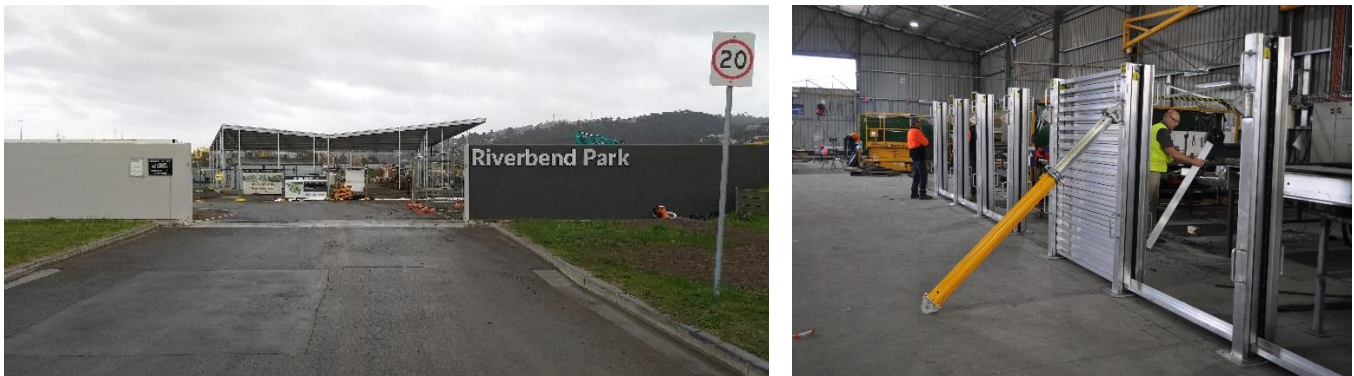
Figure 9 shows the current floodgate at the entrance to Riverbend Park, which is proposed to be widened and renewed with an alternative Bauer gate system.

Figure 9. Photos of existing Tarooma St sliding floodgate and new Bauer gate

A new floodgate system has been manufactured and is currently stored at the Remount Depot in Mowbray; a permanent storage facility will be constructed at the time of installation expected in October 2019. There will be need to modify the existing levee during civil works, to accommodate a wider floodgate and access to Riverbend Park.
