D1 Consulting Engineers Pty Ltd

Structural Report

269 Charles Street, Launceston

5th October 2020

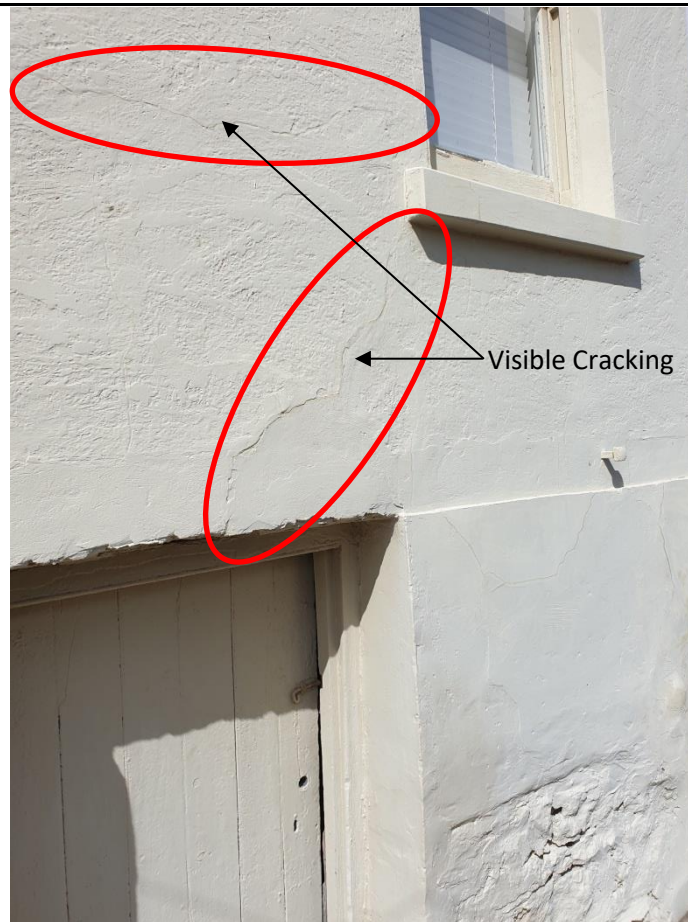
Visible cracking within the western corner of the house which is currently slightly leaning outwards with radiating cracks that are signs of foundation failure. This has occurred due to the existing brick/bluestone retaining wall has failed just at the stair well. Refer to Front yard staircase.

House Western corner from access door.

1. The main reason for the structural failure within the house is due to the load transfer from the building footprint proximity to the bluestone retaining wall.
2. The reason of the bluestone retaining wall failure is due to the proximity of the house footprint transferring its loads into the retaining wall causing it to fail as seen within this report.
3. The existing structural design was constructed to best practices of the time when the building was originally built but was positioned too close to the existing bluestone retaining wall.

- The bluestone retaining wall will need to have sections pulled down and repaired.
- The existing building would need to be underpinned but this will not be possible due to the existing condition of the bluestone retaining wall where a service load could bring the entire bluestone retaining wall into failure along Charles Street. The only possible methods would be by demolishing the rear of the building to access the front of the house or the work to be done completely by hand which would be deemed unsafe due to the current conditions.

- The current building condition will continue to deteriorate until it is unsafe to live in. The building is beyond future repairs and it is recommended to be demolished or replaced.

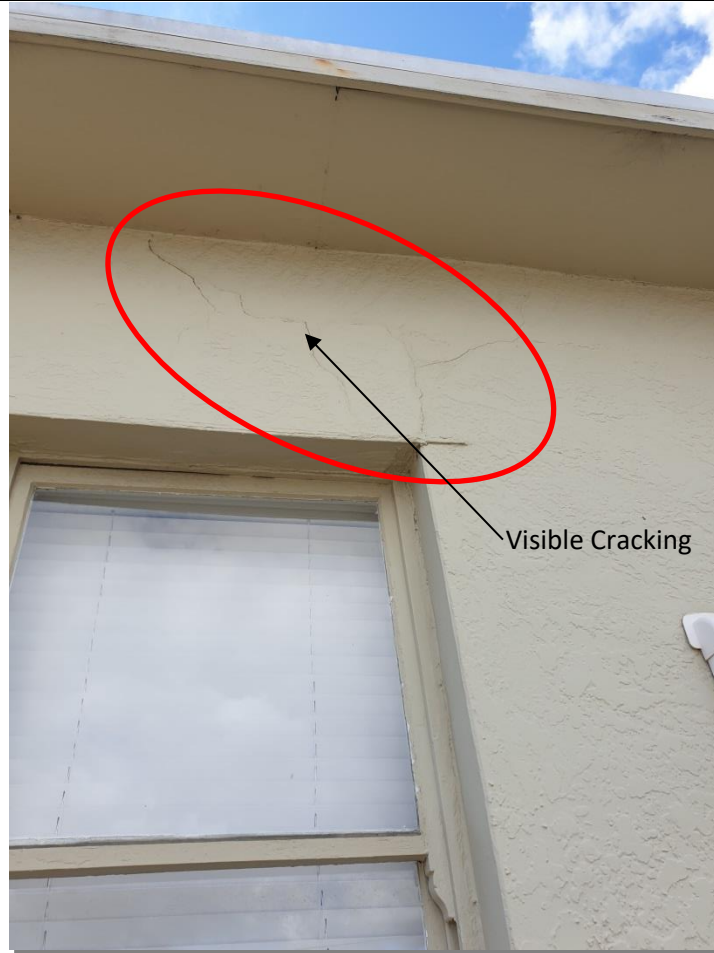
House Western window corner.

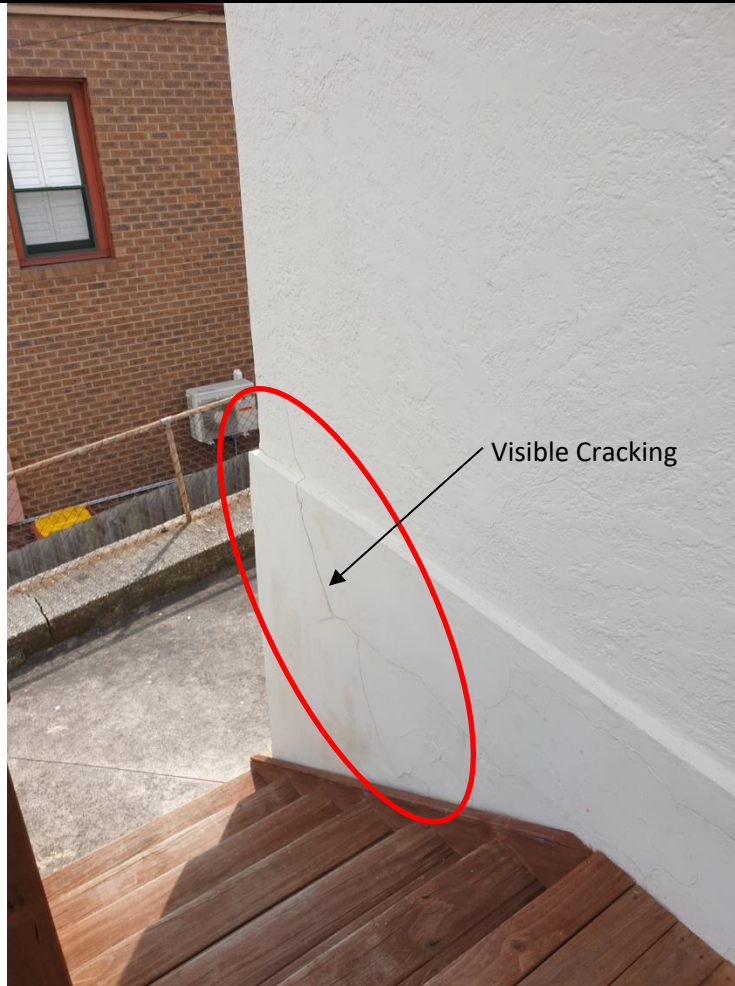
House North-West stair corner.

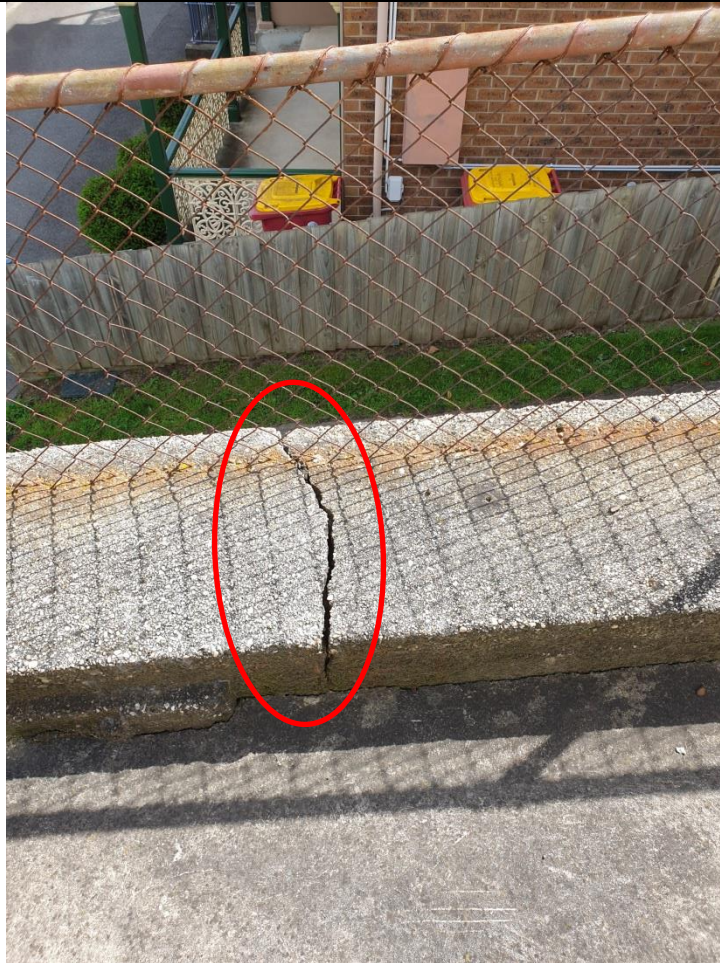
The existing front yard concrete staircase is currently in average condition, but the brick/bluestone retaining wall located on the left hand side has failed and is currently leaning towards the Charles Street.

Large crack on top of bluestone retaining wall above staircase.

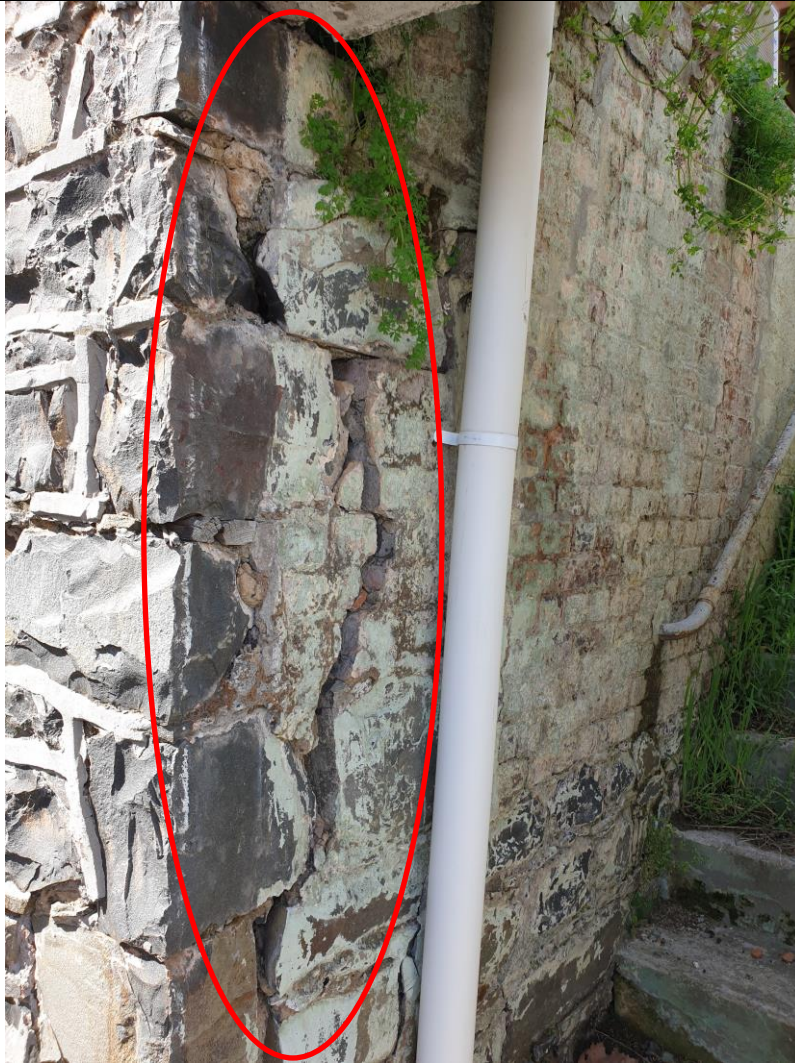
Large crack on within of brick/bluestone retaining wall adjoining the stairwell.

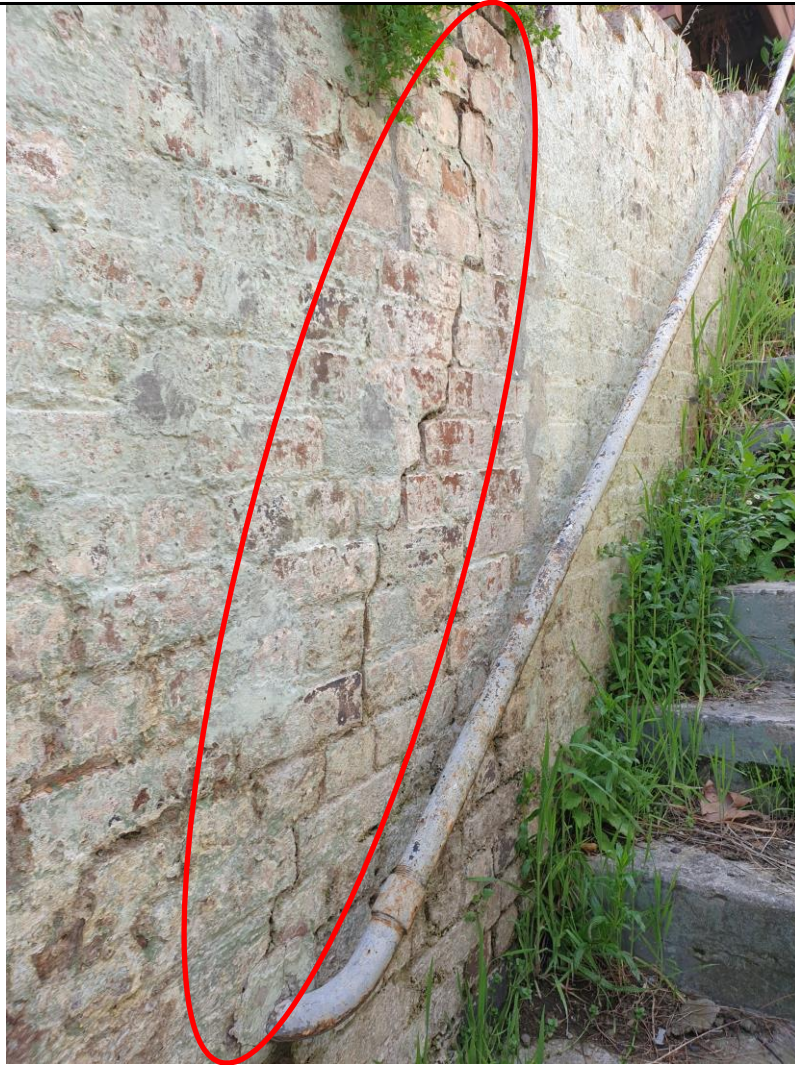
Large crack further up staircase within brick/bluestone retaining wall.

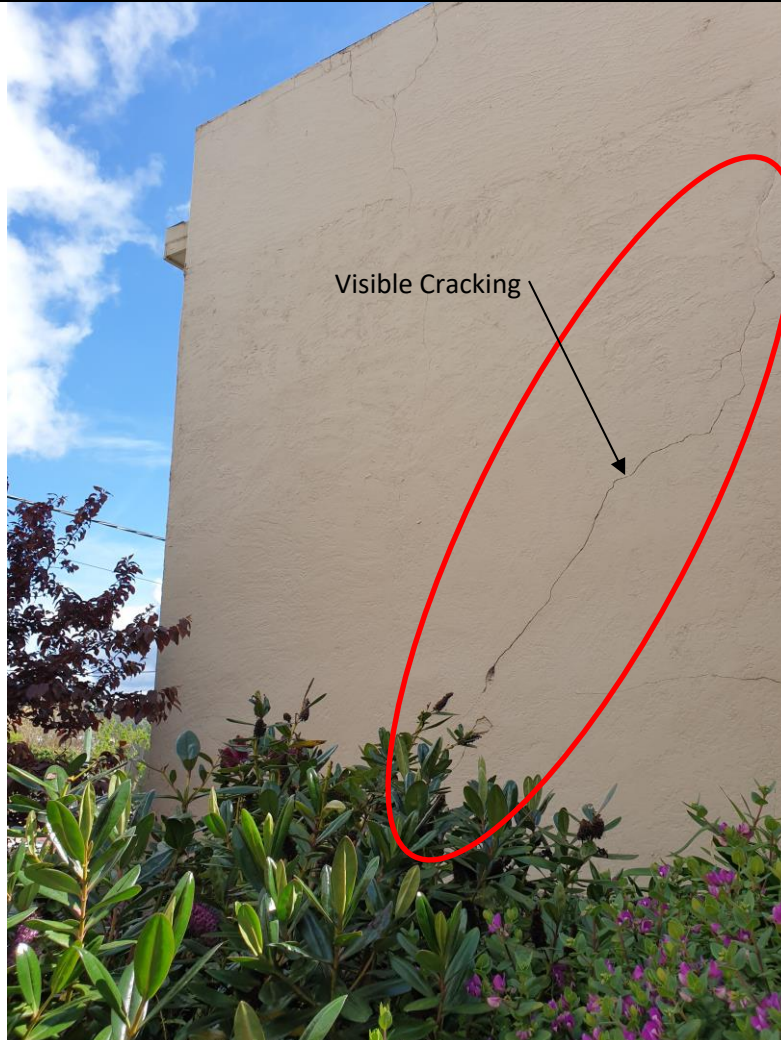
Visible cracking within the southern corner of the house. These cracks radiate from the existing foundations to the top of the building line that are signs of foundation failure. This has occurred due to the existing bluestone retaining failing on Charles Street.

Southern corner of house photo 1.

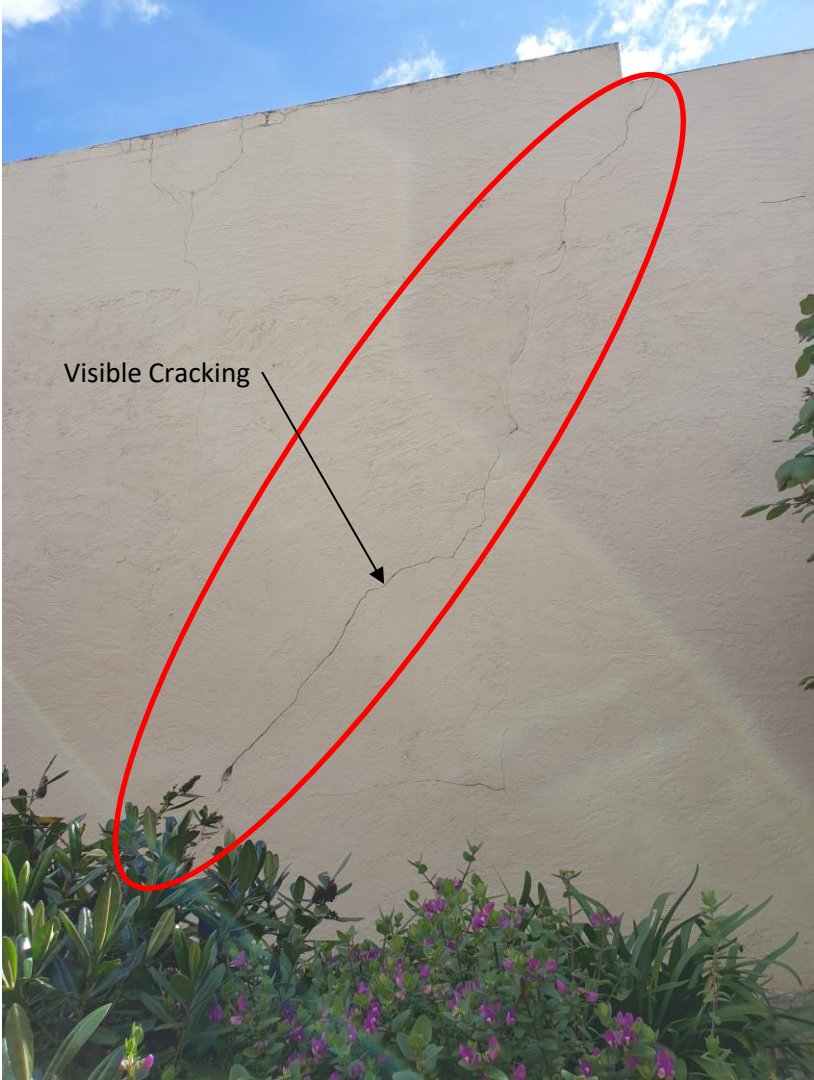
Southern corner of house photo 2.

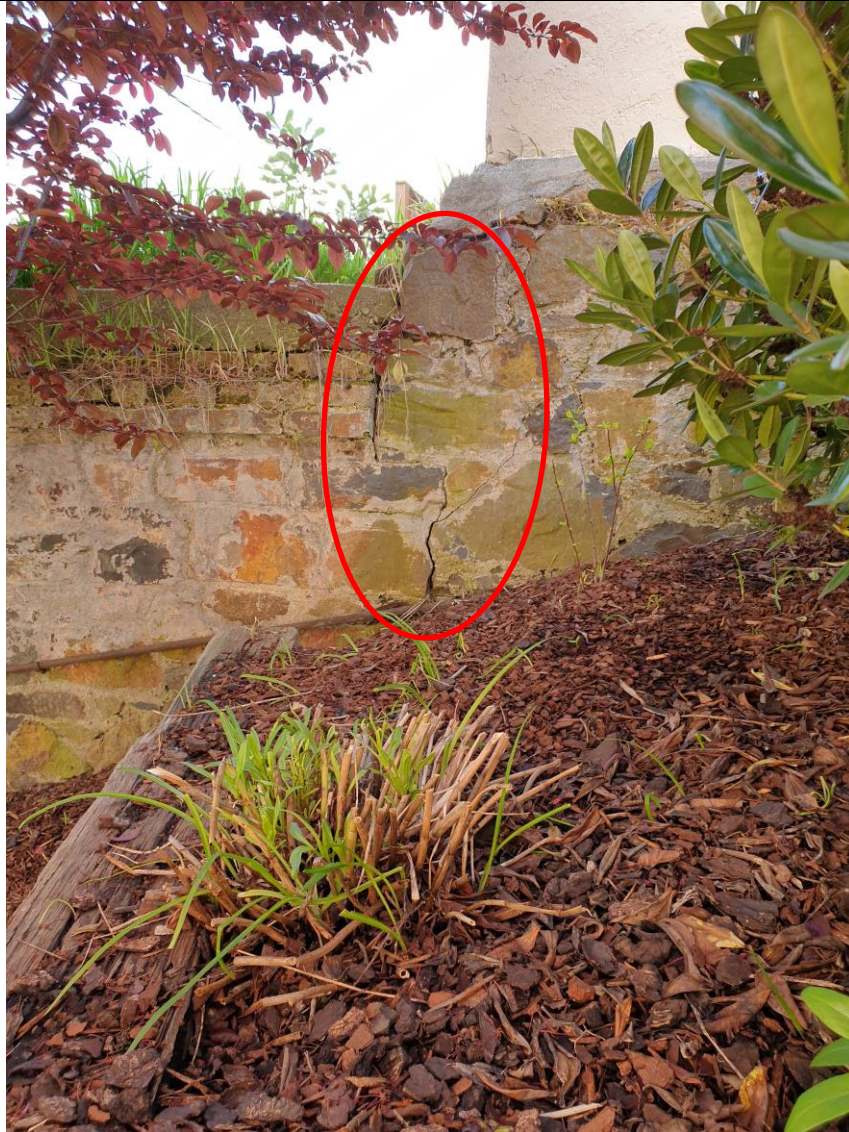
Southern house corner foundation crack

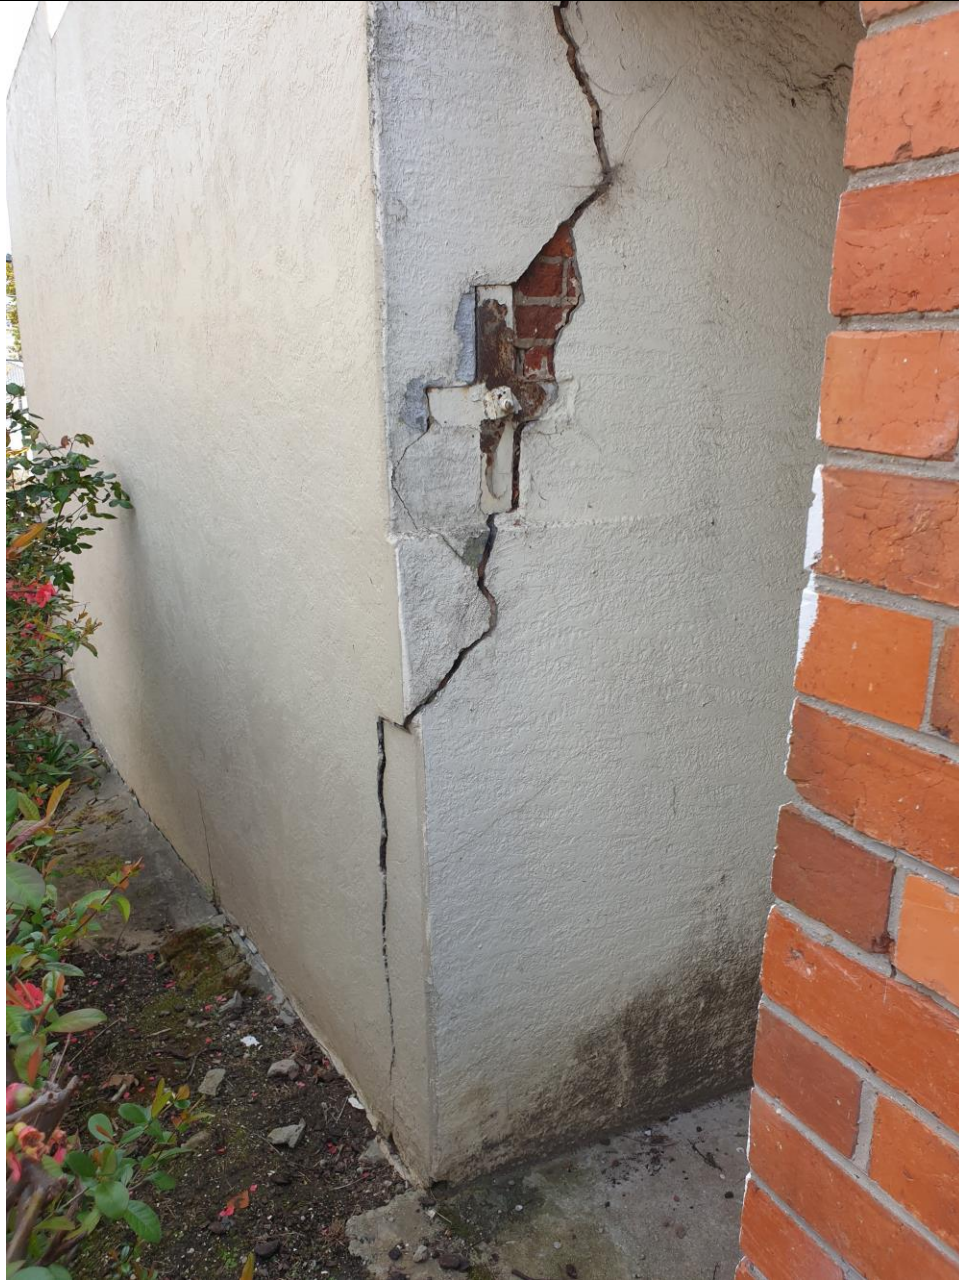
Southern house corner severe cracking

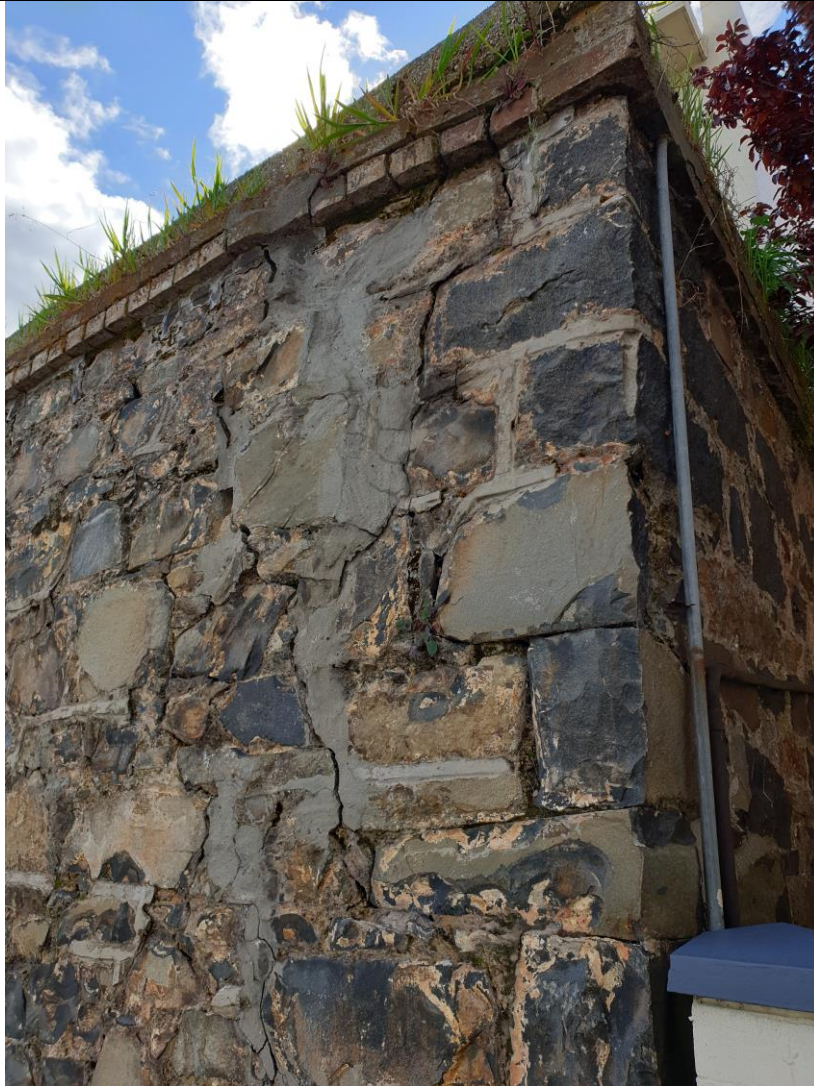
The existing bluestone retaining wall running along Charles Street, has failed, There are visible signs of repair works that have also failed.

Cracking in southern corner of existing bluestone retaining wall Photo 1.

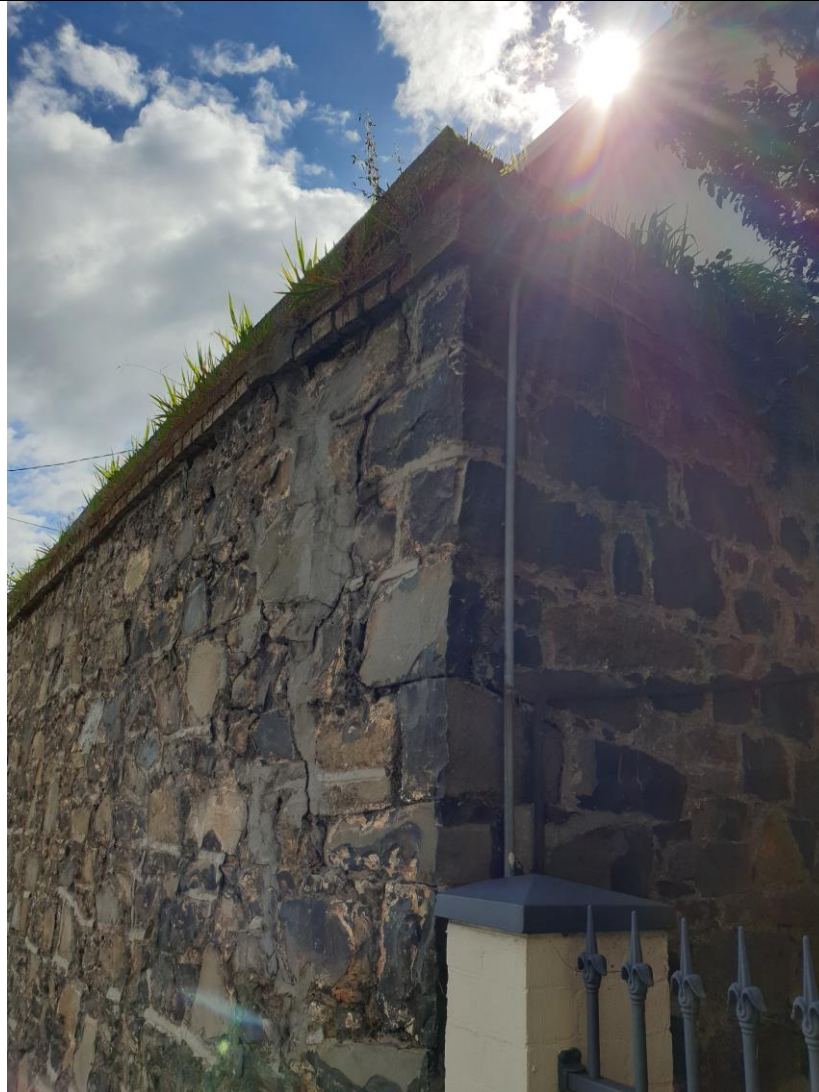
Cracking in southern corner of existing bluestone retaining wall Photo 2.
