Re: 9 Rose Lane, Launceston South

Landslide Risk Assessment

Geotechnical Site Review

Report No: 7390A

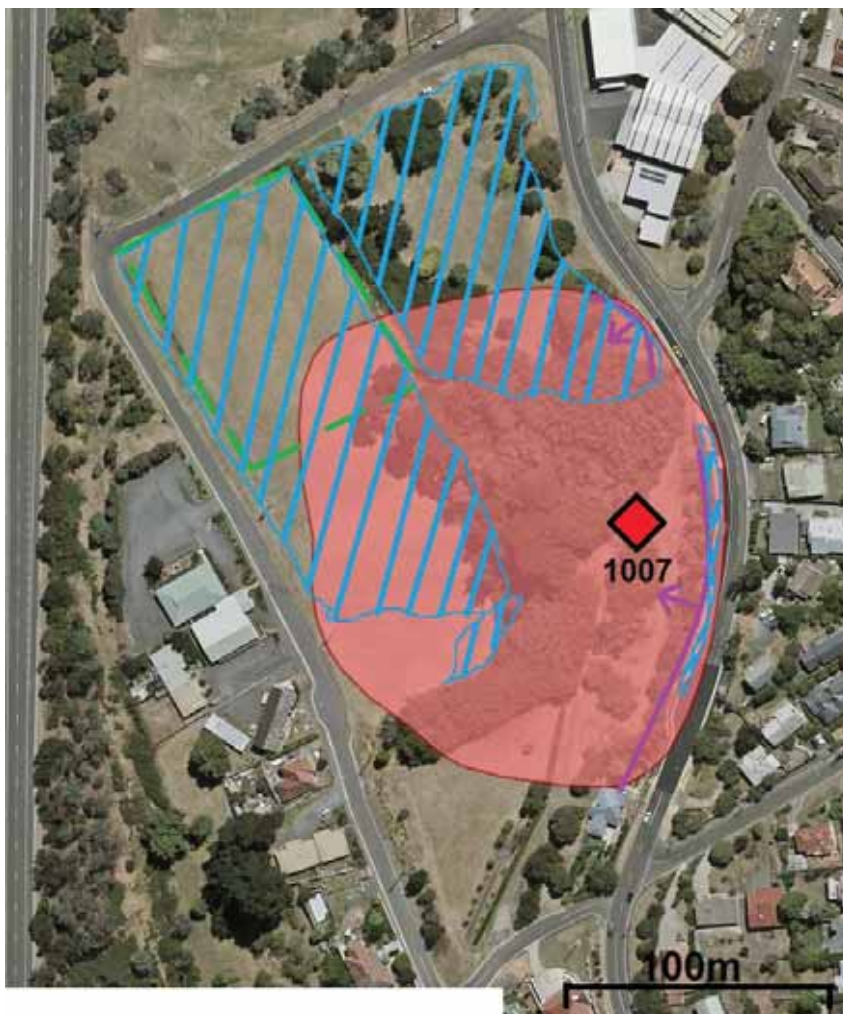
FIGURE 2 - MRT LANDSLIDE MAPPING

The Mineral Resources Tasmania (MRT) Tasmanian Landslide Inventory sheet, 1:25,000 scale, shows an active landslide (No. 1007) just below the western side of Westbury Road and including a significant area downhill (Figure 2). The same area is also shown as low to high slide susceptibility in the MRT Shallow Slide and/or Flow Susceptibility sheet. However, the same landslide is not present in the MRT Tasmanian Proclaimed Landslip Zones sheet, and it also has not been assessed as Zone A or Zone B. Two reports acquired from MRT database cited the landslip down to the western side of Westbury Road

Recent aerial image showing the MRT Landslide No. 1007 extend (in red), the Rose Lane Units development area (green dashed), the two landslips cited in the I. Jennings 1962 report (in purple), and the observed areas that were filled during the past over 70 years since 1946 (lined blue).

The Rose Lane Unit site is partially included in the MRT Landslide No. 1007 area at the south-eastern edge and is marginally included as low slide susceptibility zone.

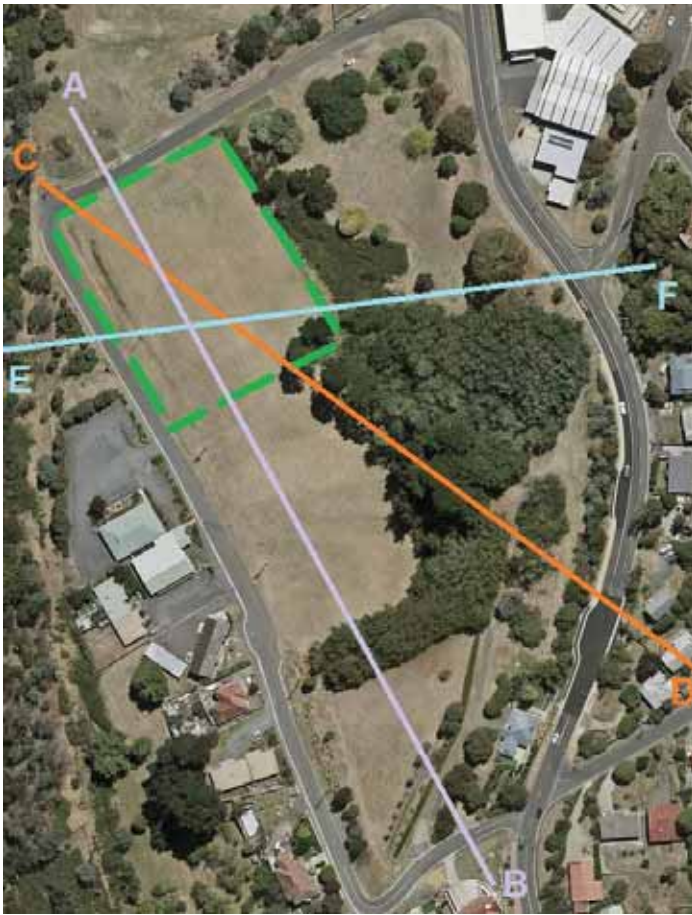
FIGURE 3 - SECTIONS OF SITE FOR ANALYSIS

The probability at Section A-B is: 0.4%	The Factor of Safety is 2.5
The probability at Section C-D is: 0.0%	The Factor of Safety is 1.85
The probability at Section E-F is: 0.0%	The Factor of Safety is 2.1

The probability at Section A-B is: 0.5%	The Factor of Safety is 2.1
The probability at Section C-D is: 0.0%	The Factor of Safety is 1.85
The probability at Section E-F is: 13.9%	The Factor of Safety is 1.3

The above results indicate that any land slide upslope of the proposed unit development would have been triggered by the quarry excavation and post filling, the probability of a land slide is very low. *(Note that the values indicated above are based on probabilistic analysis using estimated parameters. Although a quantitative analysis, variations on these results is likely with minor variations and assumptions; hence the numbers above should not be taken as absolute, but used for comparison between the differing scenarios).*
