### Development Application -Redevelopment of Macquarie House

## **MACQUARIE HOUSE REDEVELOPMENT NOTES FOR PLANNING SUBMISSION**

# MACQUARIE HOUSE DEVELOPMENT

CIVIC SQUARE, LAUNCESTON, TASMANIA

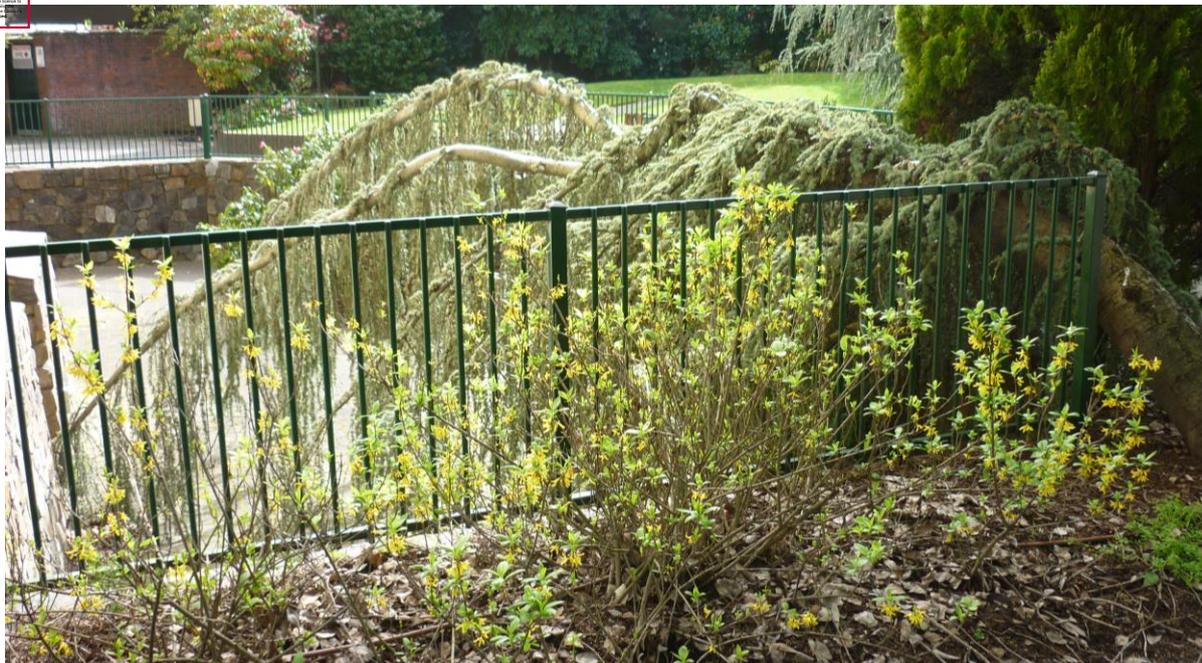
**Image 01:** Weeping-form tree proposed for removal - viewed from upper level edge of existing courtyard space.

As part of these changes to the access arrangements around the building perimeter, it is proposed to remove some existing vegetation on the southern edge of the courtyard area, including a large weeping-form tree in this location that is incompatible with the proposed new stair access location, and dominates the lower level courtyard area making a large portion of this space unusable (refer Image 01 and 02 below). One additional tree at the rear of the building has also been identified for removal due to its proximity to the new building envelope, and its growth habit (refer image 03 and 04 below).

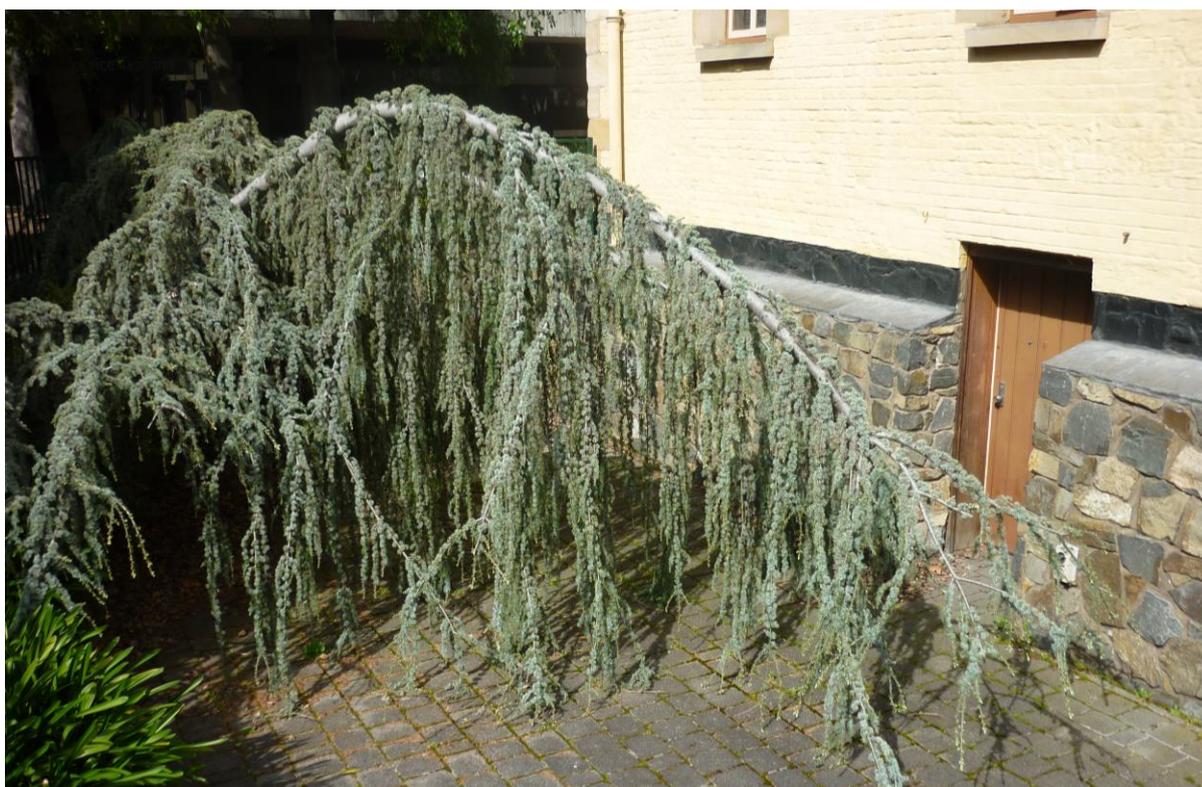
**Image 02:** Weeping-form tree proposed for removal - viewed from existing basement access stair landing.

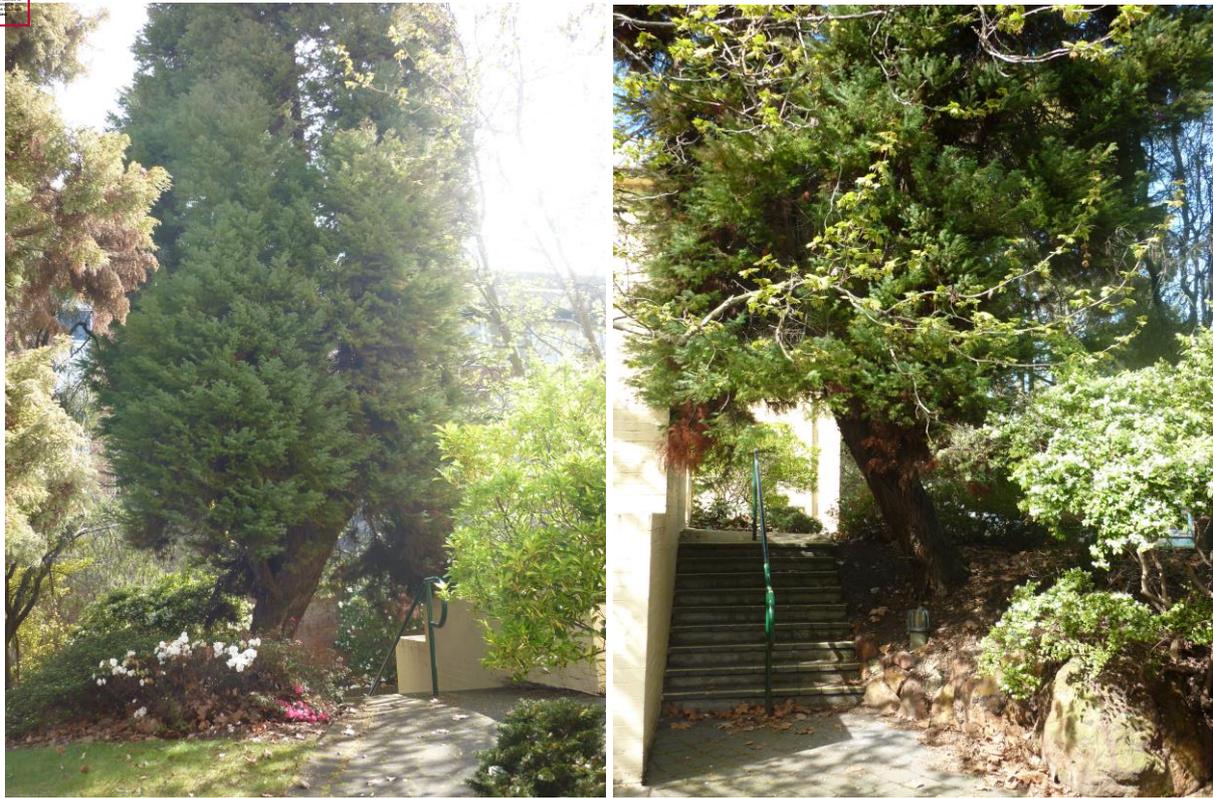
**Image 03 & 04:** Tree located adjacent existing rear stair access (north-west corner) proposed for removal, due to proximity to proposed building envelope, and leaning growth habit.

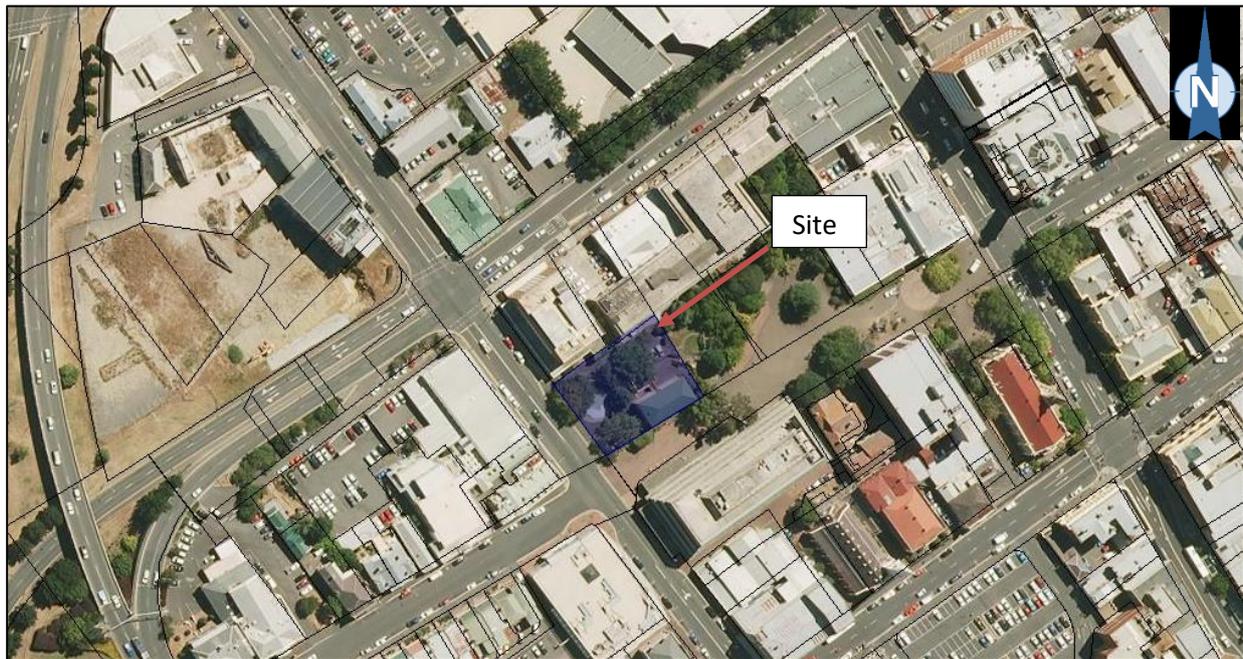
Figure 1 Site Plan

The property is currently owned by the Launceston City Council, with construction proposed of a general learning area with wet area, support spaces and toilet facilities. The investigation area (the Site) covers approximately 1437 m2. The sites location is shown on Figure 1.

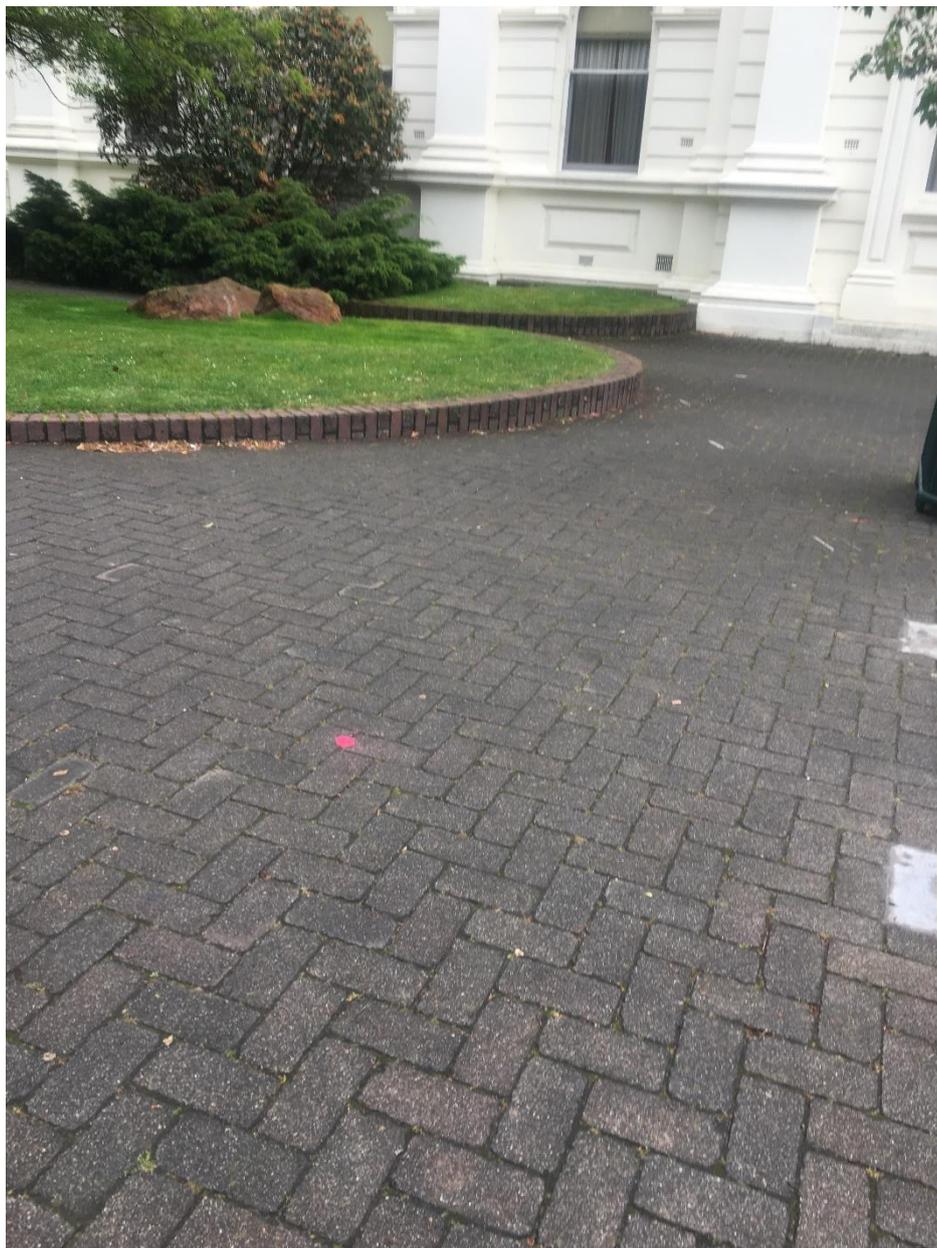
Figure 2. Civic Square Sample Point – up gradient

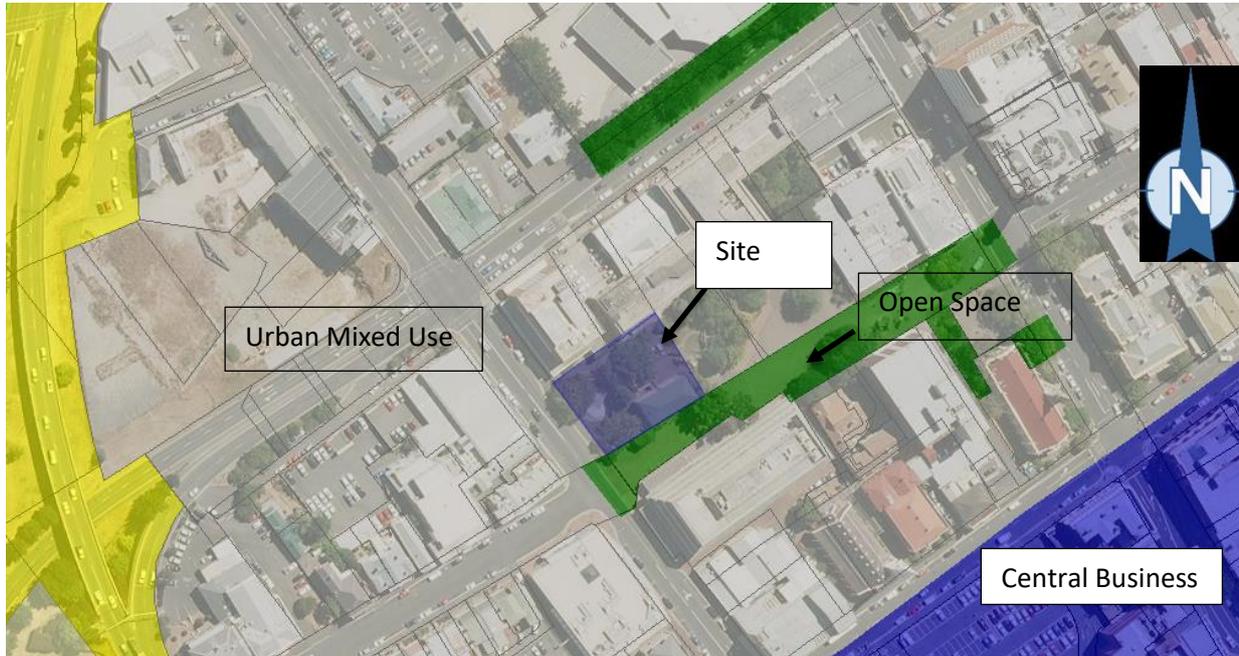
The site is zoned “Urban Mixed Use” (Launceston Interim Planning Scheme 2015, Figure 2) and is largely surrounded by “Urban Mixed Use”. Sections of “Open Space” are present to the south and north, with “Central Business” to the south-east.

Figure 3 Zoning – Urban Mixed Use

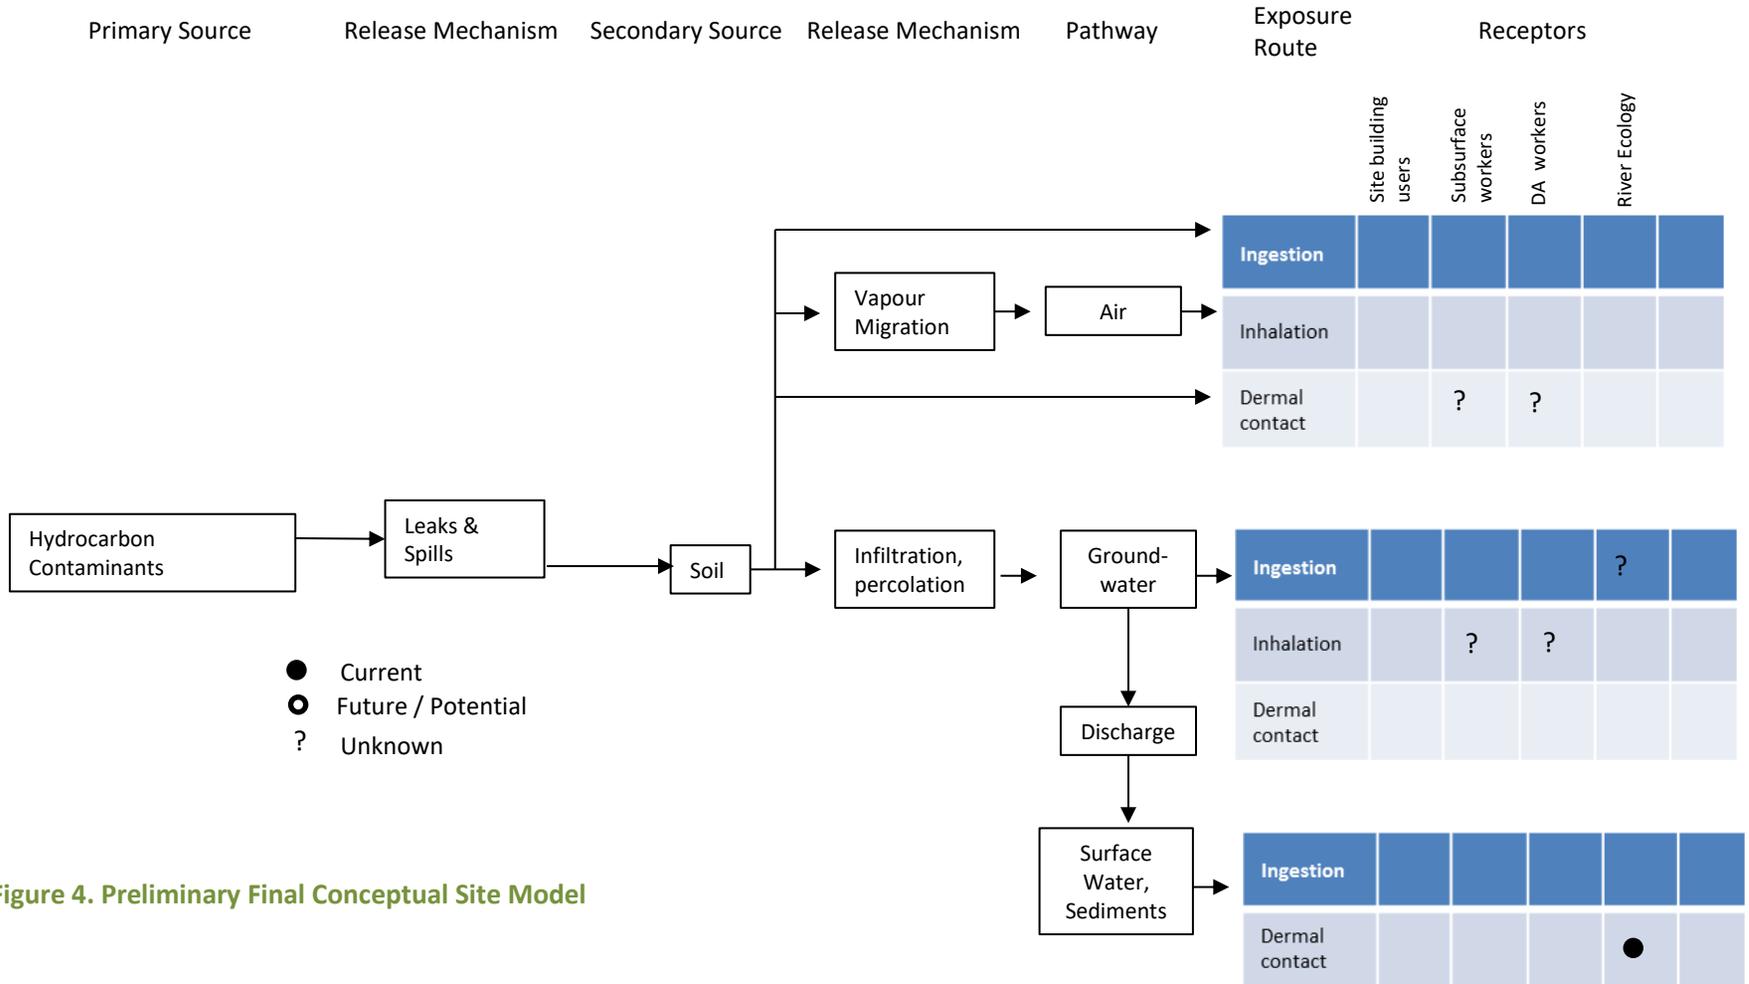
Figure 4. Preliminary Final Conceptual Site Model

Groundwater contamination from underground fuel tanks up gradient from the Civic Square is a possibility. The inferred groundwater direction is to the west. A wider investigation indicates that the presence of underground fuel tanks located at 68-72 Cameron Street in the 1930's, up gradient of the proposed development, along with 94 Cameron Street, west of the development. If these tanks have leaked it could potentially impact on groundwater directly away from the development to the west. A preliminary Conceptual Site Model (CSM) is presented in Figure 4.

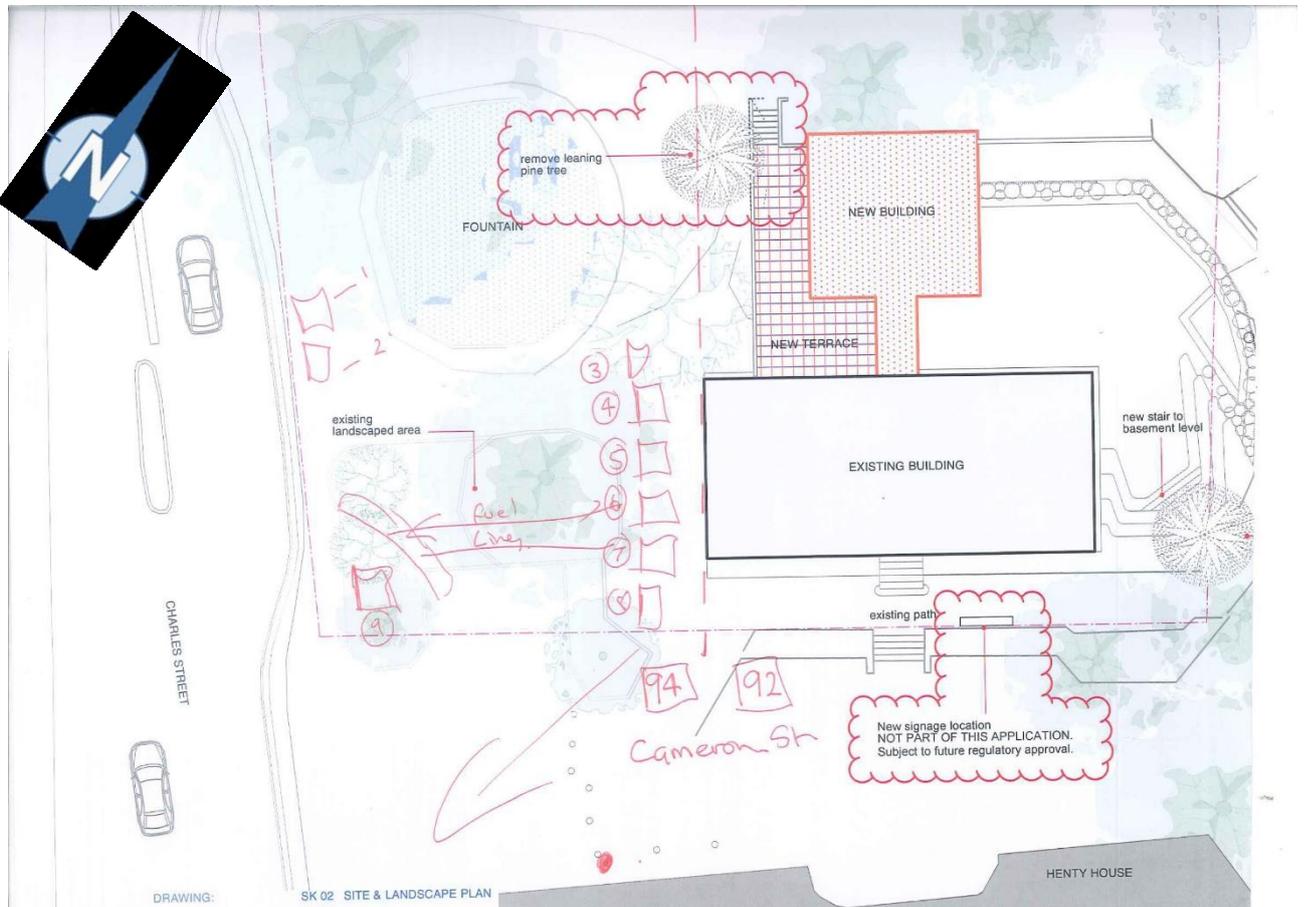
All available WST data was reviewed from the early 1930's while part of the site was a service station. It was concluded and summarised in figure 5. Firstly that the service station is on what was 94 Cameron Street down gradient and not where the development is to occur at 92 Cameron Street. Thus contaminating activities did not occur near the development and even so down gradient of the development. This removes risk of vapour and contaminated soil. The history search did not discover if any of the 9 tanks found were removed. It was also noted that if a plume from the UPSS did exist it would go to the west away from the development and city square across Charles Street. This is the main risk determined in this assessment. There are no civil issues as garden and fountains cover the potentially impacted areas.

**Figure 5 Historic Locations of UPSS**

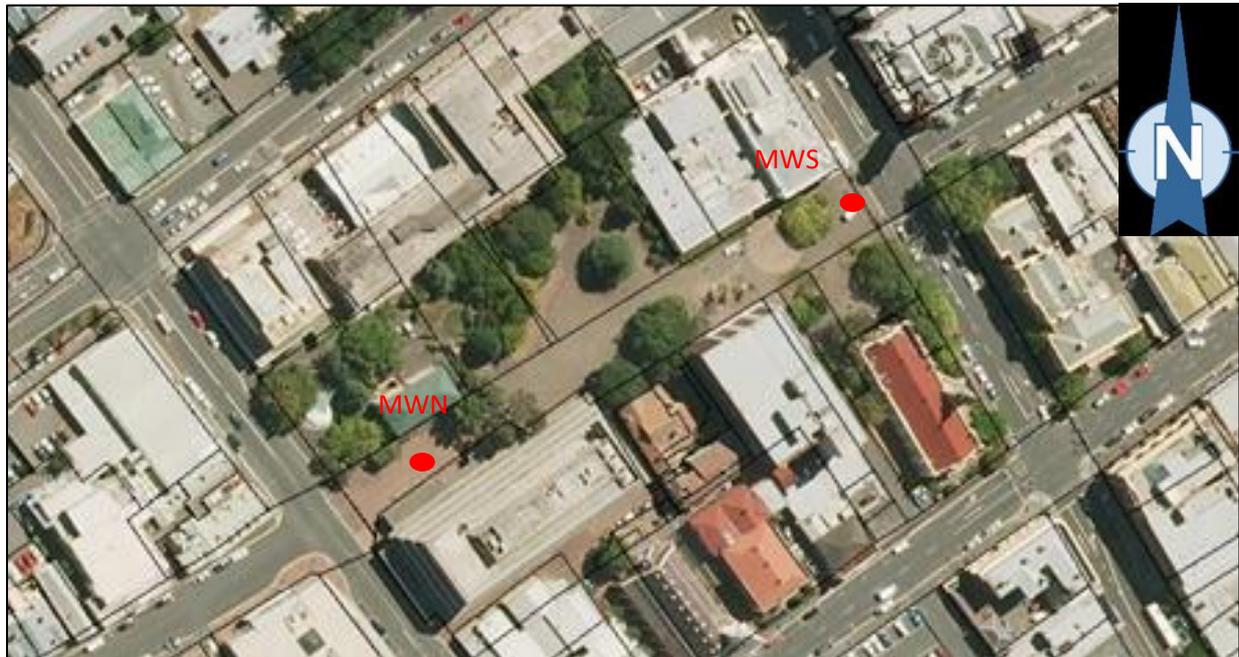
**Figure 6 Proposed Bores MWN (North) and MWS (South)**

On the 27/10/2016 two groundwater bores were installed and the bores conditioned and purged. Soil samples were taken along with PID readings using a MultiRAE Pro (Table 8). No odour was detected in the bores MWN and MWS. The borelog and drilling notes are provided in Appendix 2.

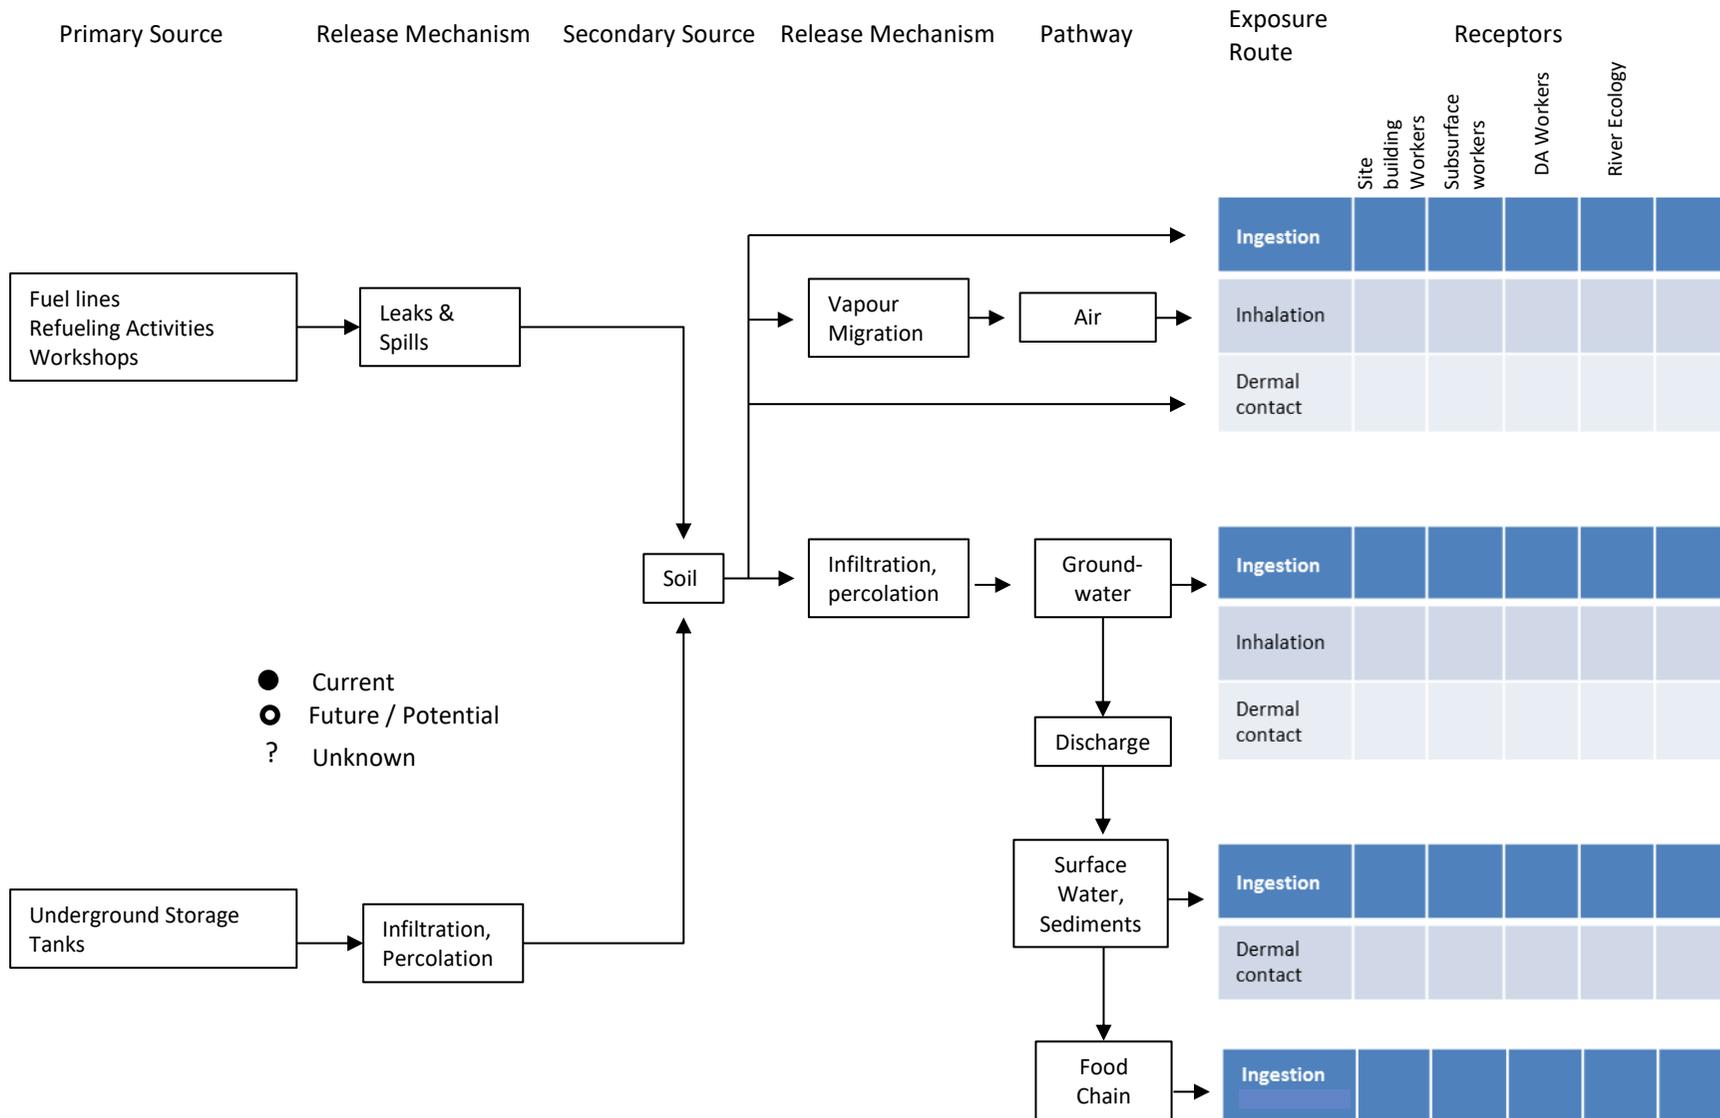
Figure 7 - Revised CSM

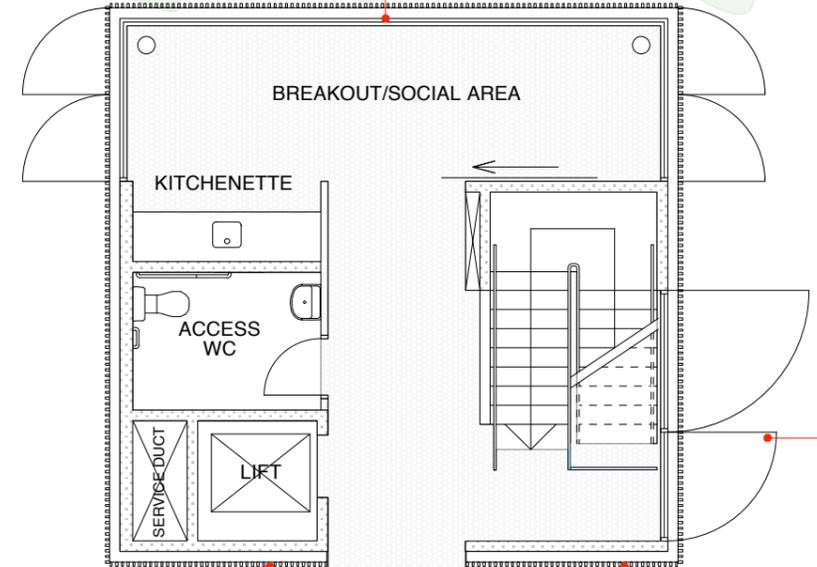
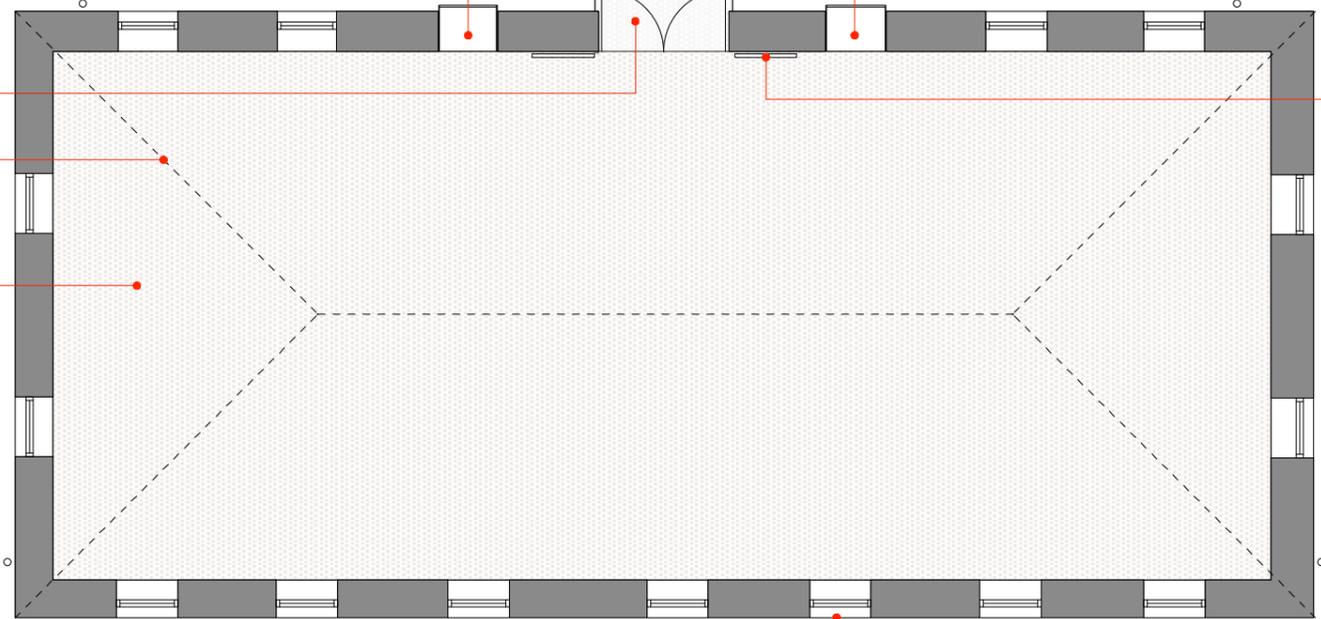
sliding screens over clear glazed windows

hinged timber screen panels for maintenance

fixed timber screen over pre-cast conc. walls

new frameless windows to replace bricked up window

carpet and levelling underlay over existing floor

relocated existing timber doors

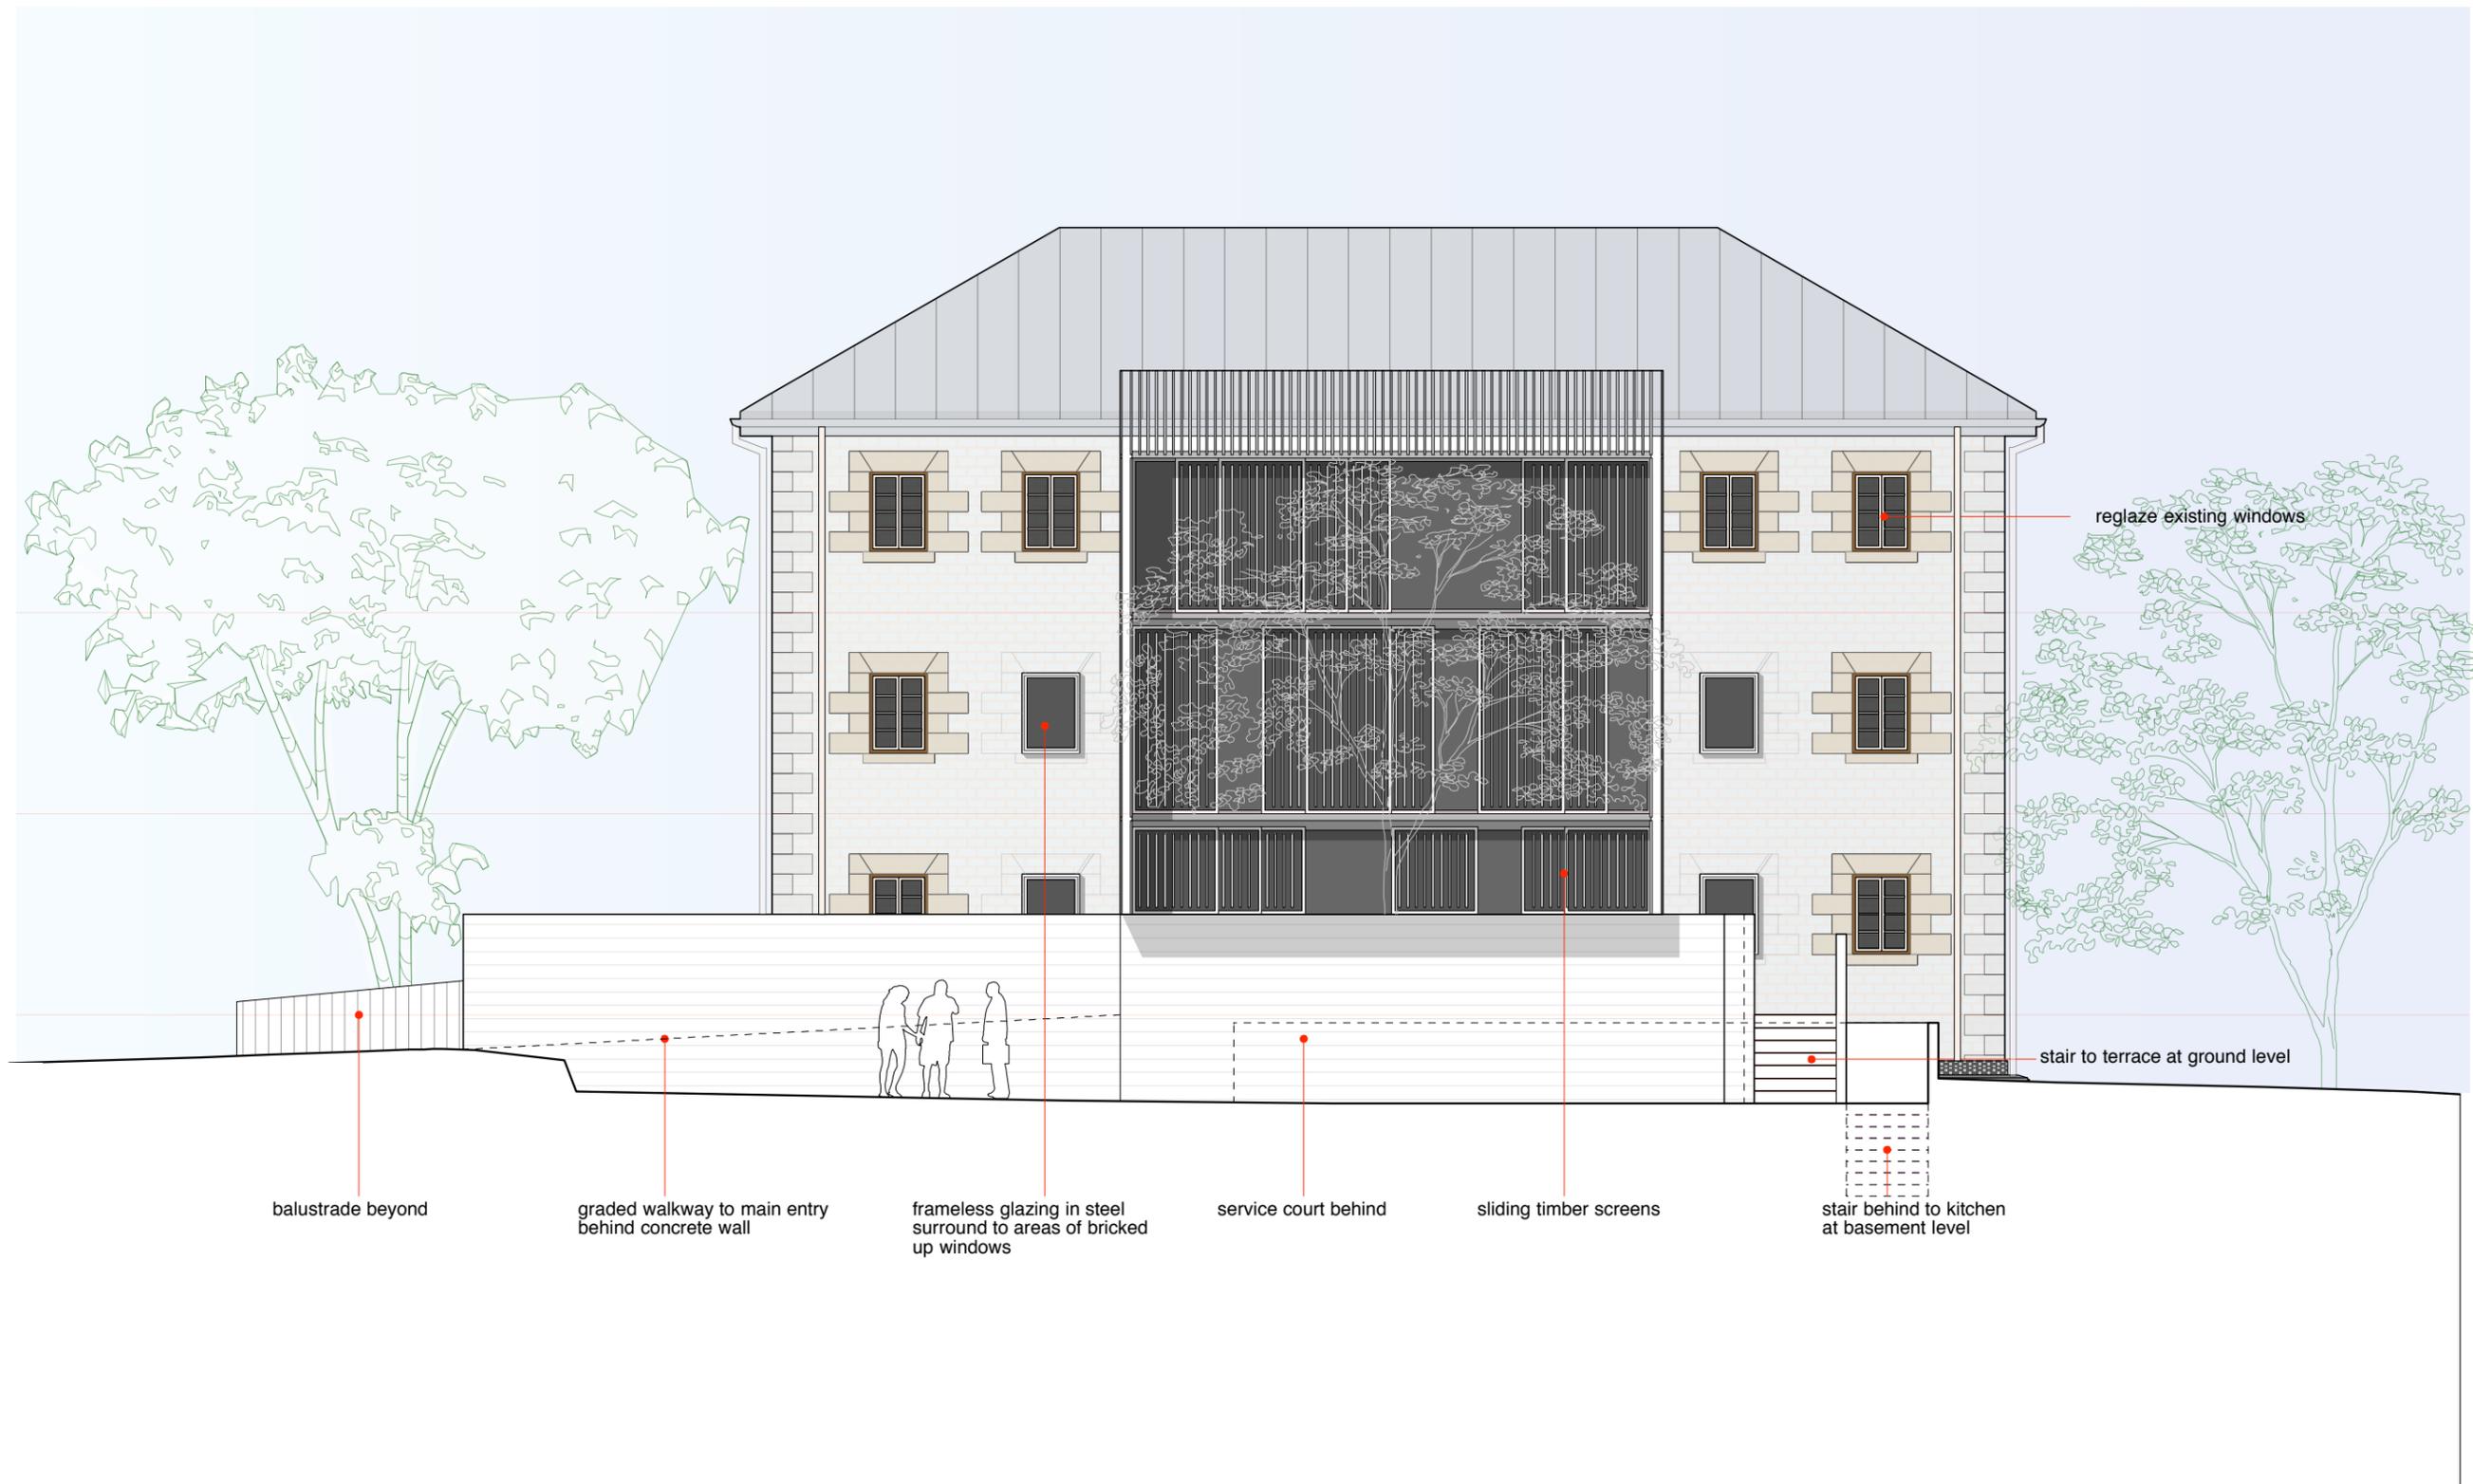
balustrade beyond

graded walkway to main entry behind concrete wall

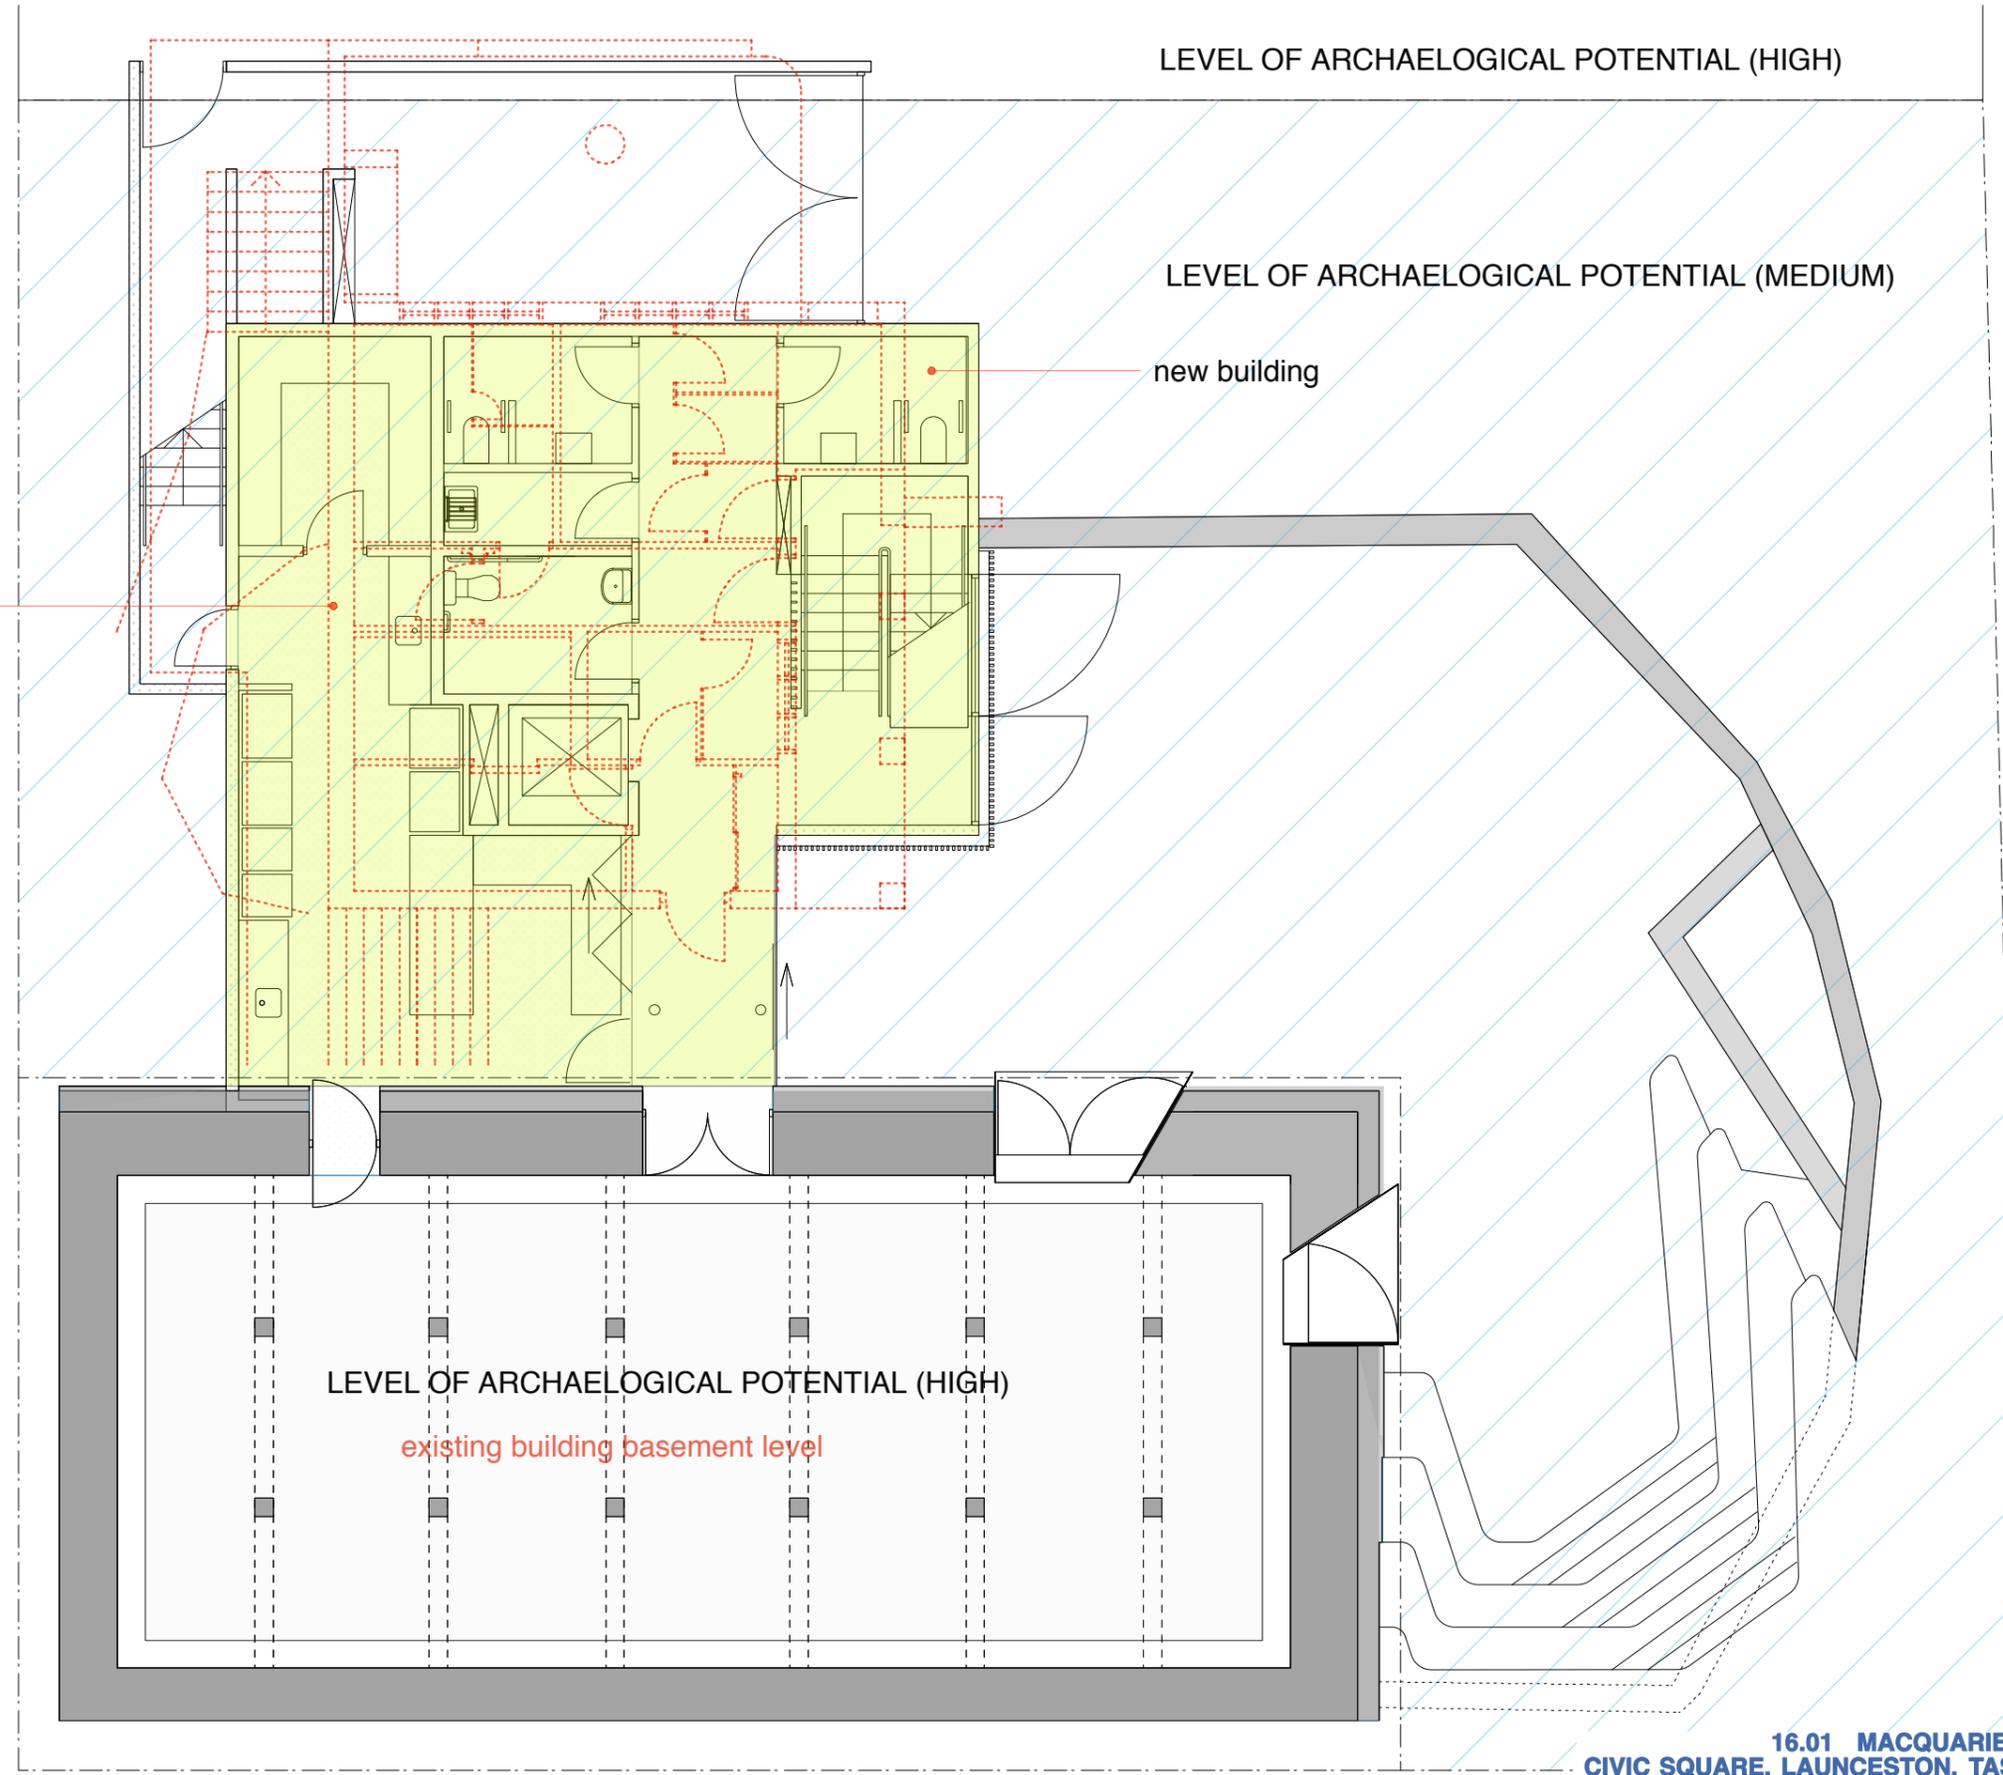
existing building shown dotted

LEVEL OF ARCHAEOLOGICAL POTENTIAL (HIGH)

All of the proposed new works external to Macquarie House are to the rear of the original building, in an area which has been significantly disturbed and heavily excavated. This area has been defined as being of medium archaeological potential which, according to the report's management policies, requires any excavations in the area to be archaeologically monitored. However, should the sub-paving strata be found to be virgin ground (sub-historic ground level) it is suggested no further archaeological input will be required.
