## Attachment 2 - 202 George Street, Launceston - Plans to be endorsed

The proposal relates to the demolition of 202 George Street, property id 6678760 title reference 69385/1. The site is zoned inner residential with a Heritage Place overlay over the dwelling. The site is not on the Stage heritage register however, as per table E13.2.11 202 George street classified on the Local Heritage Places registrar.

### Dilapidation / heritage report:

### E13.6.1 Demolition

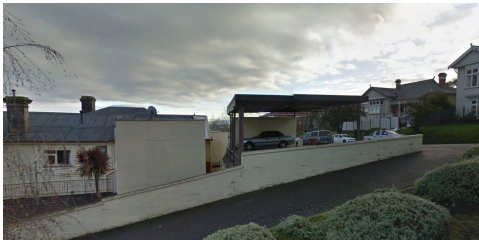
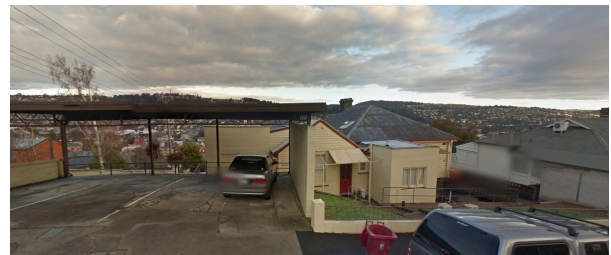
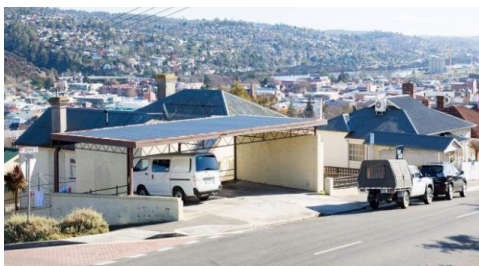
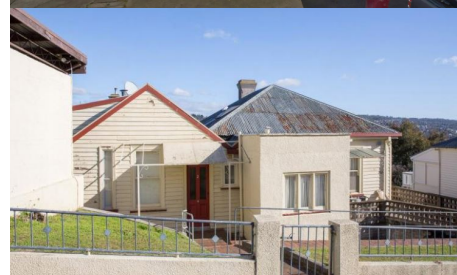
### Photos of 202 George

Furthermore, there seems to have been a number of un-sympathetic extensions added to the dwelling including a bedroom facing George street and another facing Balfour which are both of a texture coat finish. There are extensive concrete block walls that form both balustrades and supports for concrete decks that wrap 2 x sides of the dwelling. There are a number of framed in window openings, a mix of timber and aluminium framed windows, 80's style brick archway

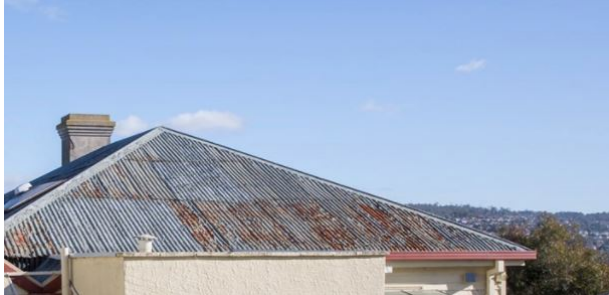
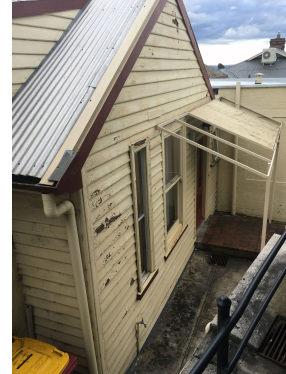
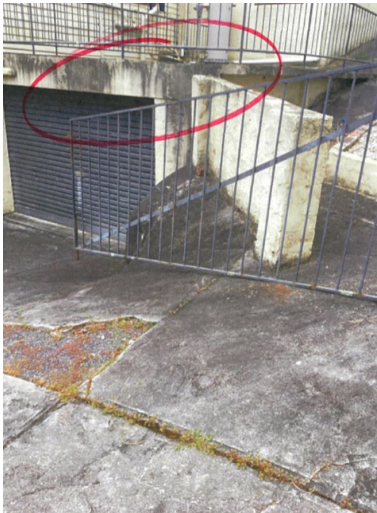
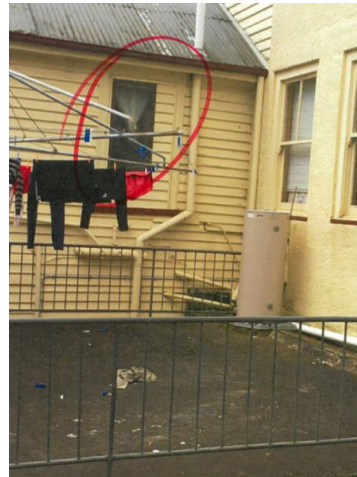
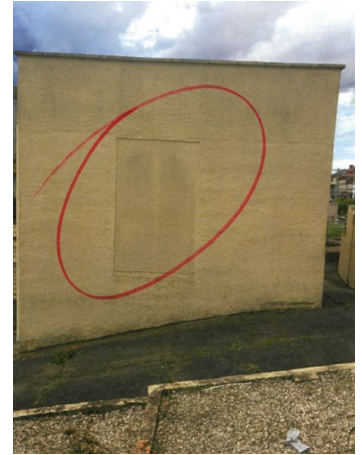
There is considerable water damage due to drainage issues, windows have been infilled and replaced in part of the openings with aluminium windows. The roofing and flashing require replacing, along with most weatherboards. The home requires re-painting, concrete decks required re-waterproofing, the home is not energy efficient, old, run down and generally in disrepair.

While we do not endorse the strategy of 'demolition by neglect' the current condition of the home required enormous investment to bring the building up to current building regulations and OHS conditions.

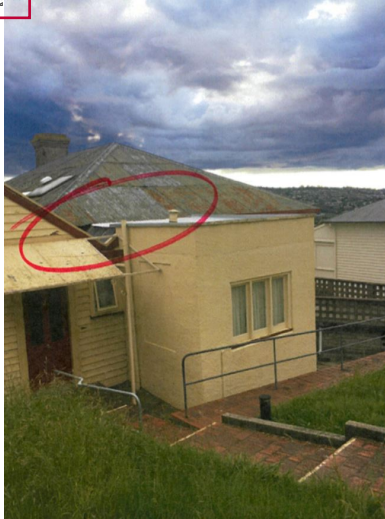
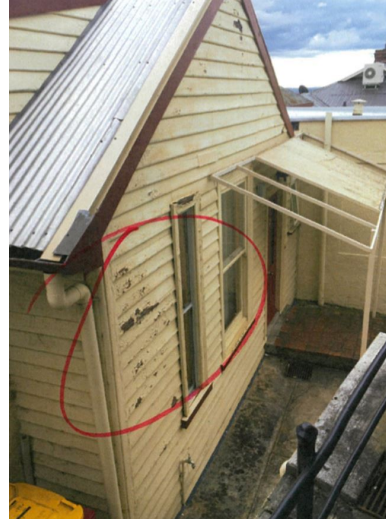
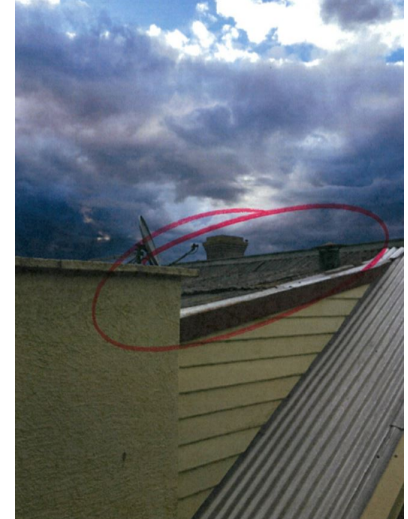
Deterioration is happening at a considerable rate, weatherboards are damaged, unsuitable and complicated box gutters / roof forms provide a high risk of failing. Roofing and roof sheets are lifting and are rusty. Windows are unsealed and frames are weathered or rotting.

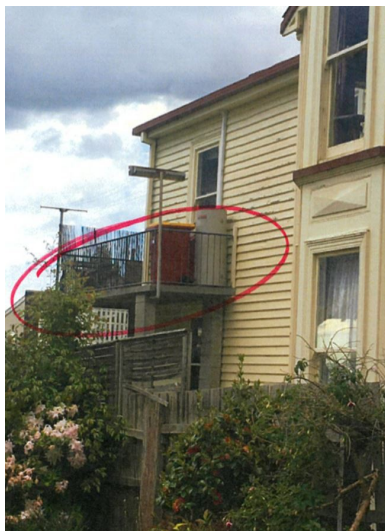
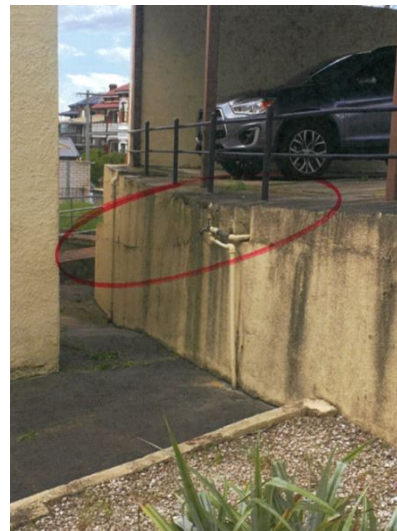
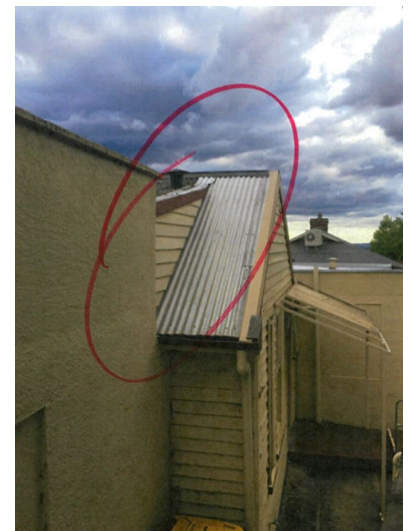
There are many unsafe parts of the dwelling due to poor workmanship and site movement. There are large cracks in concrete work, the concrete decks are not safe.

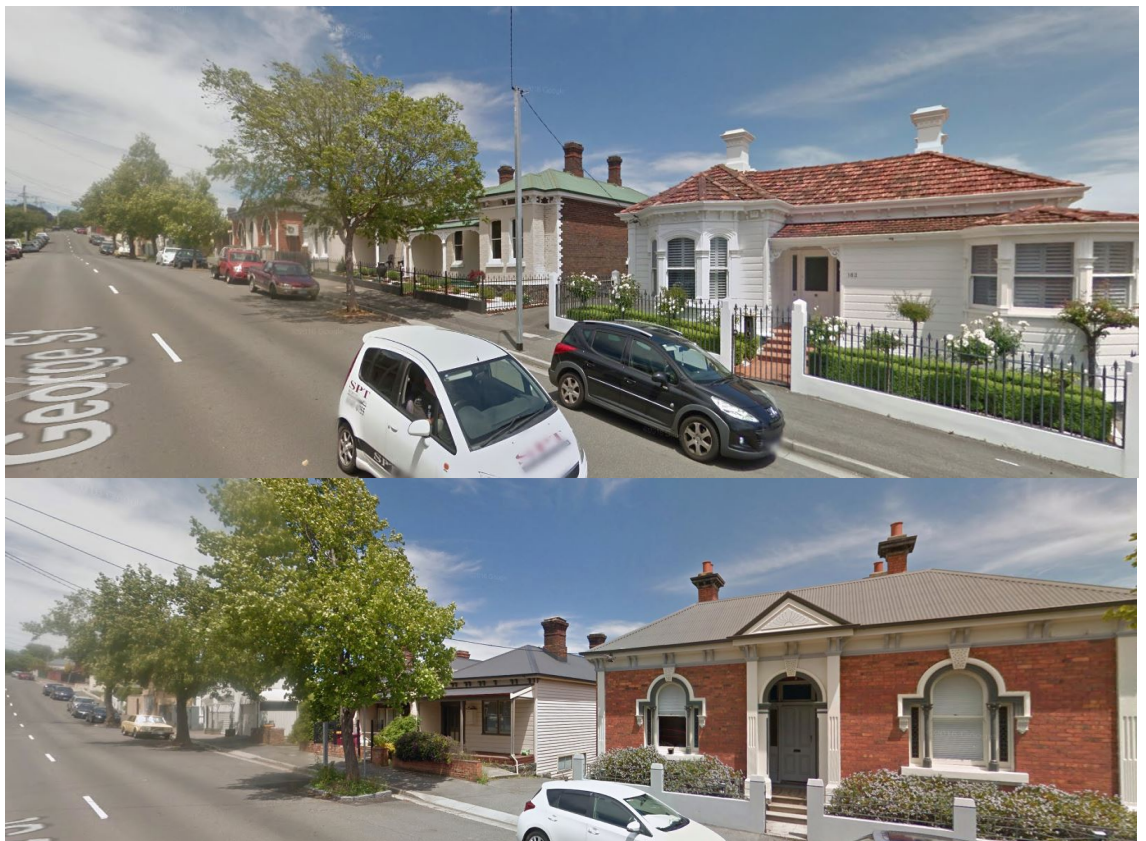
#### George street streetscape

streetscape. Most dwellings give a 'front' door presence that address the street and have a consistent setback from the street. 202 George streets main building is set back a considerable distance from the George street boundary and is not in keeping with surrounding context.

202 George does not have any real presence and does not make a perceived positive contribution to the character of the area. The additions, garaging and carport parking areas detract from the predominant character of the area.

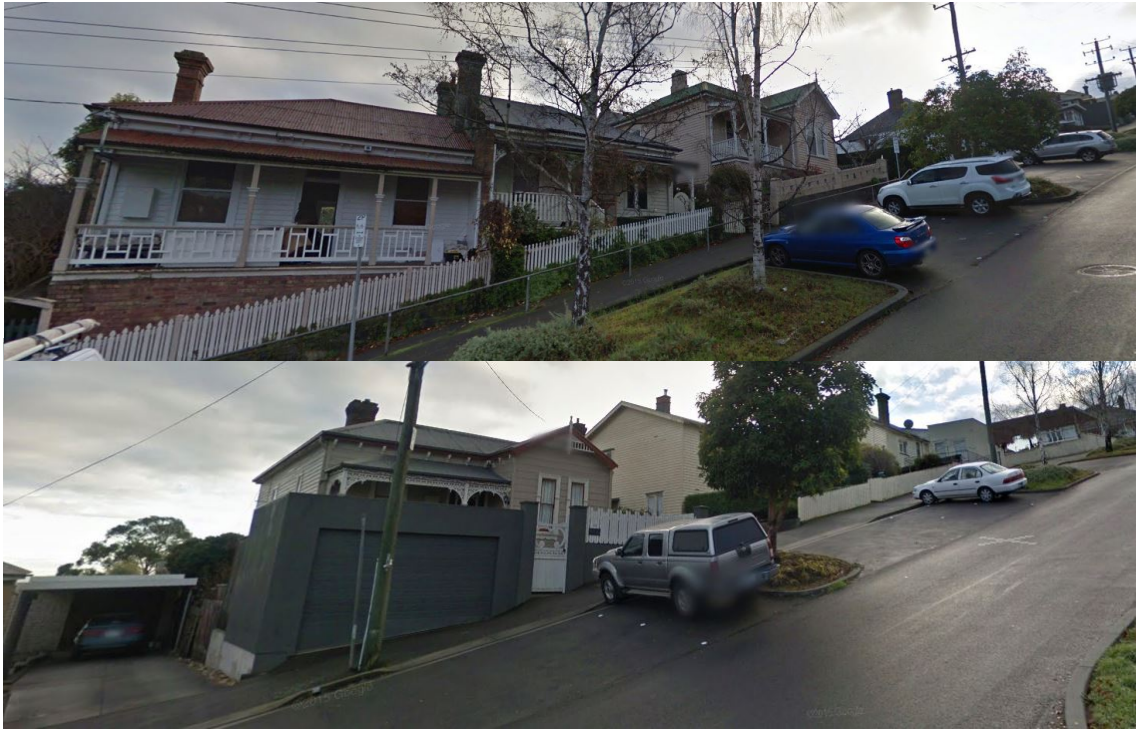
### Balfour street streetscape

The original form and massing of the dwelling has been predominately lost due to the additions and added parking areas. There is no sign of original joinery and the windows and doors seemed to have no unique characteristics. The addition of concrete walkways and parking areas furthermore detract from the surrounding character of 'well kept' gardens and front fence character.

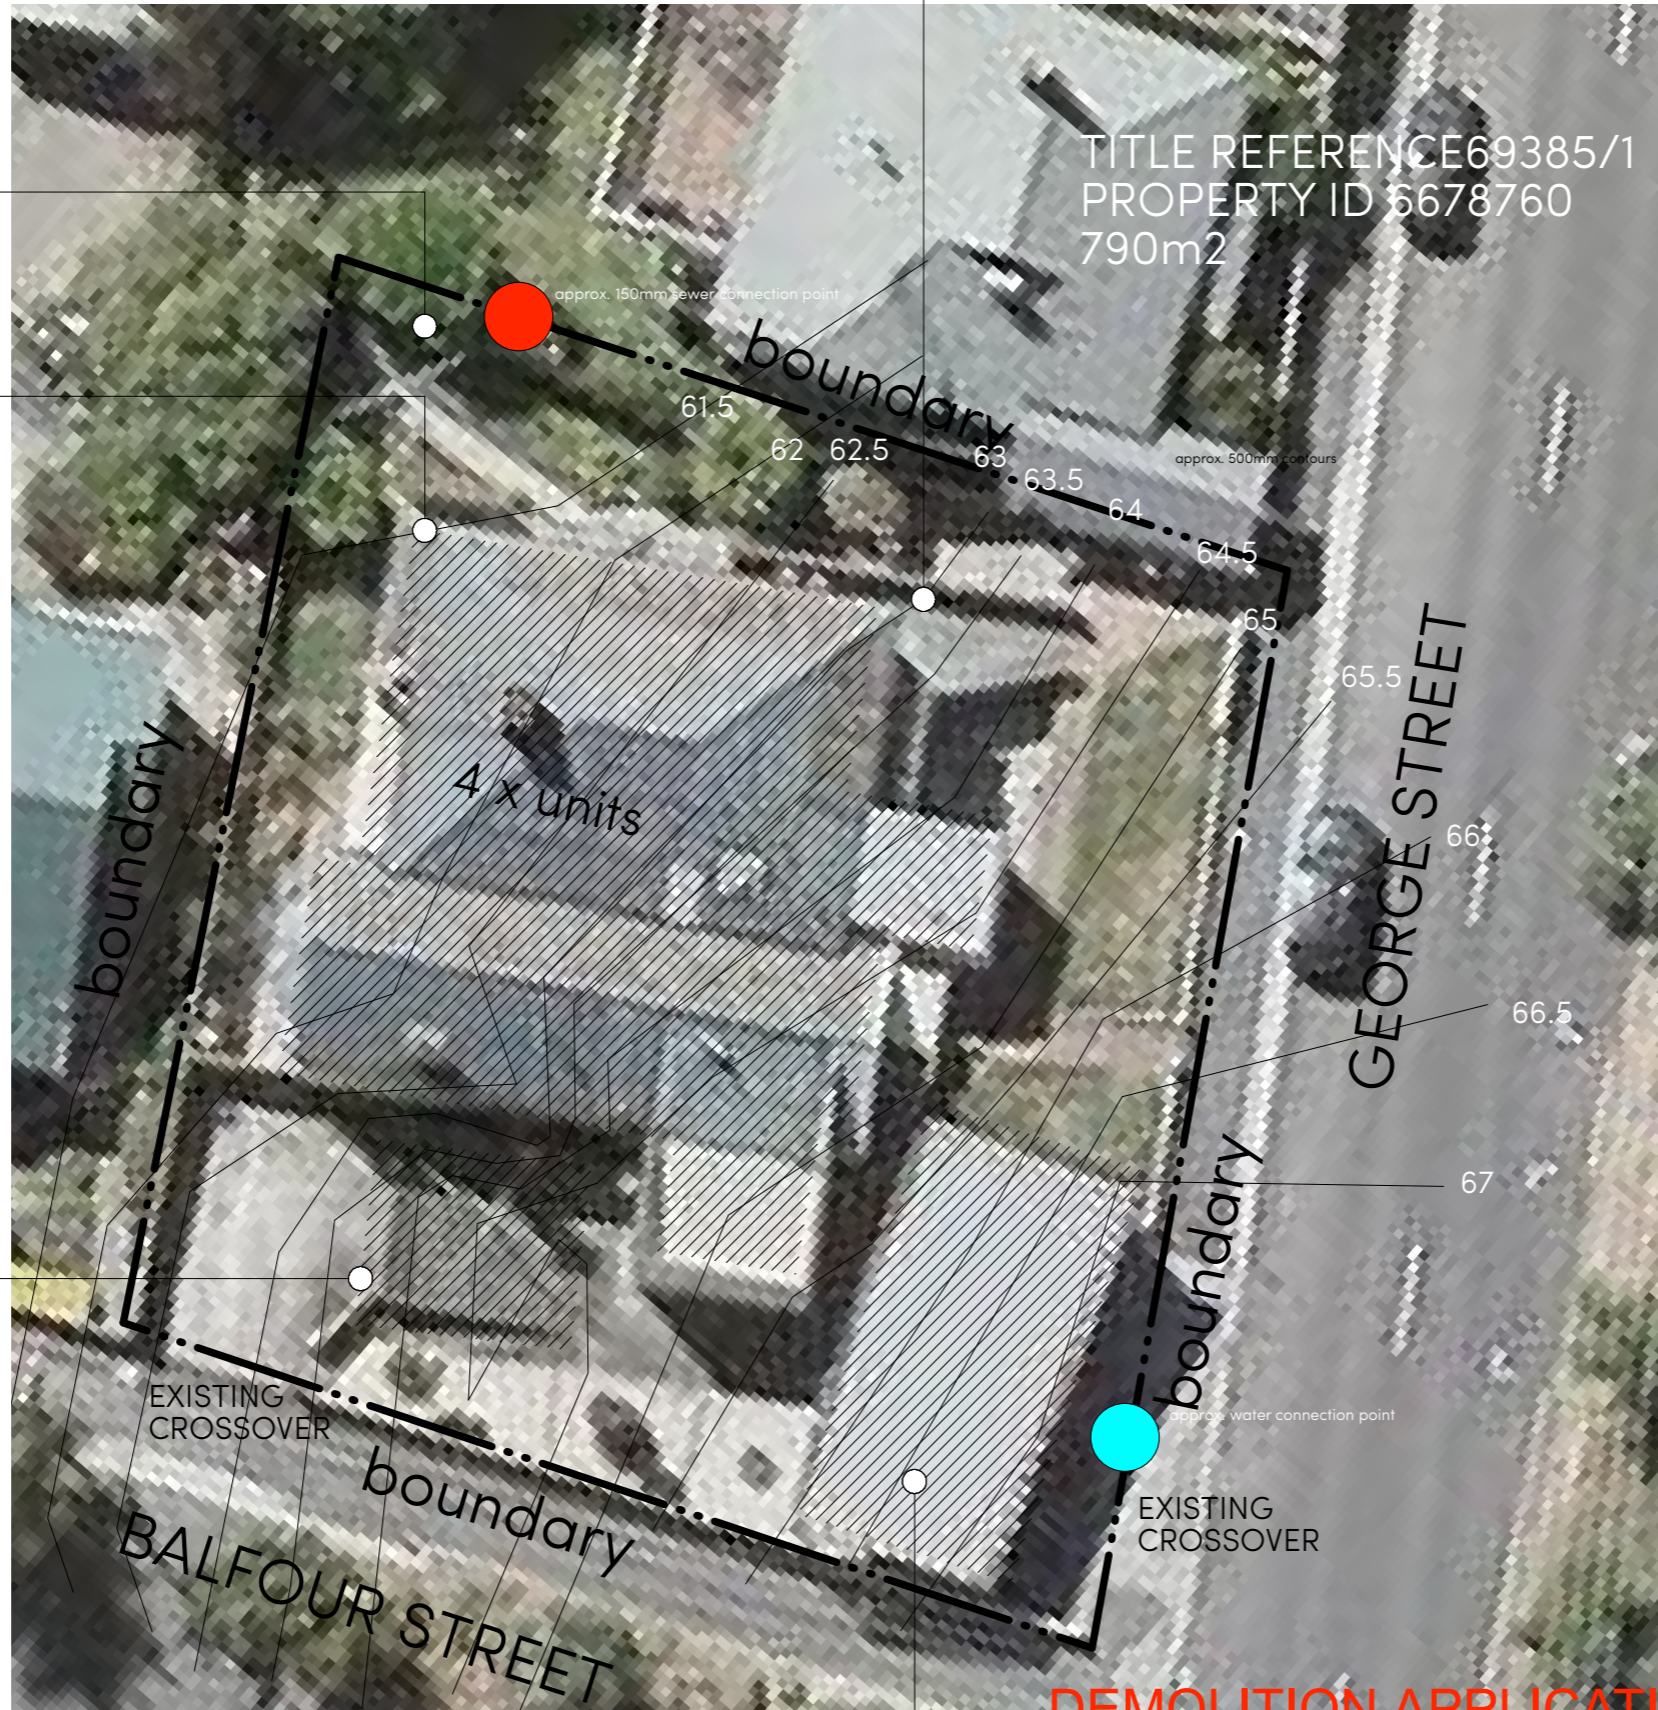
walkway / deck to be removed

shrub's to be removed

hatch area denotes area of proposed demolition

area of garage to be removed

area of carport / retaining walls to be removed

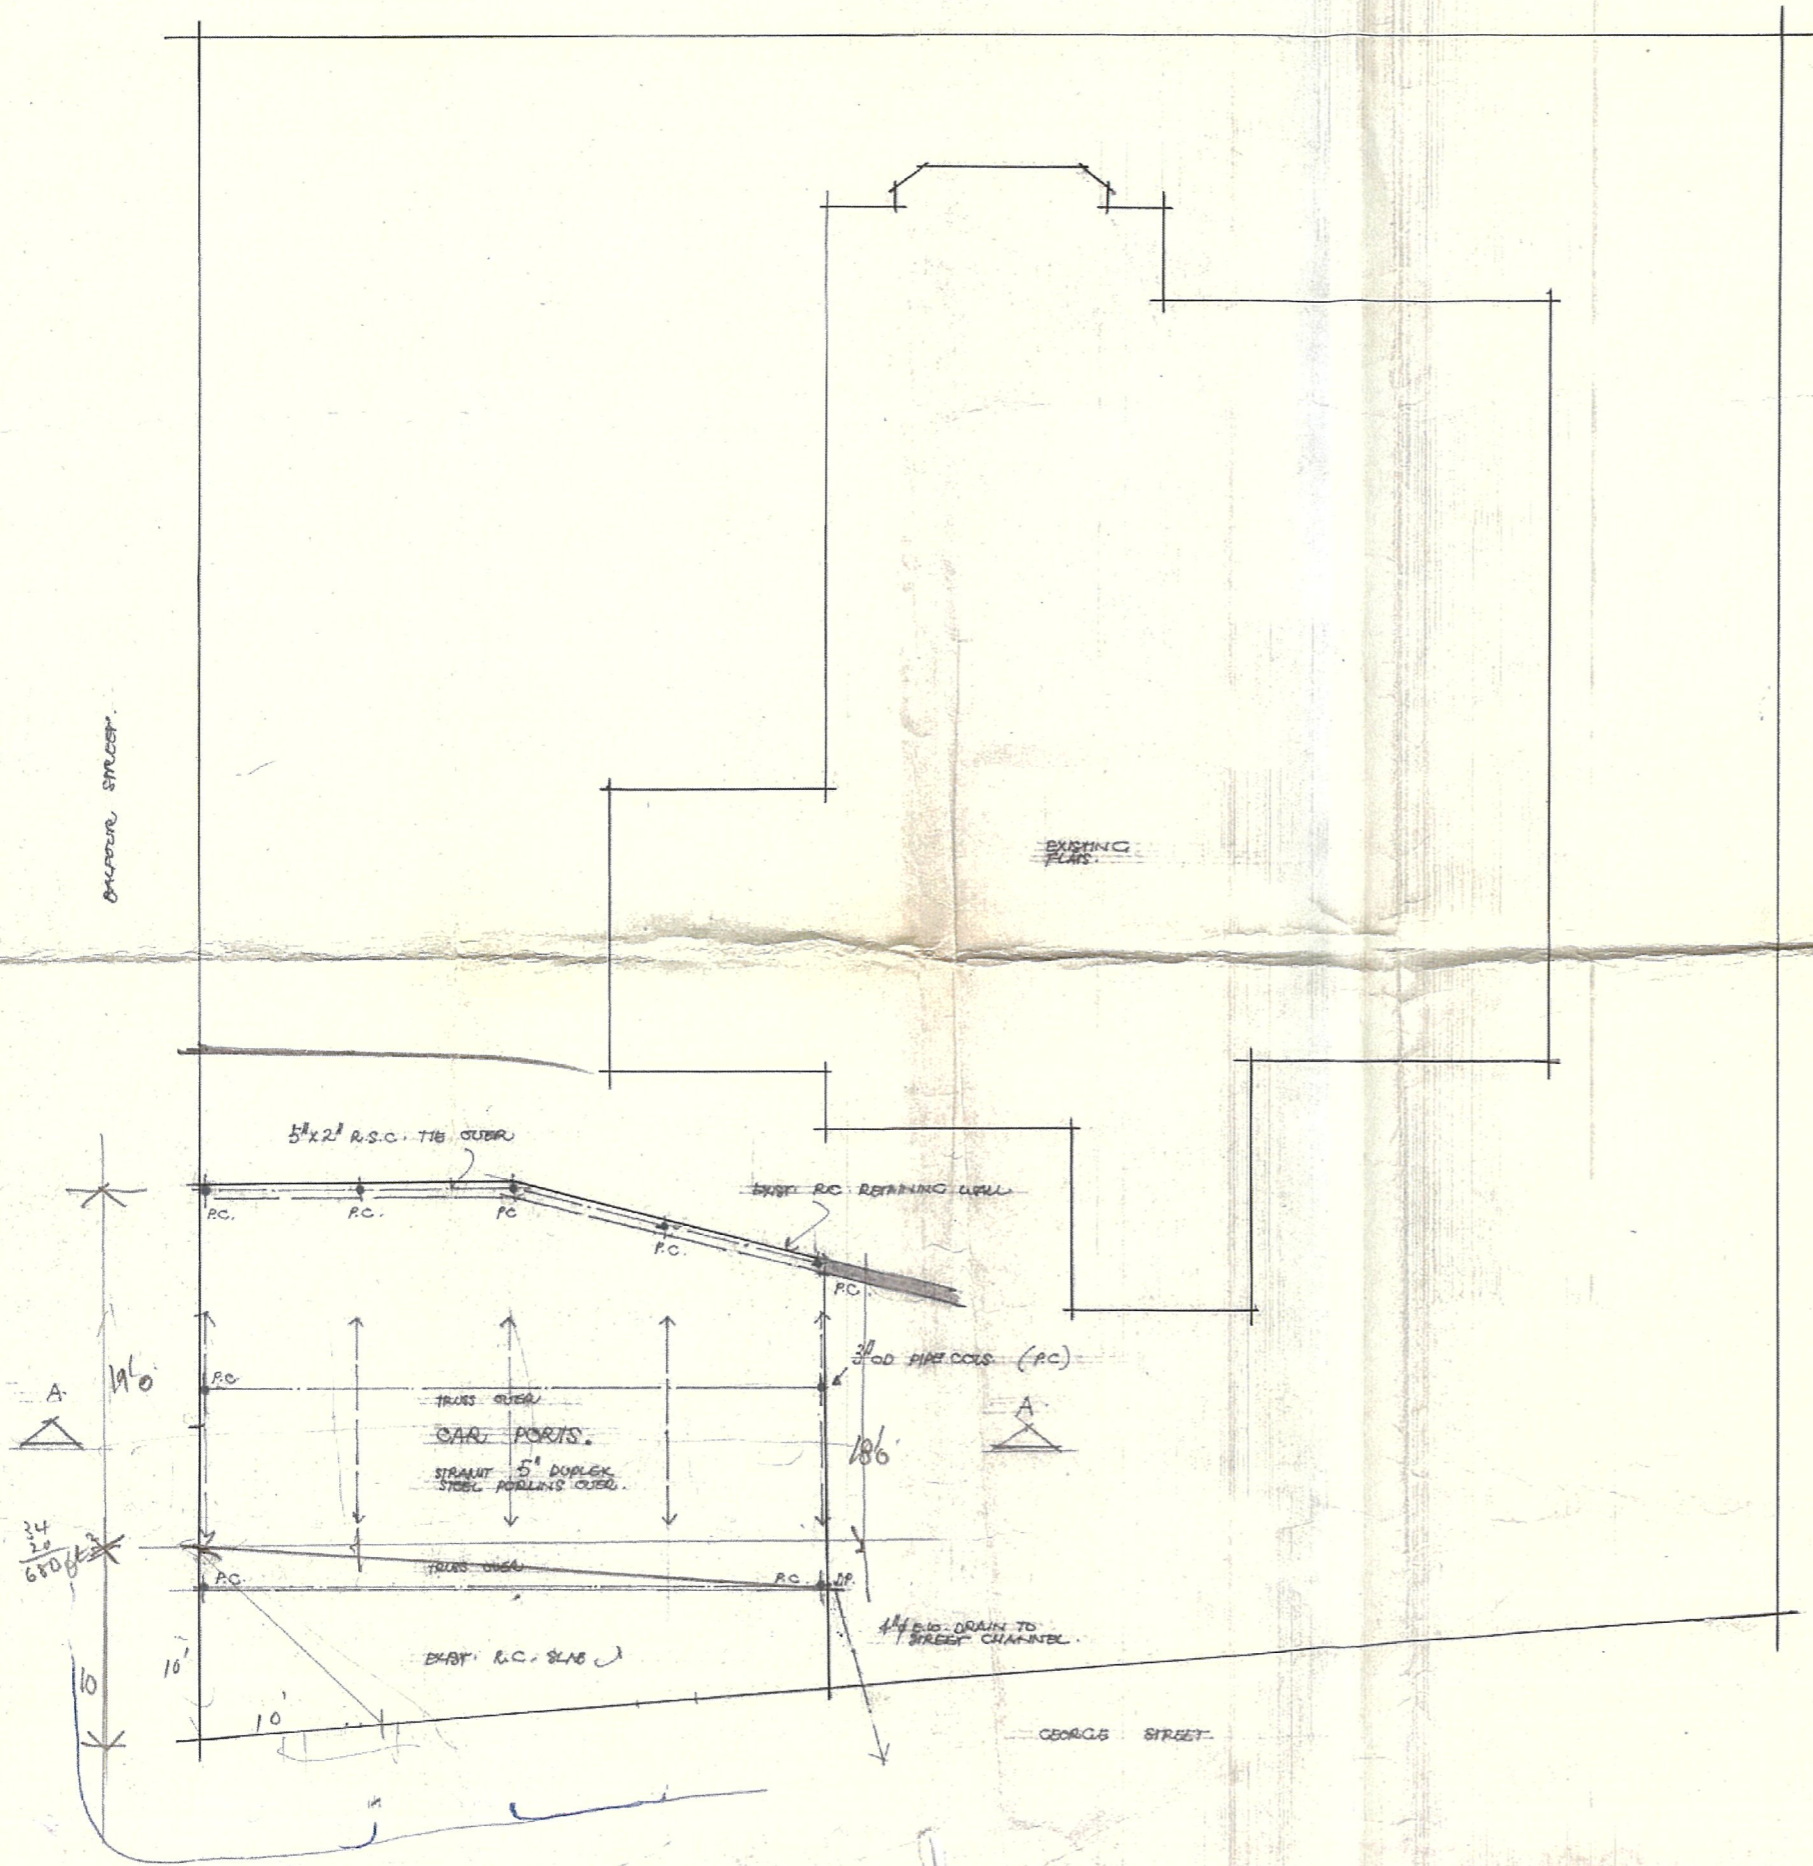
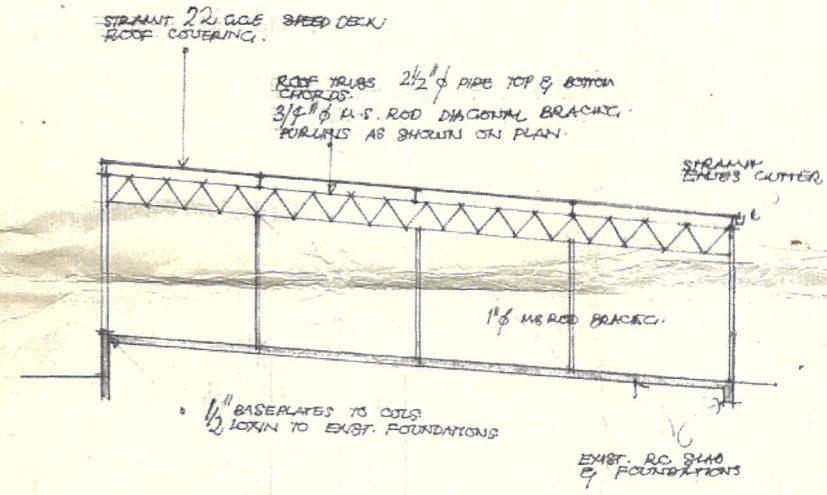
CAR PORTS - NO 202 GEORGE STREET.  
 FOR MR. M. BORTOLOTT.

FLOOR & SITE PLAN : SCALE : 1/8 INCH = 1 FOOT.
