RE: Updated Site Assessment, 69-71 Cimitiere St and 44-50 Tamar St, Launceston

Site Investigation - 69-71 Cimitiere St and 44-50 Tamar St, Launceston

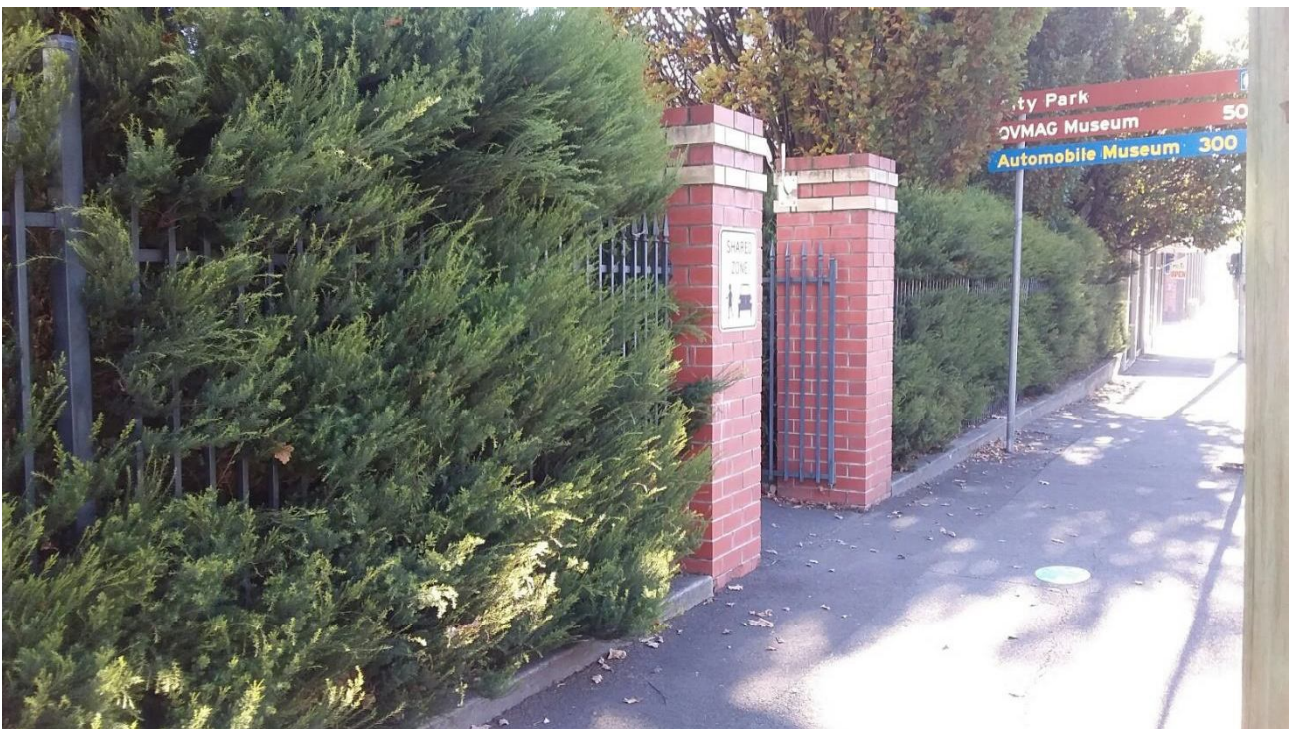
Figure 3 - Existing fence/gate on Tamar St, opposite Albert Hall.

#46-50 Tamar St – currently only front gate and fence from previous business, (see Figure 3) with bitumen sealed car parking area across the remainder of the site. This is the site of the proposed Hotel Verge structure. (See Attachment 2 and Figure 6) No obvious contaminants on or from this site.

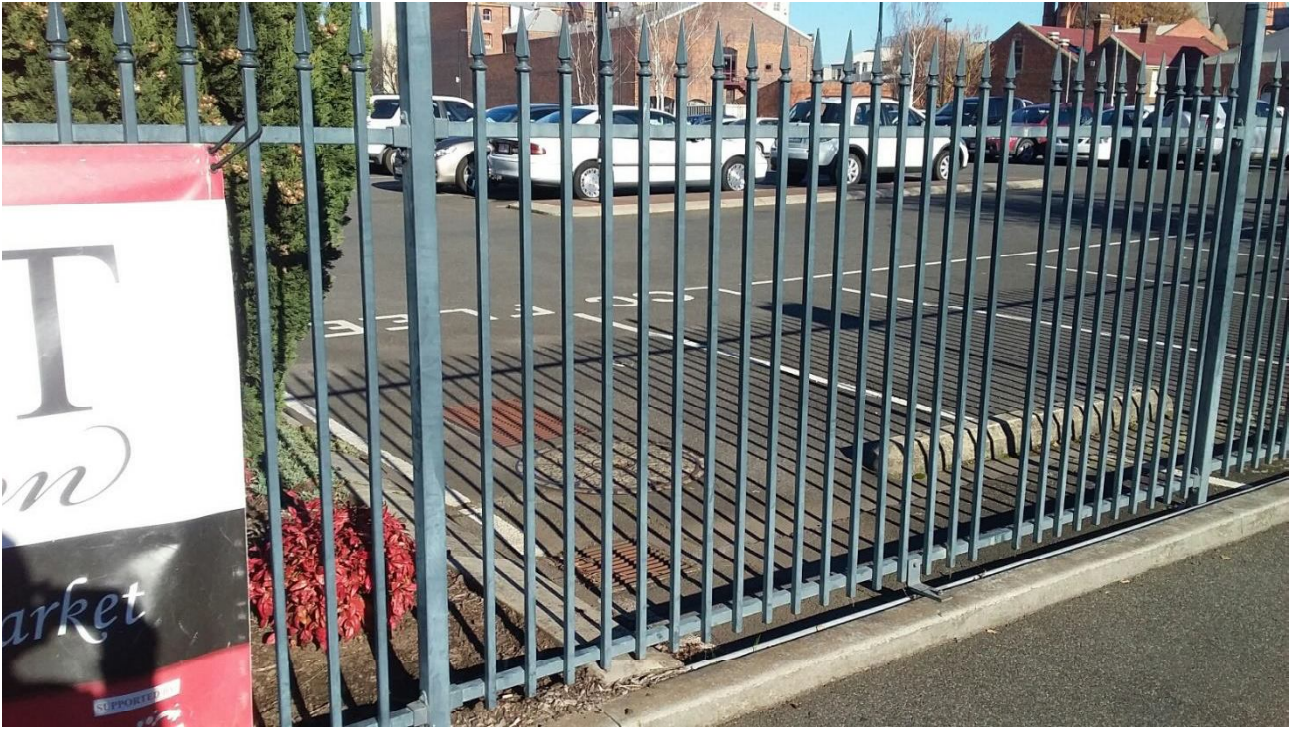
Figure 4 - View to SW from Cimitiere St

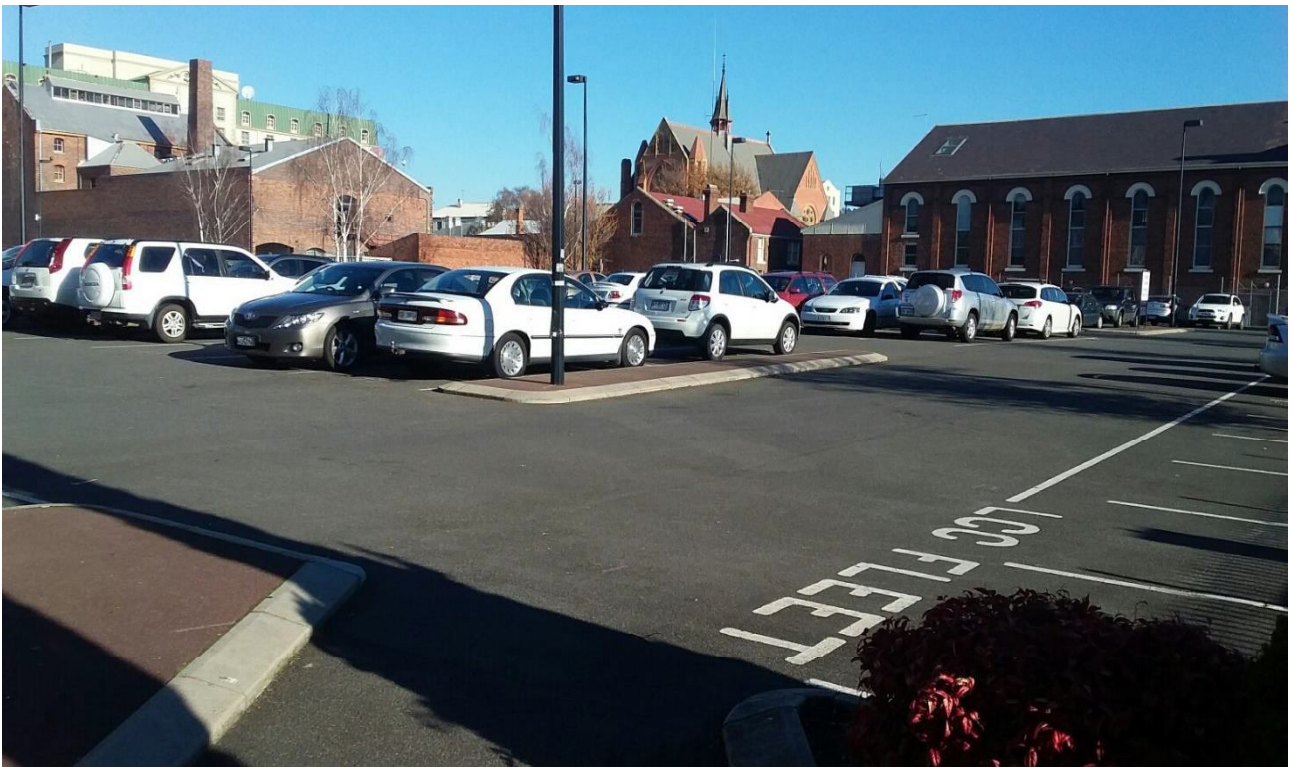
Figure 5 - View to South West over carparks. (approx site of former UPS.)

A full search of the Worksafe database concluded that all tanks and pumps from the region (Cameron and Cimitiere St) had been removed by 1985. It is now noted that works will occur close to where the UPSS was (see attached plans).

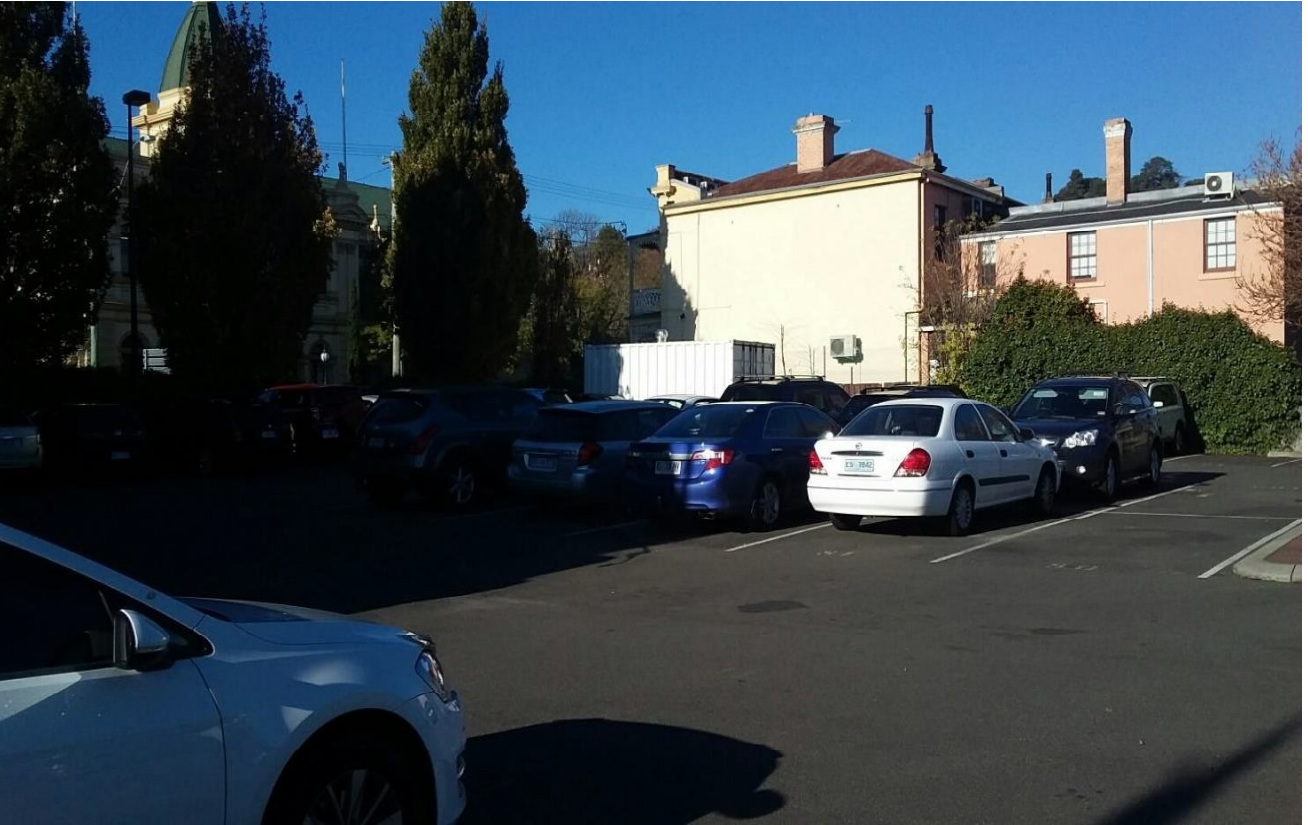
Figure 6 Site of proposed Hotel structure.

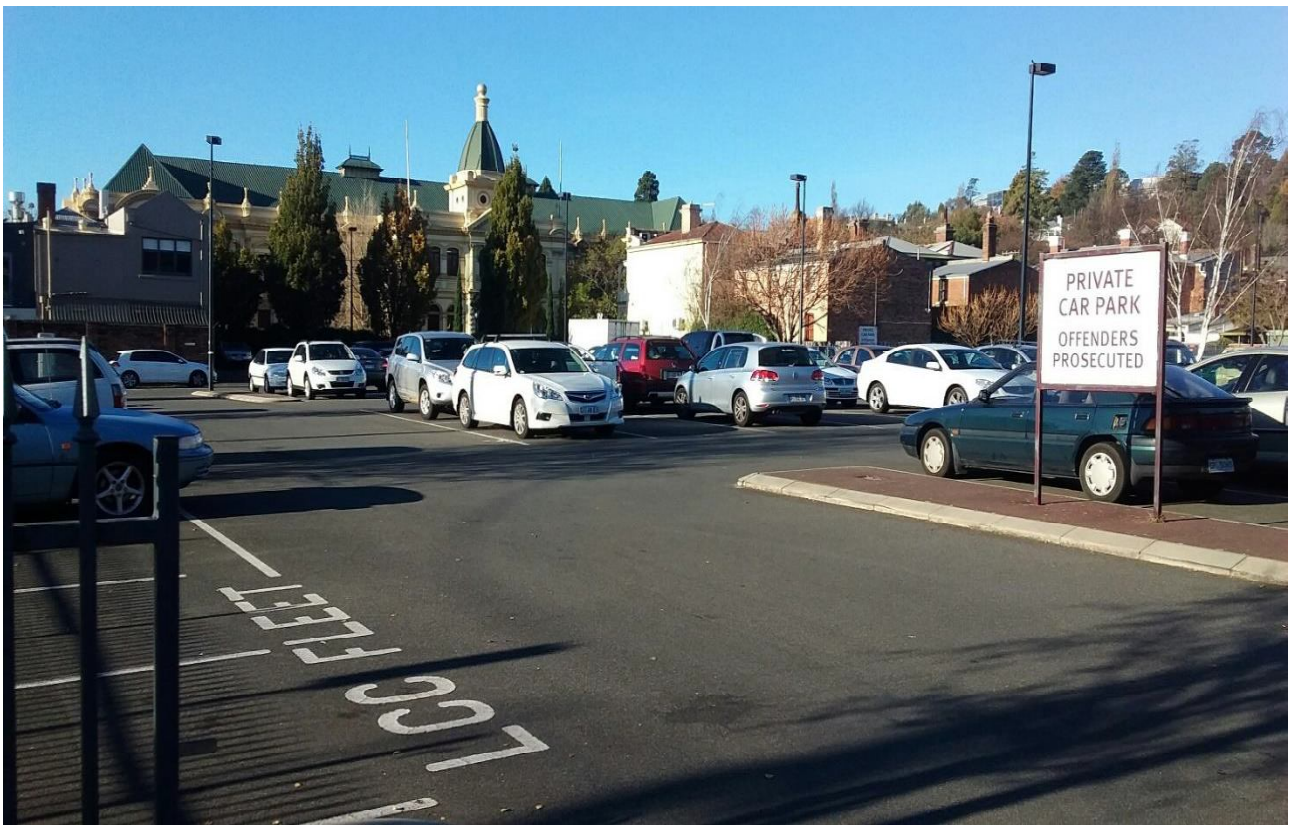
Figure 7 View to the east, over site of proposed Hotel Structure.
