**'End of Life' Tyre Processing and Storage**  
8 Cavalry Road, Mowbray

Date	14 December 2017
Project Number	17.005
Project Name	ELT Processing and Storage Environmental Effects Report
Author	Heidi Goess, Land Use Planning Pty Ltd
Recipient	EPA Tasmania

**Land Use Planning**  
**8 Cavalry Rd, Mowbray**  
**tyre recycling plant**  
**environmental noise assessment**

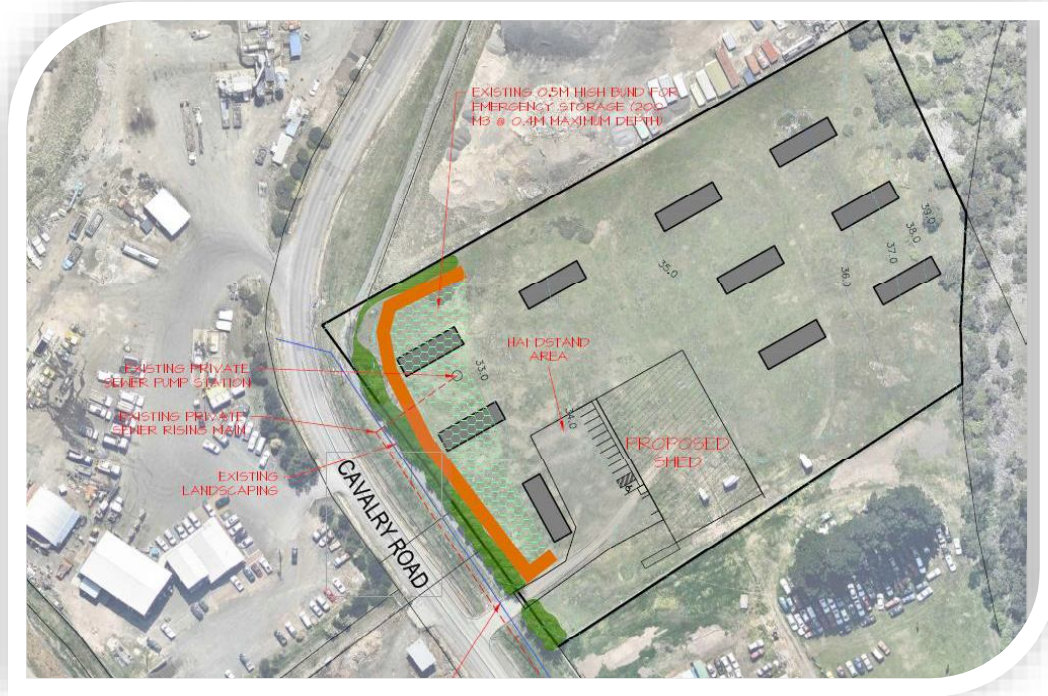
Figure 1- Site Plan showing ELT storage, Building and Associated Infrastructure

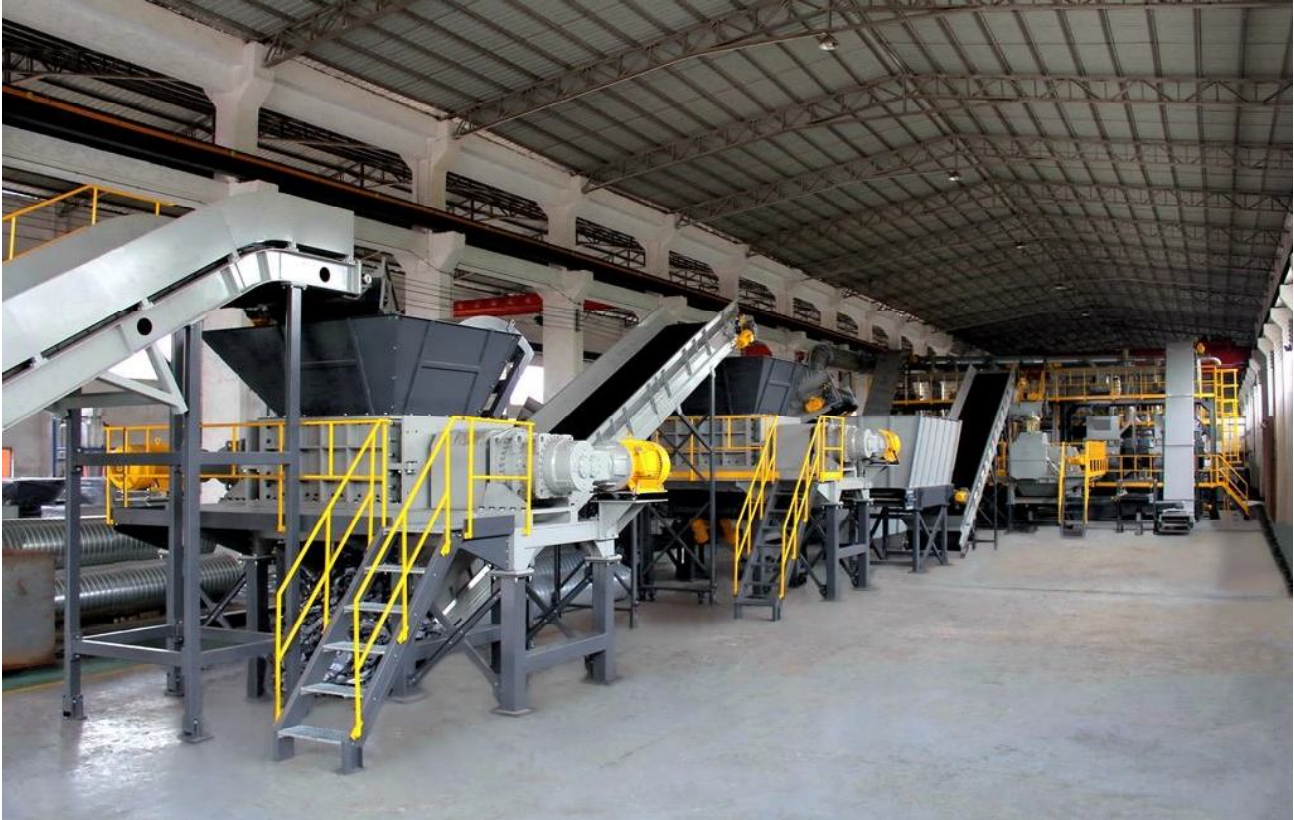
The Tire Recycling Plants are high performance, heavy duty systems designed for recycling of car, truck and OTR tires. These systems are ideal for the production of clean rubber crumb and the separation of steel and textiles. Using normal temperature and non-chemical processing technology, these recycling systems are cost effective and don't create secondary pollution. The heavy-duty shredders utilized in these systems are capable of shredding whole tires including the thick steel reinforcing bead wires enabling fully automatic operation. These plants are intended for customers who require high capacity, tire recycling systems with a capacity between 1000-10,000kg/hr.

The correct combination and sizing of the above listed equipment will provide a reliable, efficient tire recycling system that will produce a high-quality rubber granulate, clean textile and steel ideal for sale, or for use in further processing equipment.

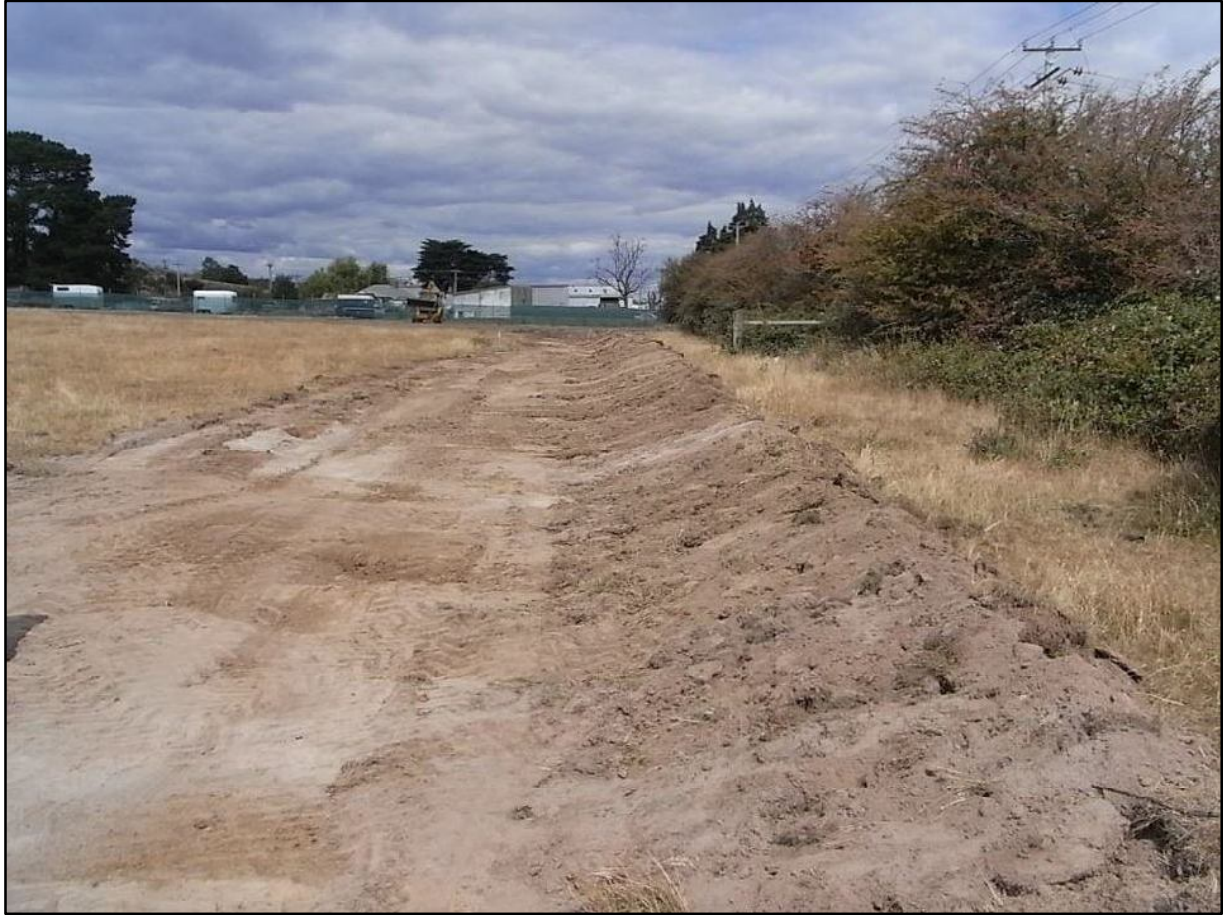
**Figure 12 – Constructed bund completed on 20<sup>th</sup> February 2017**

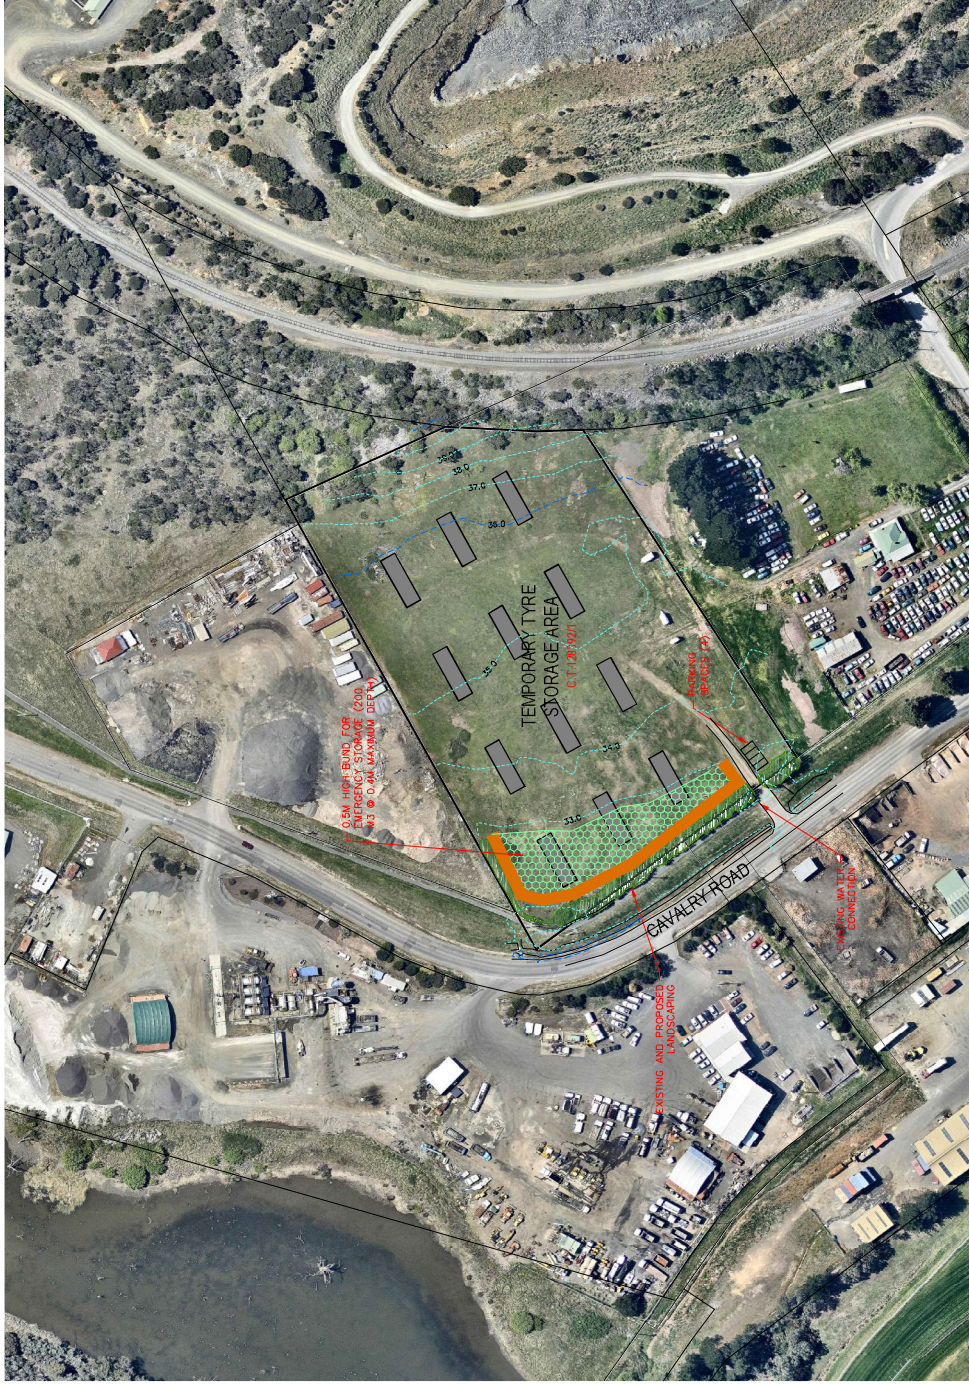
BUND STORAGE - TYPICAL SECTION  
SCALE 1:100

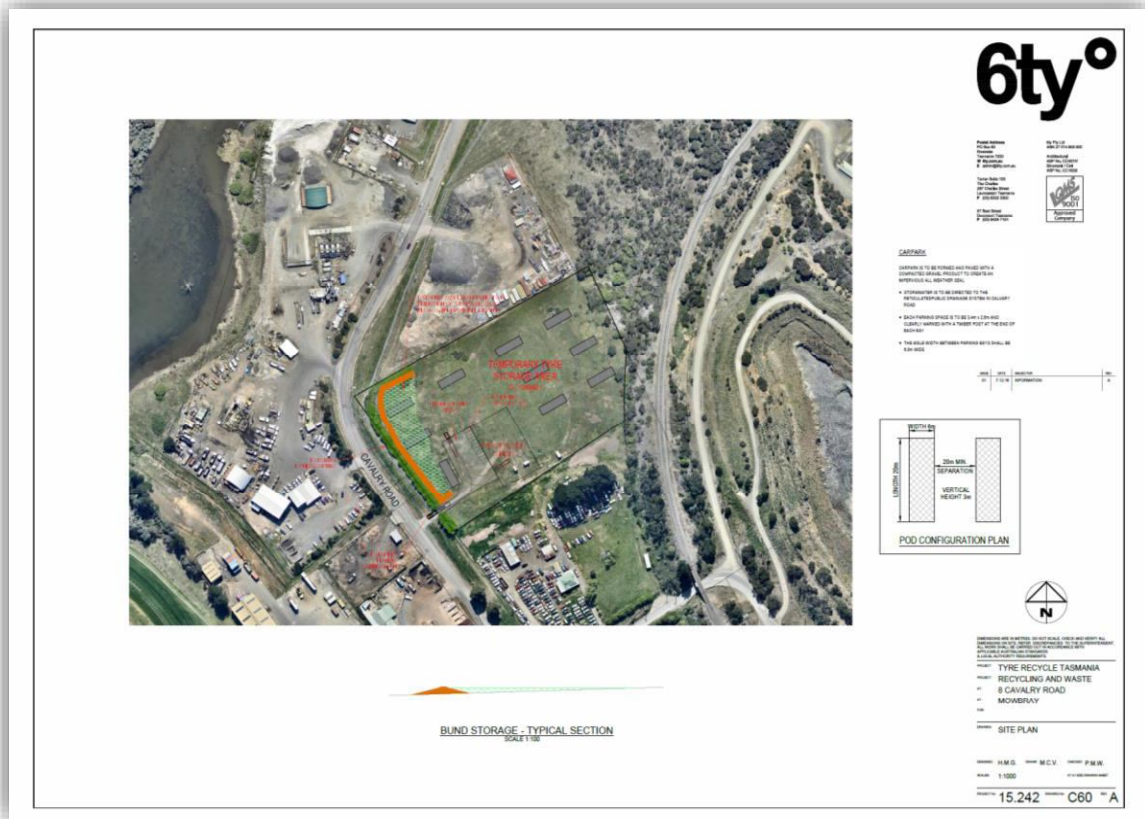
Figure 2.2 – Tyre recycling plant site plan (provided by LUP).

Figure 2.2 provides a site plan of the proposed plant while figure 2.3 shows a 3D schematic of the process line equipment to be located within the proposed shed shown in figure 2.2.

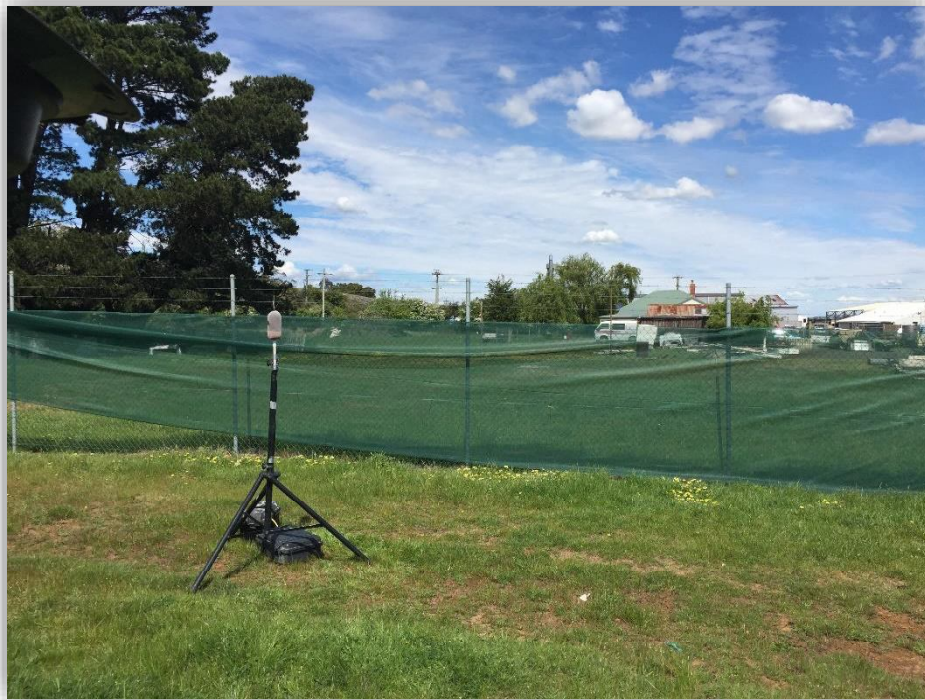
Figure 3.1 – SLM location.

Figure 3.1 shows the location of the SLM during the monitoring period.

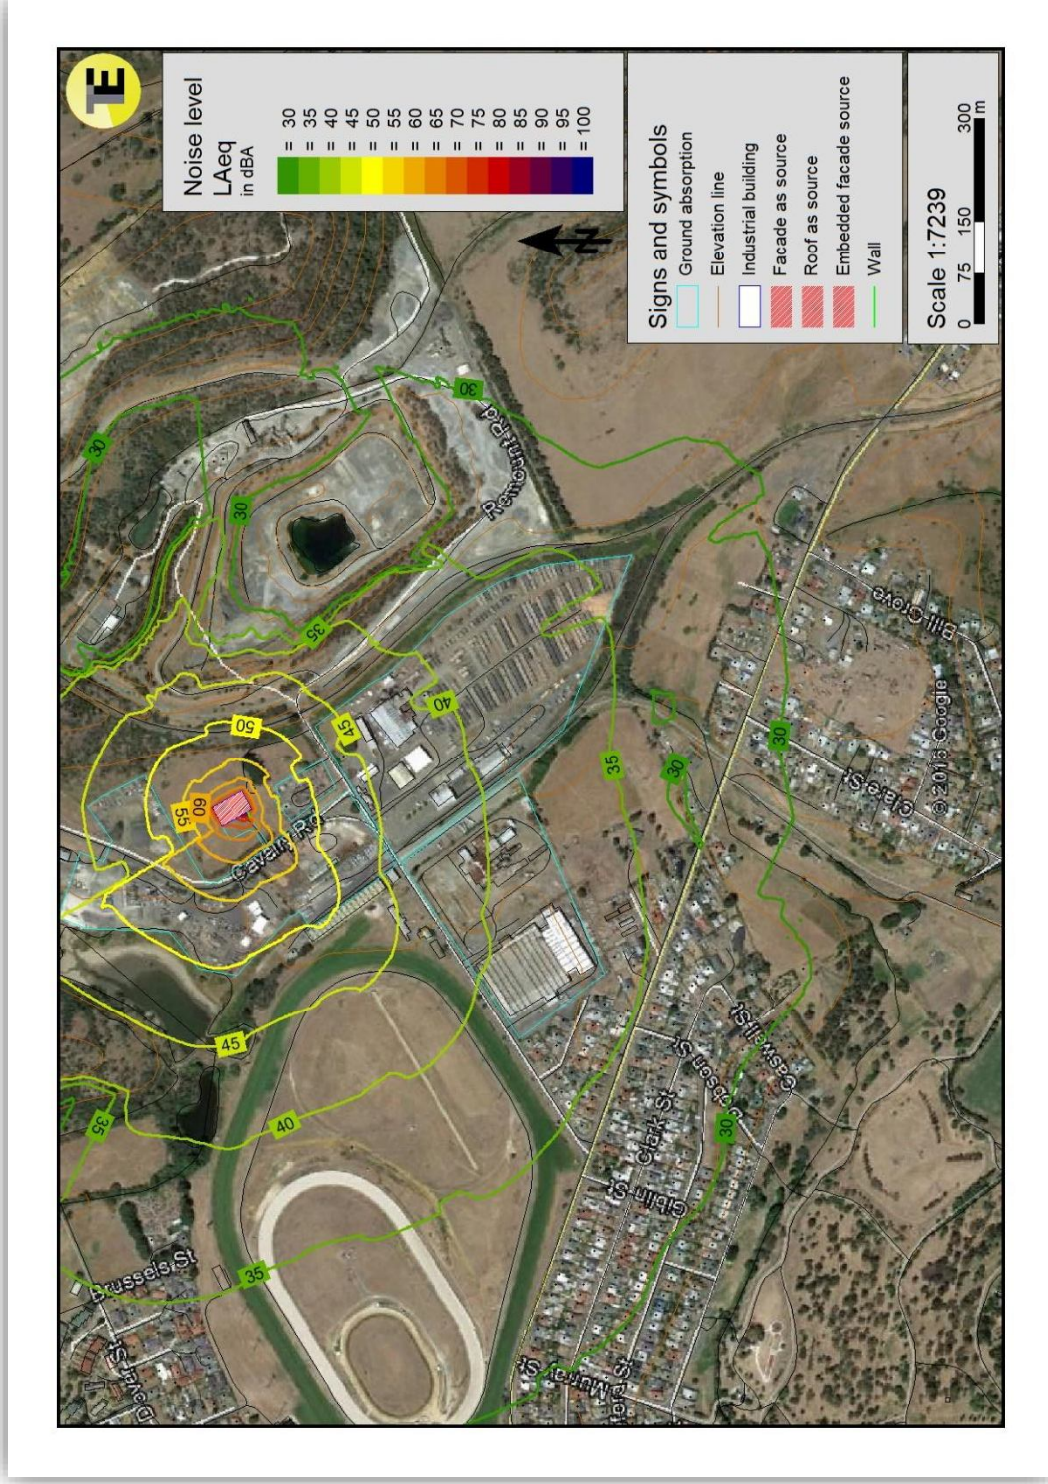
Figure 5.4 – Predicted noise emission contours, far-field.

- Far-field, contour extent encompassing residential properties to the south-west and west.
- Near-field, contour extent encompassing site boundary and adjacent commercial/light industrial properties.
