**Reserve Activity Assessment #3602 Inveresk Pedestrian Bridge:
 Step 7 Approval – External Assessment**

Construction of Inveresk Pedestrian
Bridge

UNIVERSITY OF TASMANIA PROPOSED FOOTBRIDGE

Flora and Fauna Assessment Report

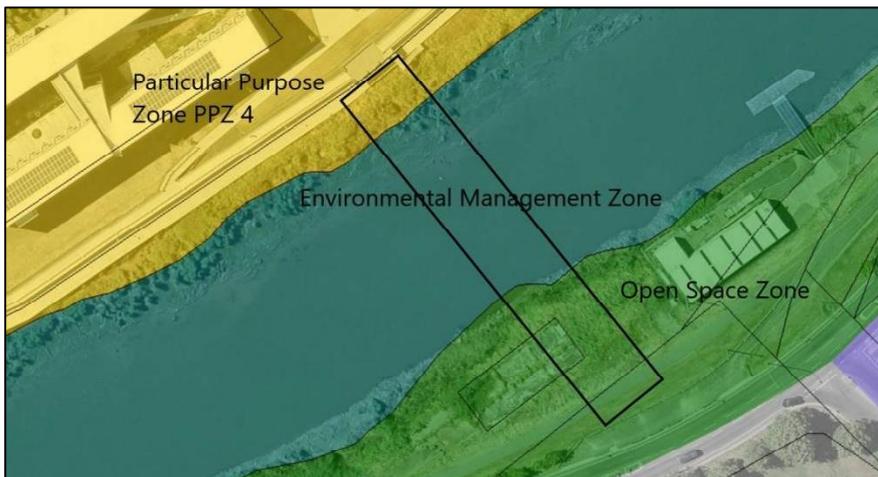
Figure 3: Zoning of the subject land (Source ListMap)

The relevant land use document is the Launceston Interim Planning Scheme 2015 (the Planning Scheme). The viewing platform, and location of the northern abutment is zoned Particular Purpose PPZ 4 - Inveresk site. The river, where pier 1 is located and potentially the location of Pier 2, is zoned Environmental Management. The southern abutment is zoned Open Space. The site zoning is shown on Figure 3. The proposed bridge falls within the Utilities use class. Utilities are a Discretionary Use in each of these zones.

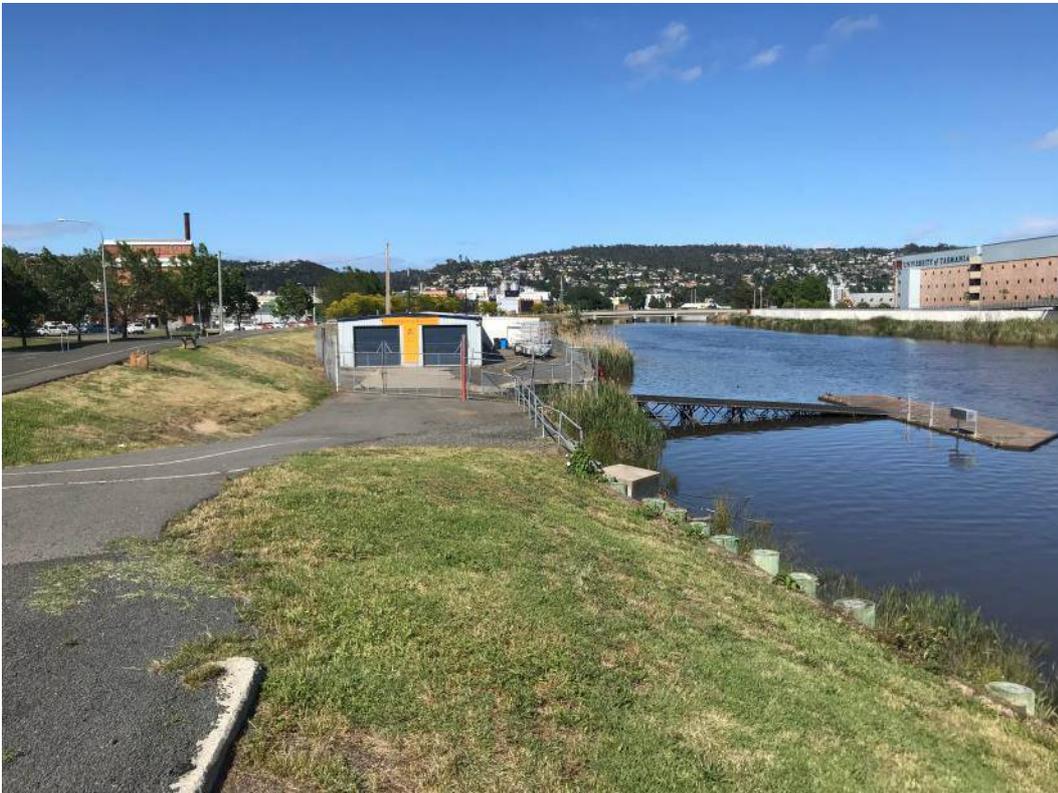
Plate 1 Looking west towards the rowing club and pontoon from eastern end of Study Area on the southern bank of the North Esk River

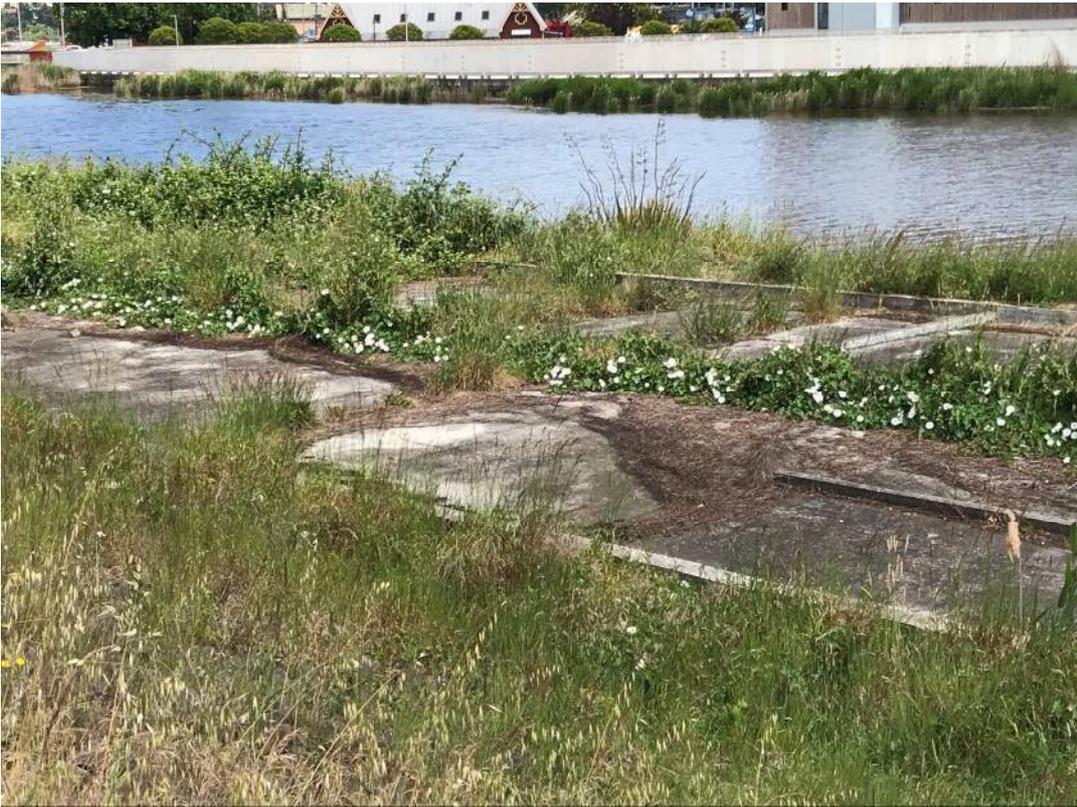
Plate 2 View from southern bank of North Esk River overlooking old rowing club house foundations.

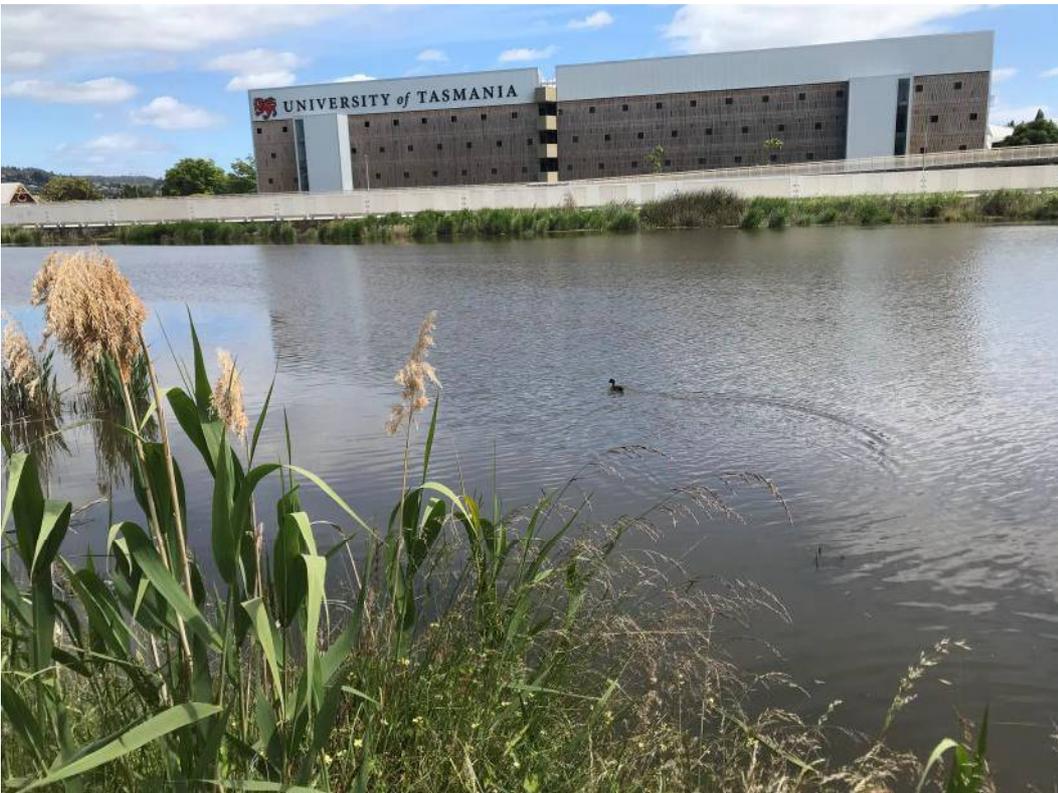
Plate 3 View from central section of Study Area from the southern bank of the North Esk River looking across to the UTAS Campus and the existing foreshore pedestrian/cycleway

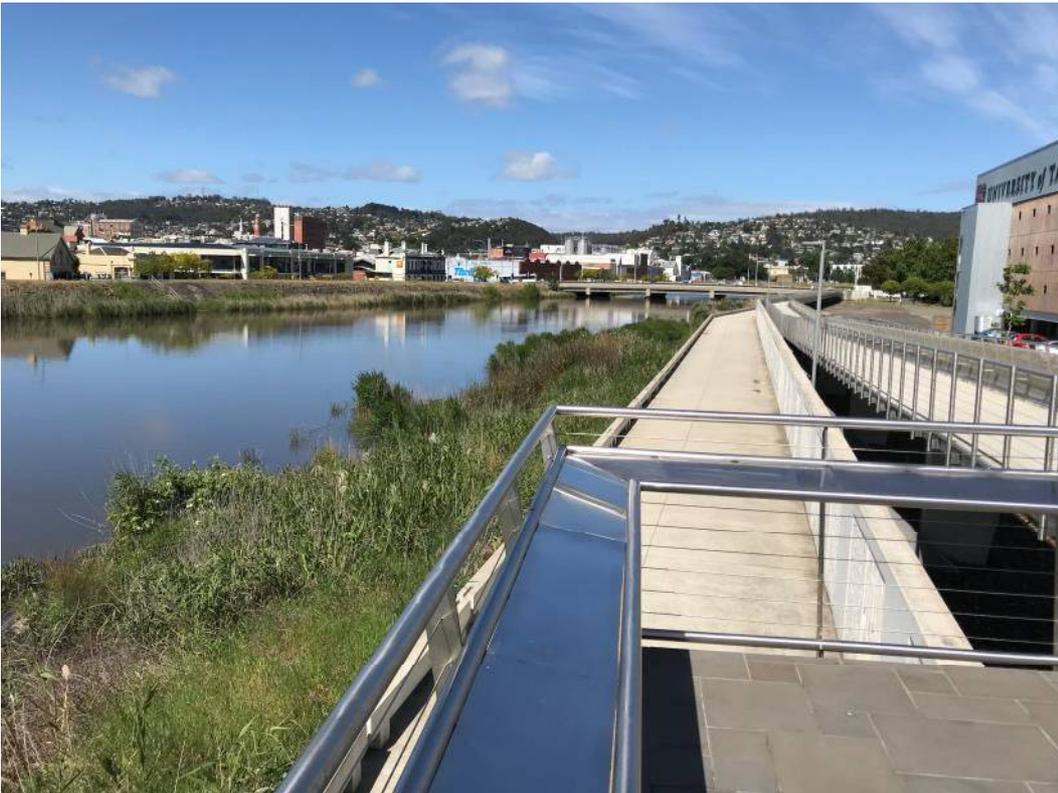
Plate 4 View west along the north bank of the North Esk River from the existing pedestrian access over the foreshore pedestrian-cycleway fronting the UTAS Campus

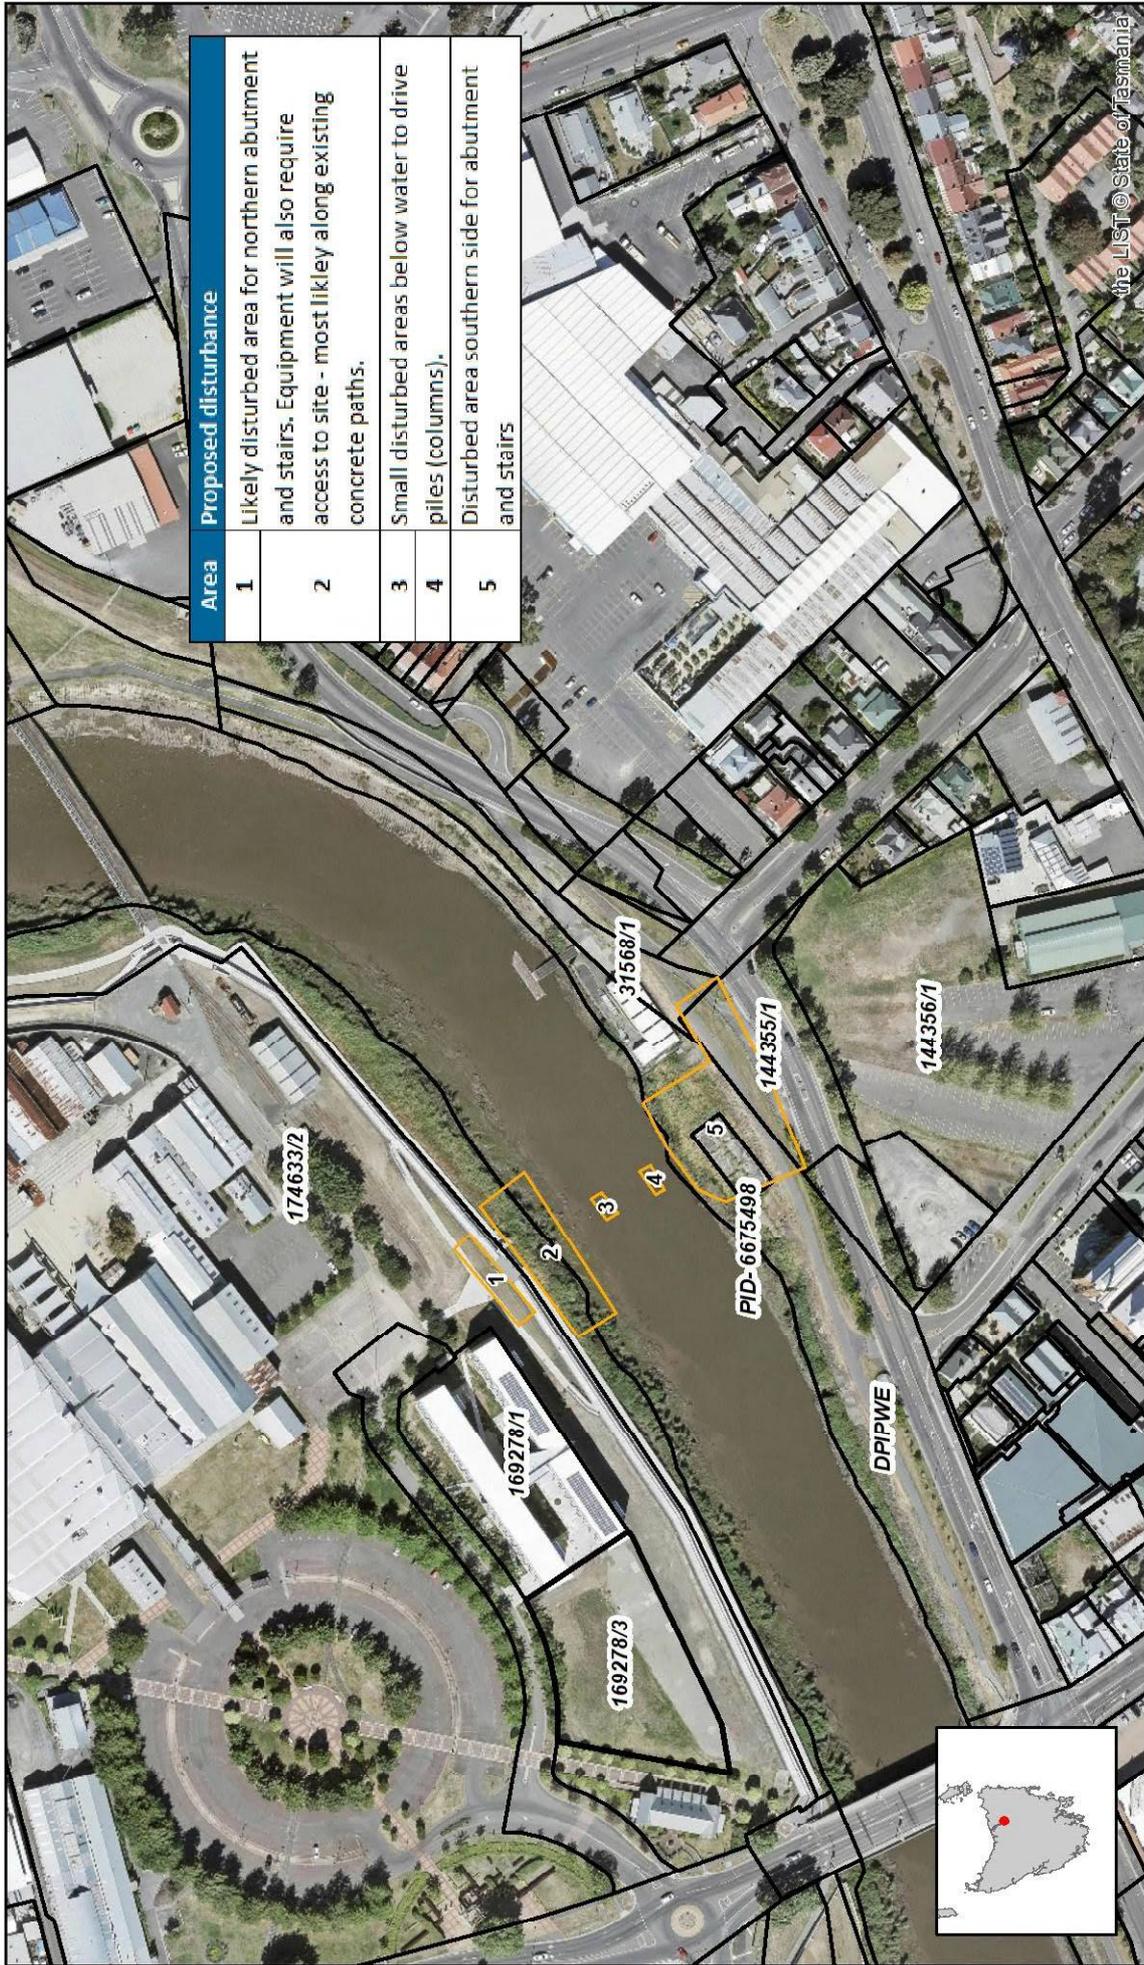
Area	Proposed disturbance
1	Likely disturbed area for northern abutment and stairs. Equipment will also require access to site - most likely along existing concrete paths.
2	Small disturbed areas below water to drive piles (columns).
3	Disturbed area southern side for abutment and stairs
4	
5

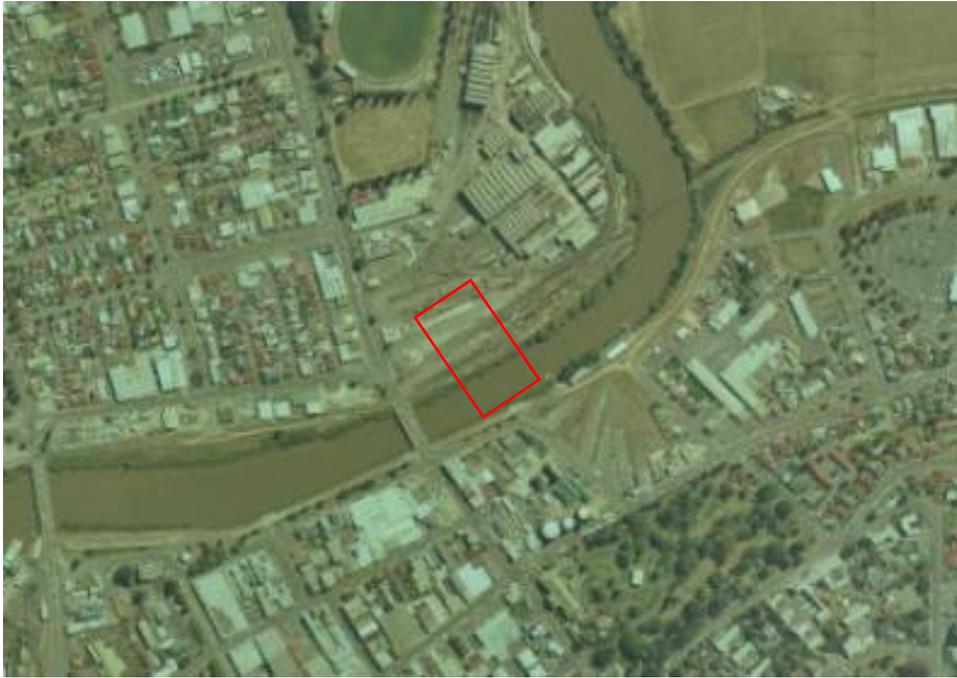
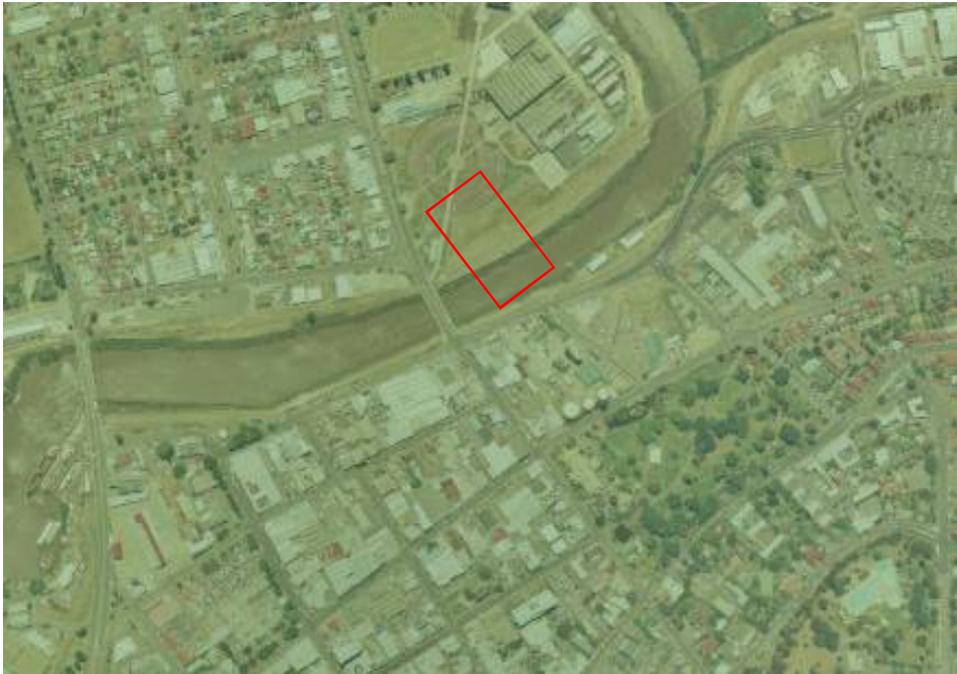
26/02/1992 Scale 1:12,500

Photo 3	26/02/1992 1:12,500	No significant changes are observed across northern and southern portions of the site immediately adjacent to the river bank. A second rectangular building on the southern nature strip appears to have been constructed to the west of the existing building. <u>Surroundings:</u> Many of the buildings in the Launceston Railyard to the north of the site appear to have been demolished. The site to the north of the railyard appears to now be used for recreational use. Infrastructure associated with the rail sidings to the south of the site appear to have been removed. Infrastructure and buildings on the Gasworks site to the west appear largely unchanged.
Photo 4	25/11/1997 1:12,500	The northern portion of the site appears to have been levelled following the demolition of the Railyards. The southern portion of the site appears to be largely unchanged. <u>Surroundings:</u> Buildings and infrastructure associated with the Launceston Railyard to the north of the site appear to have been removed and the land adjacent to the river nature strip is largely vacant. Vehicle parking and open space is present to the north beyond. The road following the southern river bank (now Boland Street) appears to have been sealed. A building appears to have been constructed to the south of the site and cars

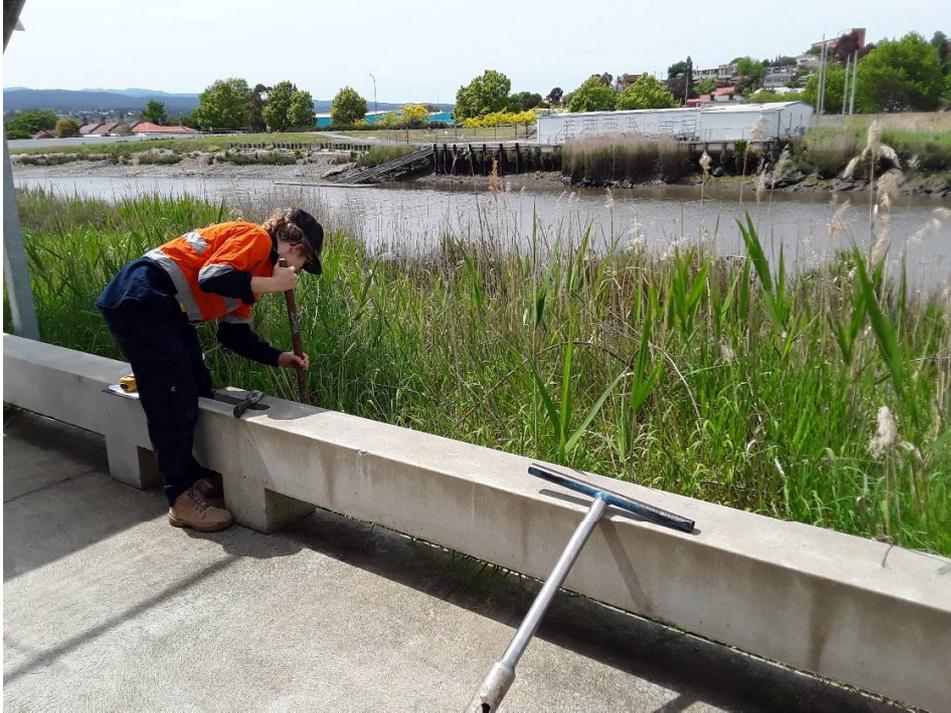
Photo showing the extent of vegetation on the river bank inside the floodwall

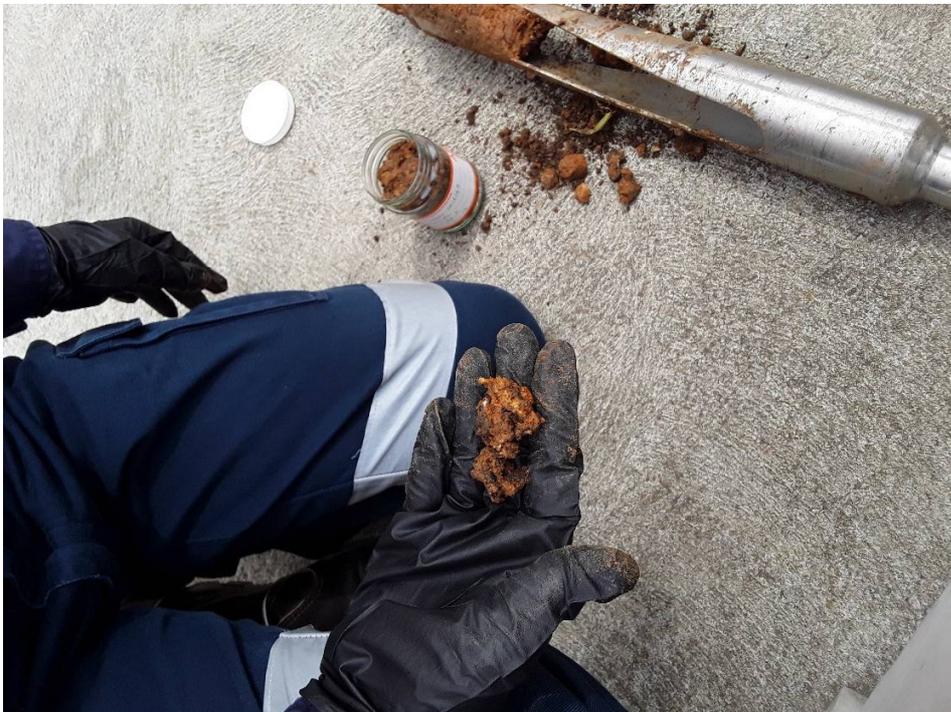
Soil composition of BH_A

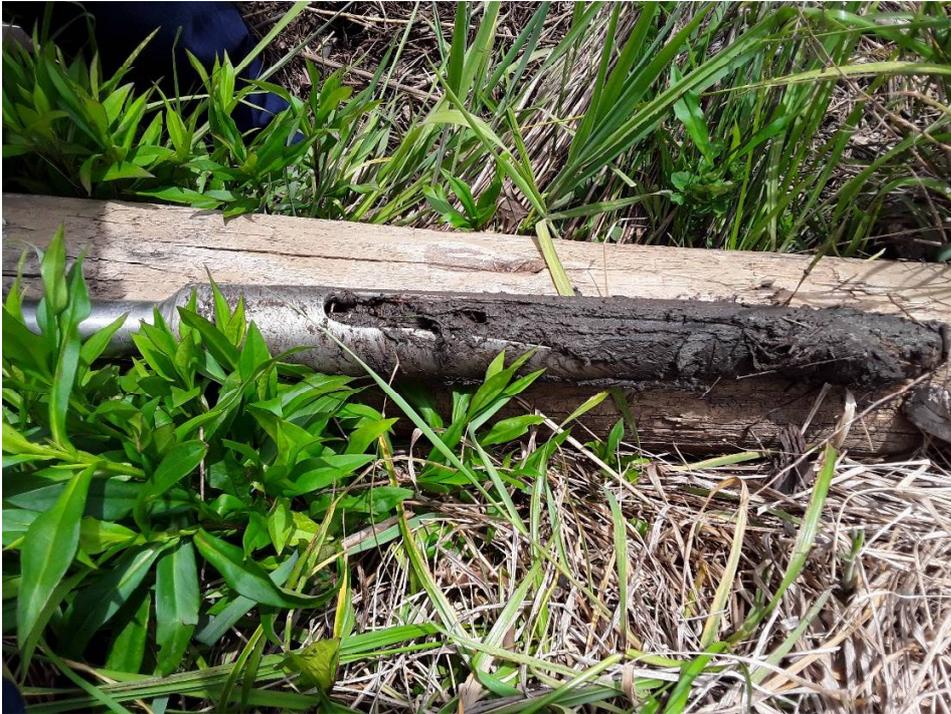
Soil composition inside flood wall (BH_B)

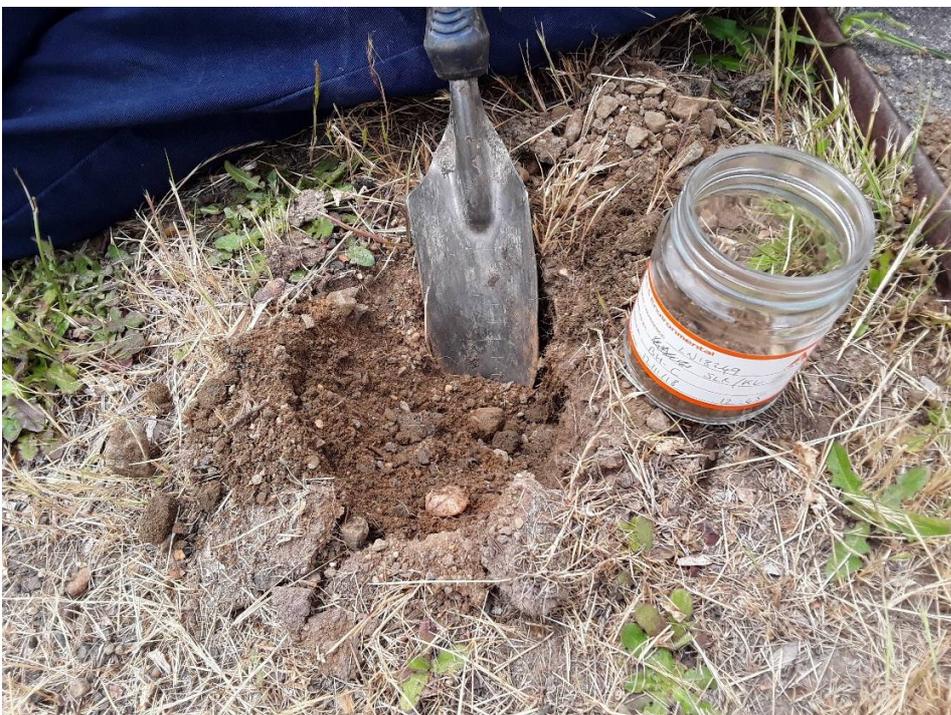
Soil composition adjacent to walkway (BH_C)

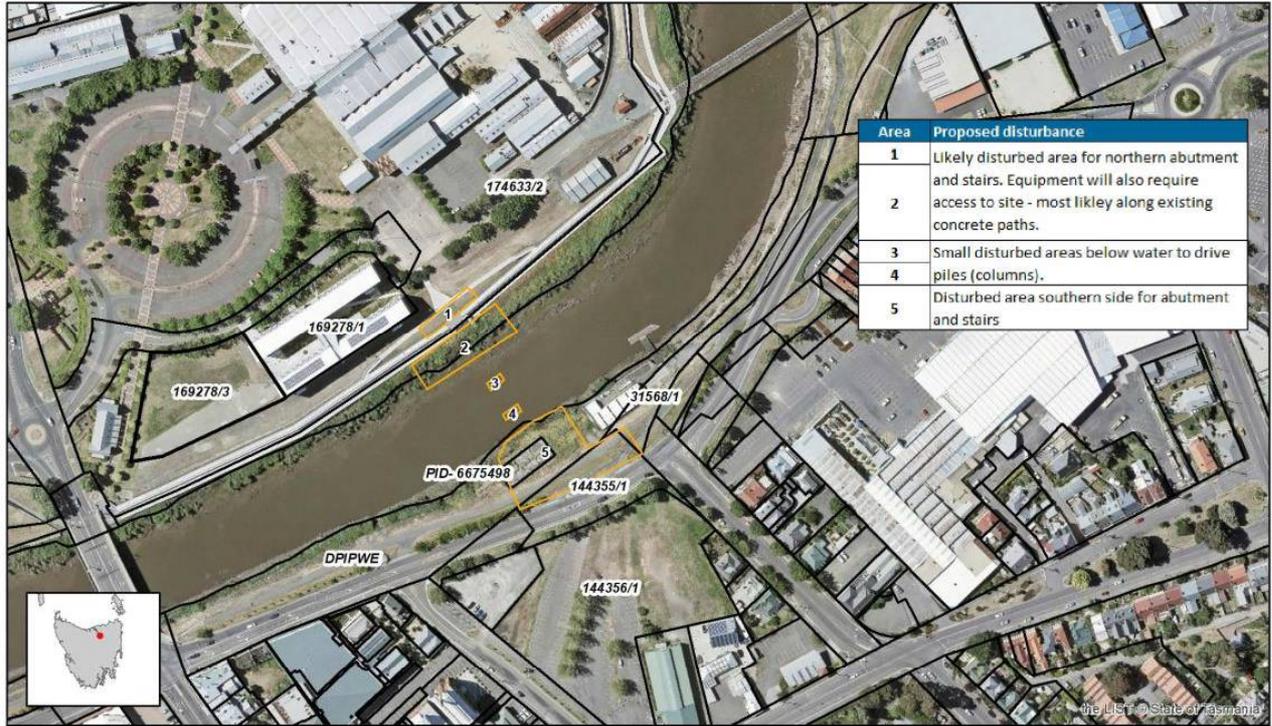
UTAS
 Site Location Plan
 pitt&sherry

The proposed bridge will occupy small areas on the northern (approximately 150 m²) and southern side (approximately 190 m²) of the North Esk River located in Launceston Tasmania (herein referred to as the 'the site'). The site occupies the river bank and nature strip on either side of the river and part of 21 Boland Street on the southern side and 6 Barnards Way Inveresk, Invermay on the northern side. The construction of the bridge will also involve the advancement of supporting piles at two locations in the river channel. The majority of the site is Department of Primary Industries, Water and Environment (DPIPWE) Crown Land and consists of a nature strip on either side of the North Esk River. The site has been disturbed in the past and hosts a number of declared and environmental weeds. No mature trees are present on site. The site also occupies part of title references 174633/2 on the north shore and title reference 144355/1 and 31568/2 on the southern shore. A Site Location Plan which indicates the land parcels and areas of soil disturbance is provided in Figure 1.
