Phase 1 Environmental Site Assessment

Proposed UTAS Pedestrian Bridge
Invermay

Prepared for
University of Tasmania (UTAS)

Date
21 May 2019

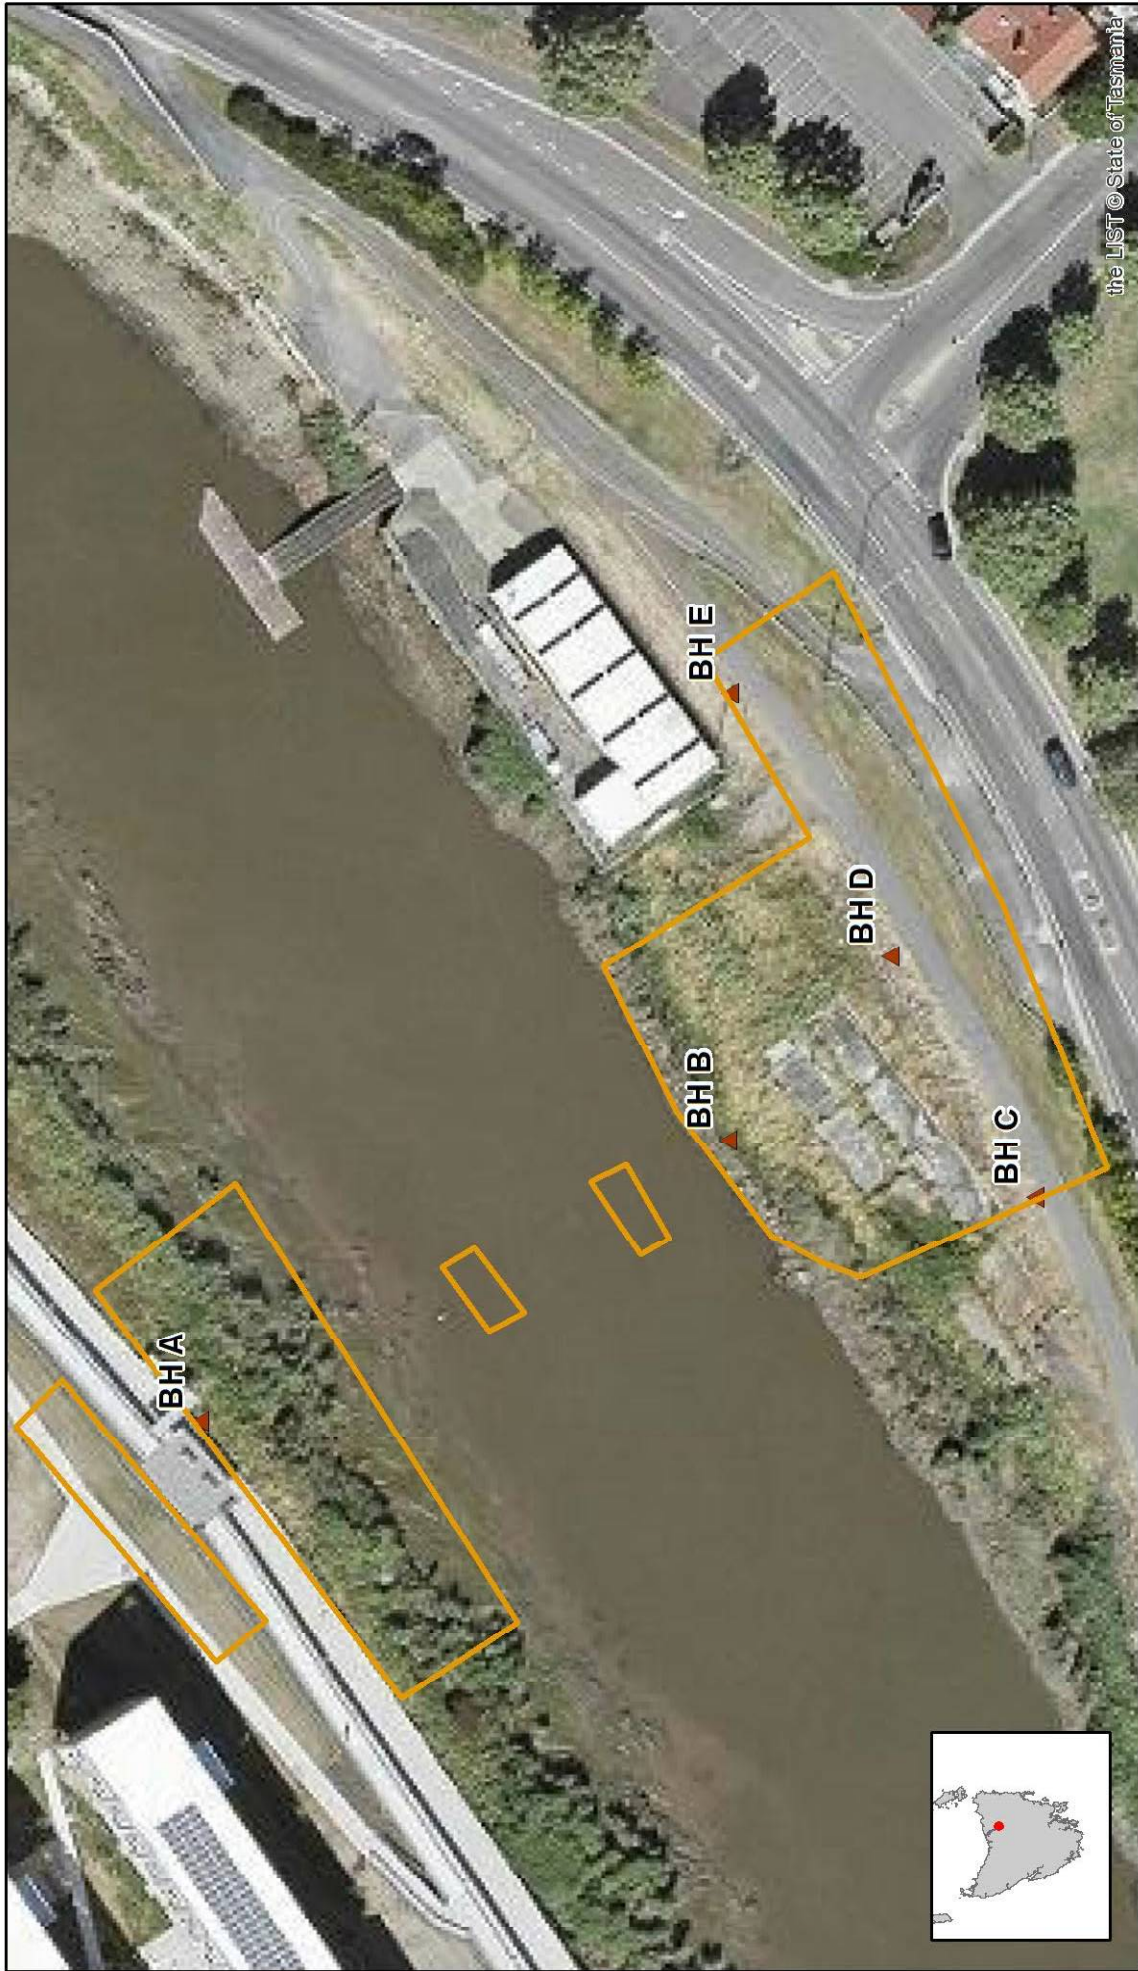
Inveresk Pedestrian Cycle Bridge
Sampling Locations

- Access for collection of samples BH-A and BH-B (refer to sample location plan in Appendix A) was difficult due to the infestation of tall weeds along the banks. Sampling was restricted to areas of hard ground. The areas close to the river were very silty and soft and could pose a potential safety hazard during site works.

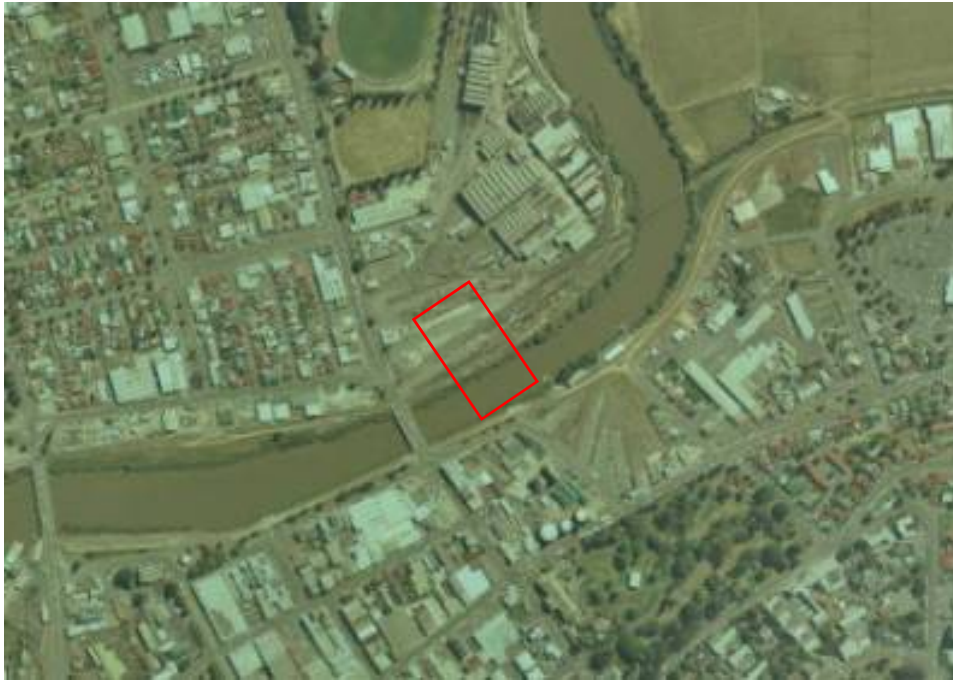
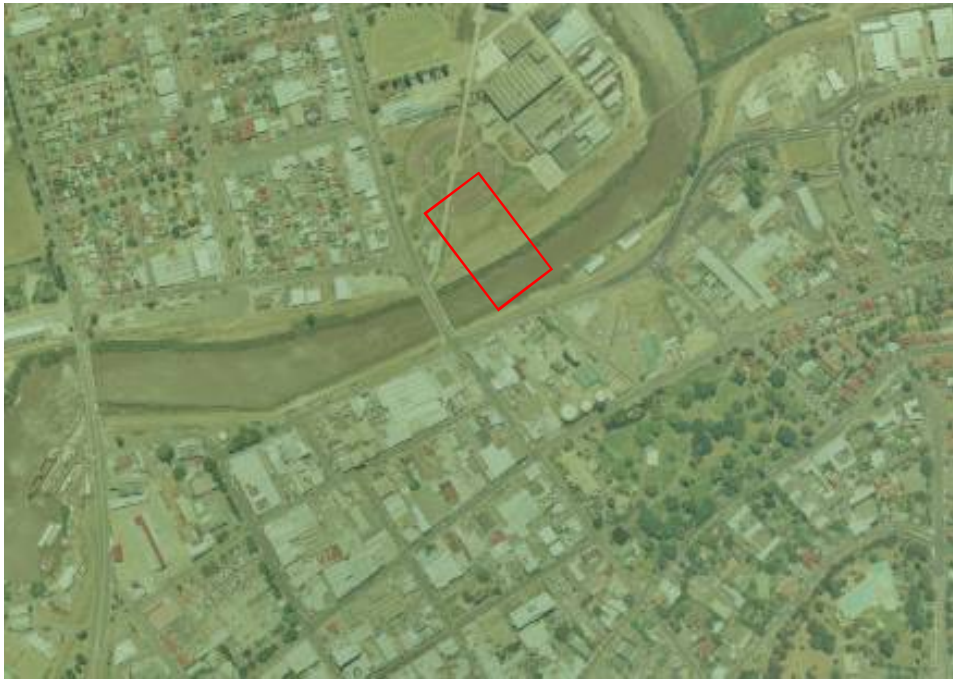
26/02/1992 Scale 1:12,500

Photo 3	26/02/1992 1:12,500	No significant changes are observed across northern and southern portions of the site immediately adjacent to the river bank. A second rectangular building on the southern nature strip appears to have been constructed to the west of the existing building. <u>Surroundings:</u> Many of the buildings in the Launceston Railyard to the north of the site appear to have been demolished. The site to the north of the railyard appears to now be used for recreational use. Infrastructure associated with the rail sidings to the south of the site appear to have been removed. Infrastructure and buildings on the Gasworks site to the west appear largely unchanged.
Photo 4	25/11/1997 1:12,500	The northern portion of the site appears to have been levelled following the demolition of the Railyards. The southern portion of the site appears to be largely unchanged. <u>Surroundings:</u> Buildings and infrastructure associated with the Launceston Railyard to the north of the site appear to have been removed and the land adjacent to the river nature strip is largely vacant. Vehicle parking and open space is present to the north beyond. The road following the southern river bank (now Boland Street) appears to have been sealed. A building appears to have been constructed to the south of the site and cars

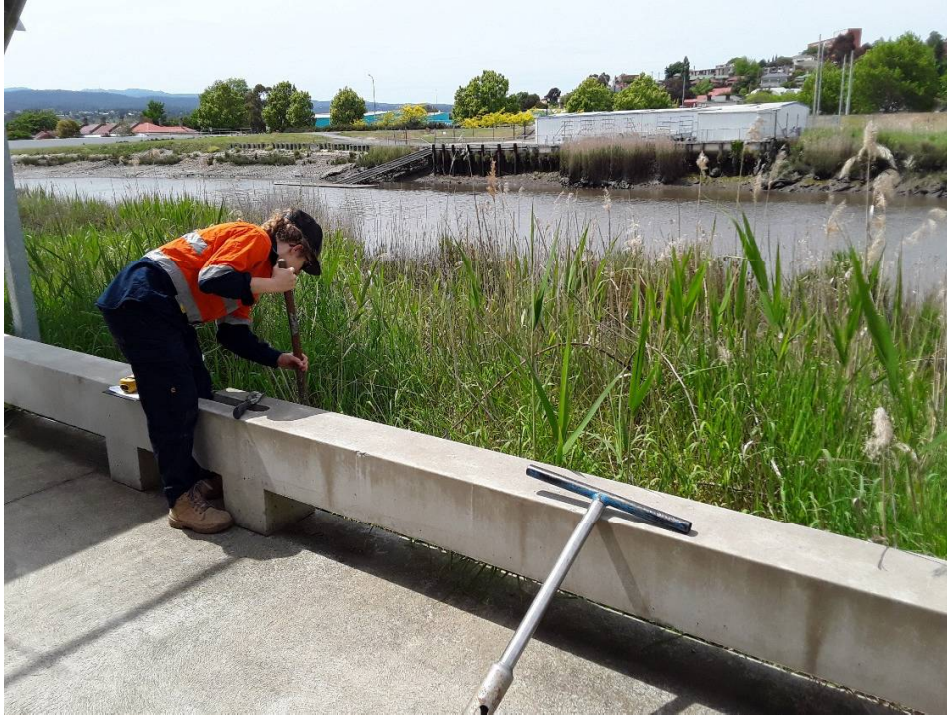
Photo showing the extent of vegetation on the river bank inside the floodwall

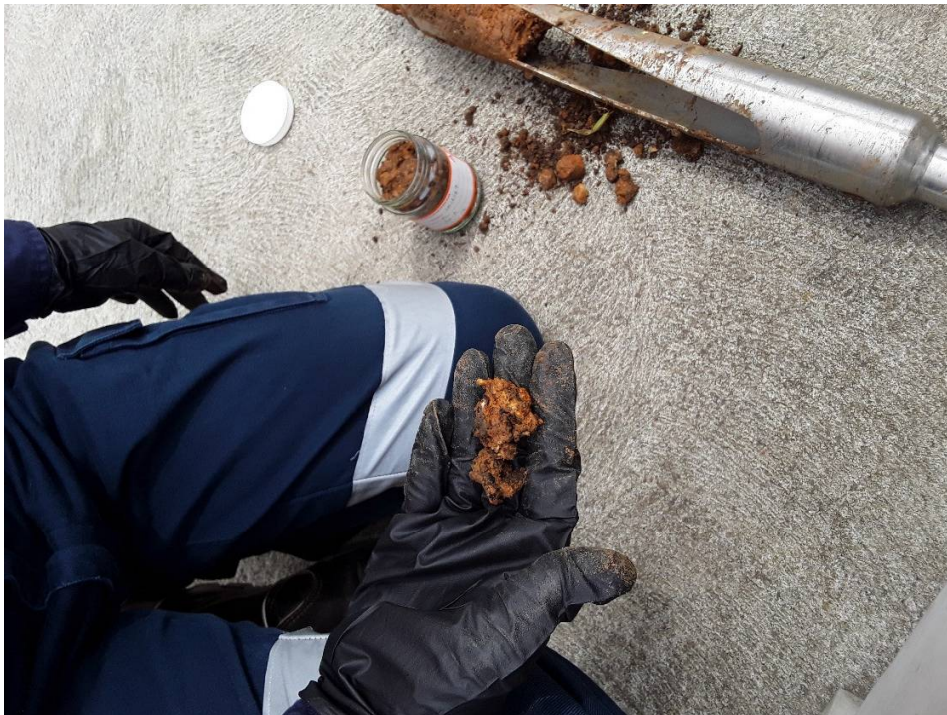
Soil composition of BH_A

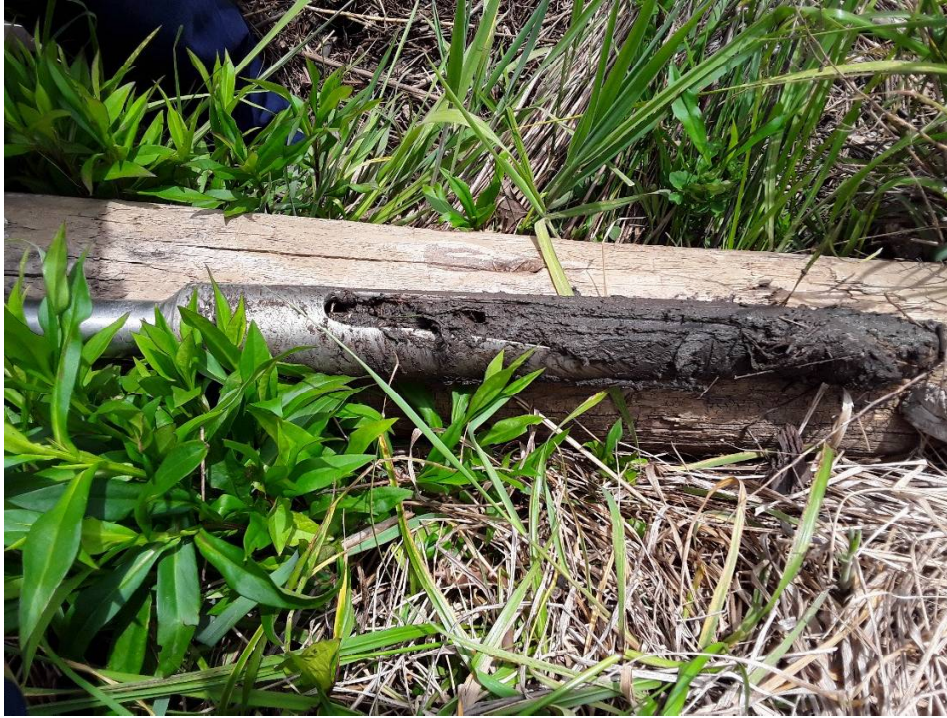
Soil composition inside flood wall (BH_B)

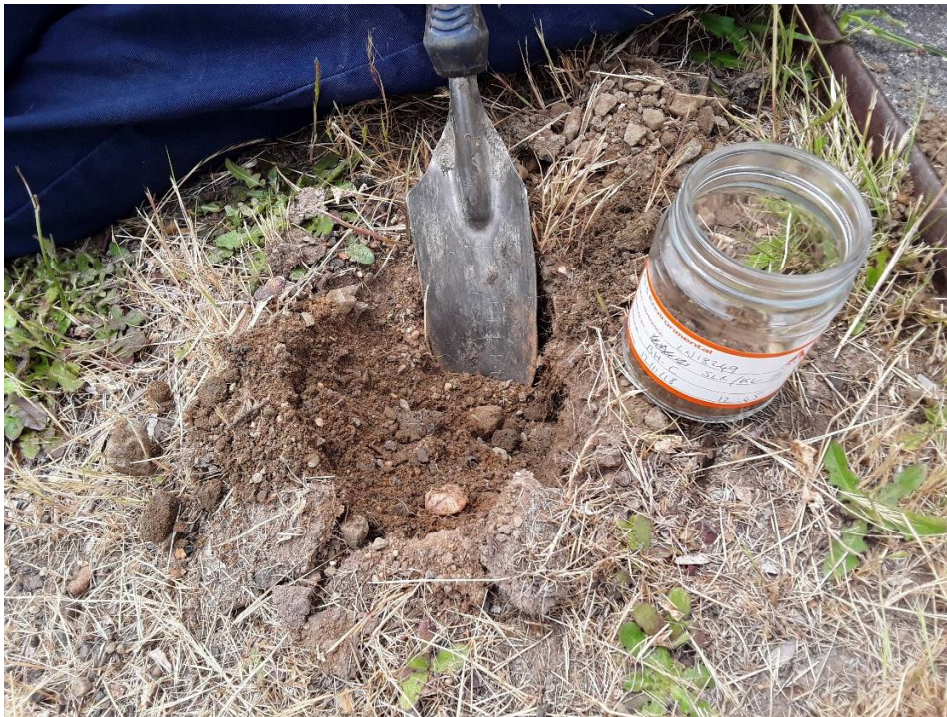
Soil composition adjacent to walkway (BH_C)
