Council Agenda - 2 May 2019 - Agenda Item 8.1 Attachment 2 - Plans for Endorsement 95-211 White Hills Road, White Hills

**RE: On-site Wastewater Disposal & Stormwater Detention Evaluation & Design
195 White Hills Road, White Hills**

On-site Wastewater Disposal & Stormwater Detention Evaluation & Design

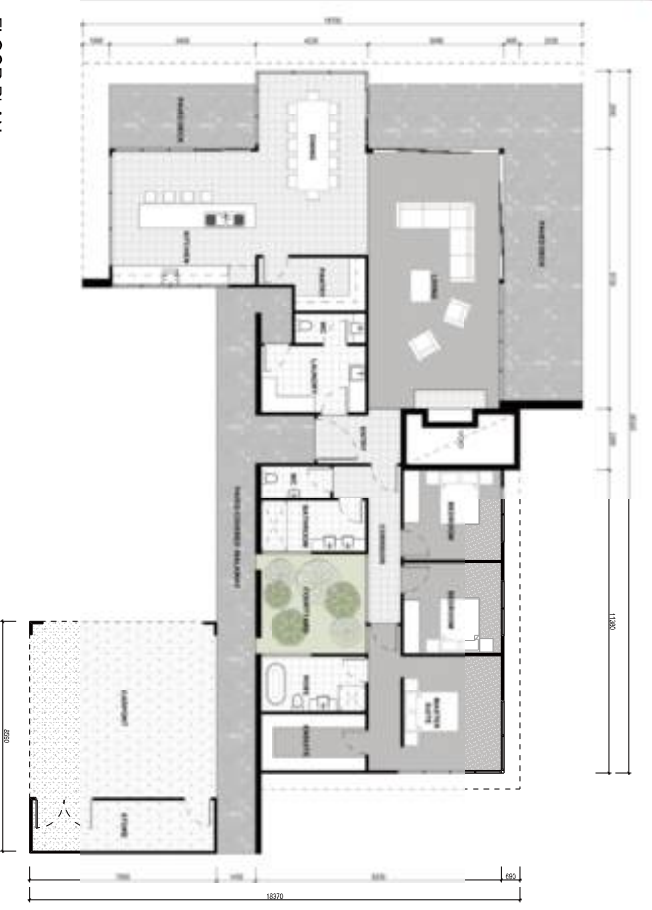
FLOOR PLAN
SCALE: 1:100

DRAWN PROPOSED FLOOR PLAN

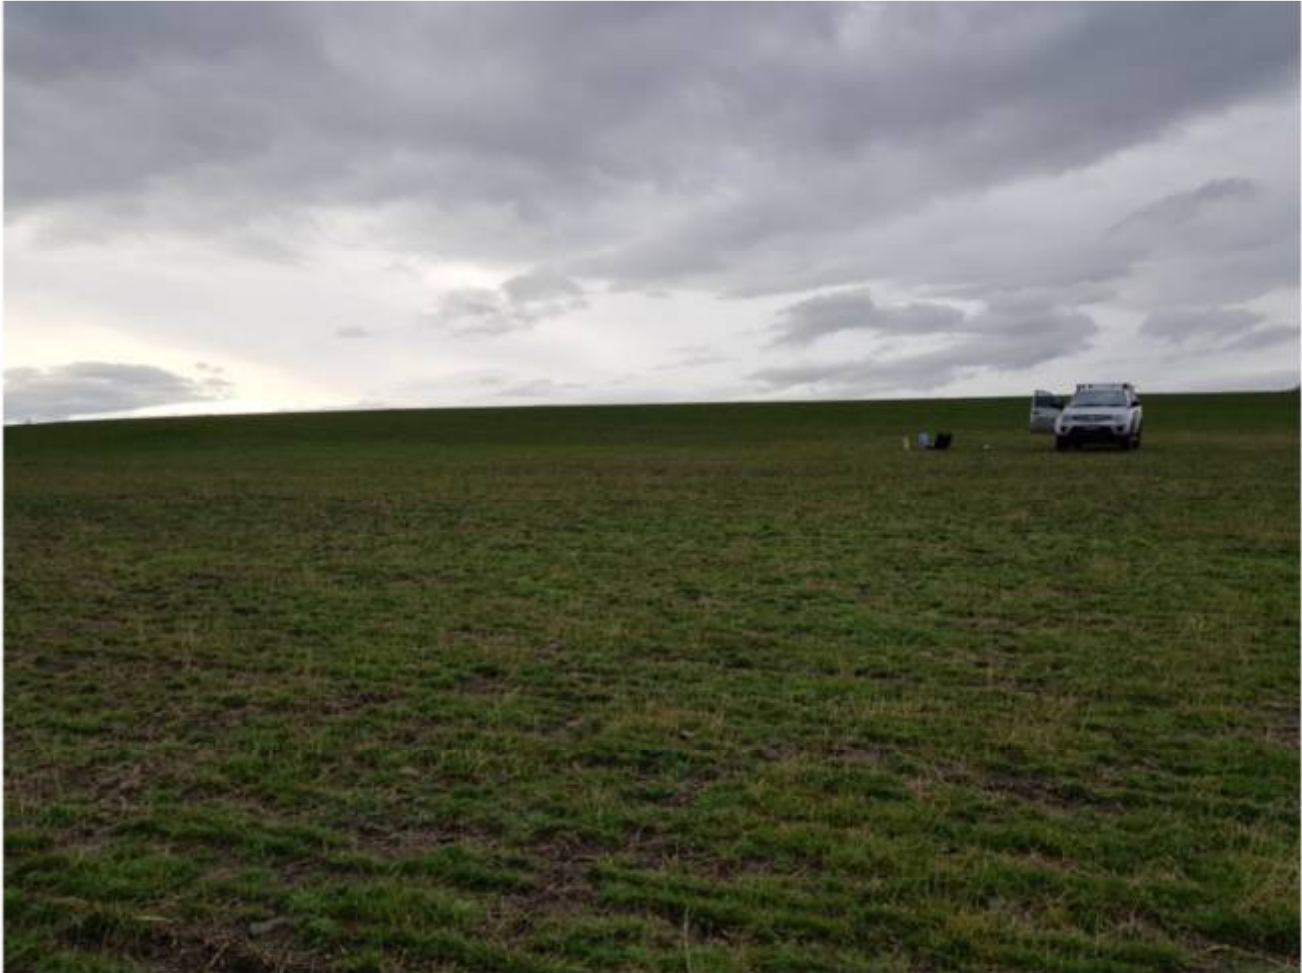
Plate 1 - Looking east towards the proposed wastewater disposal area

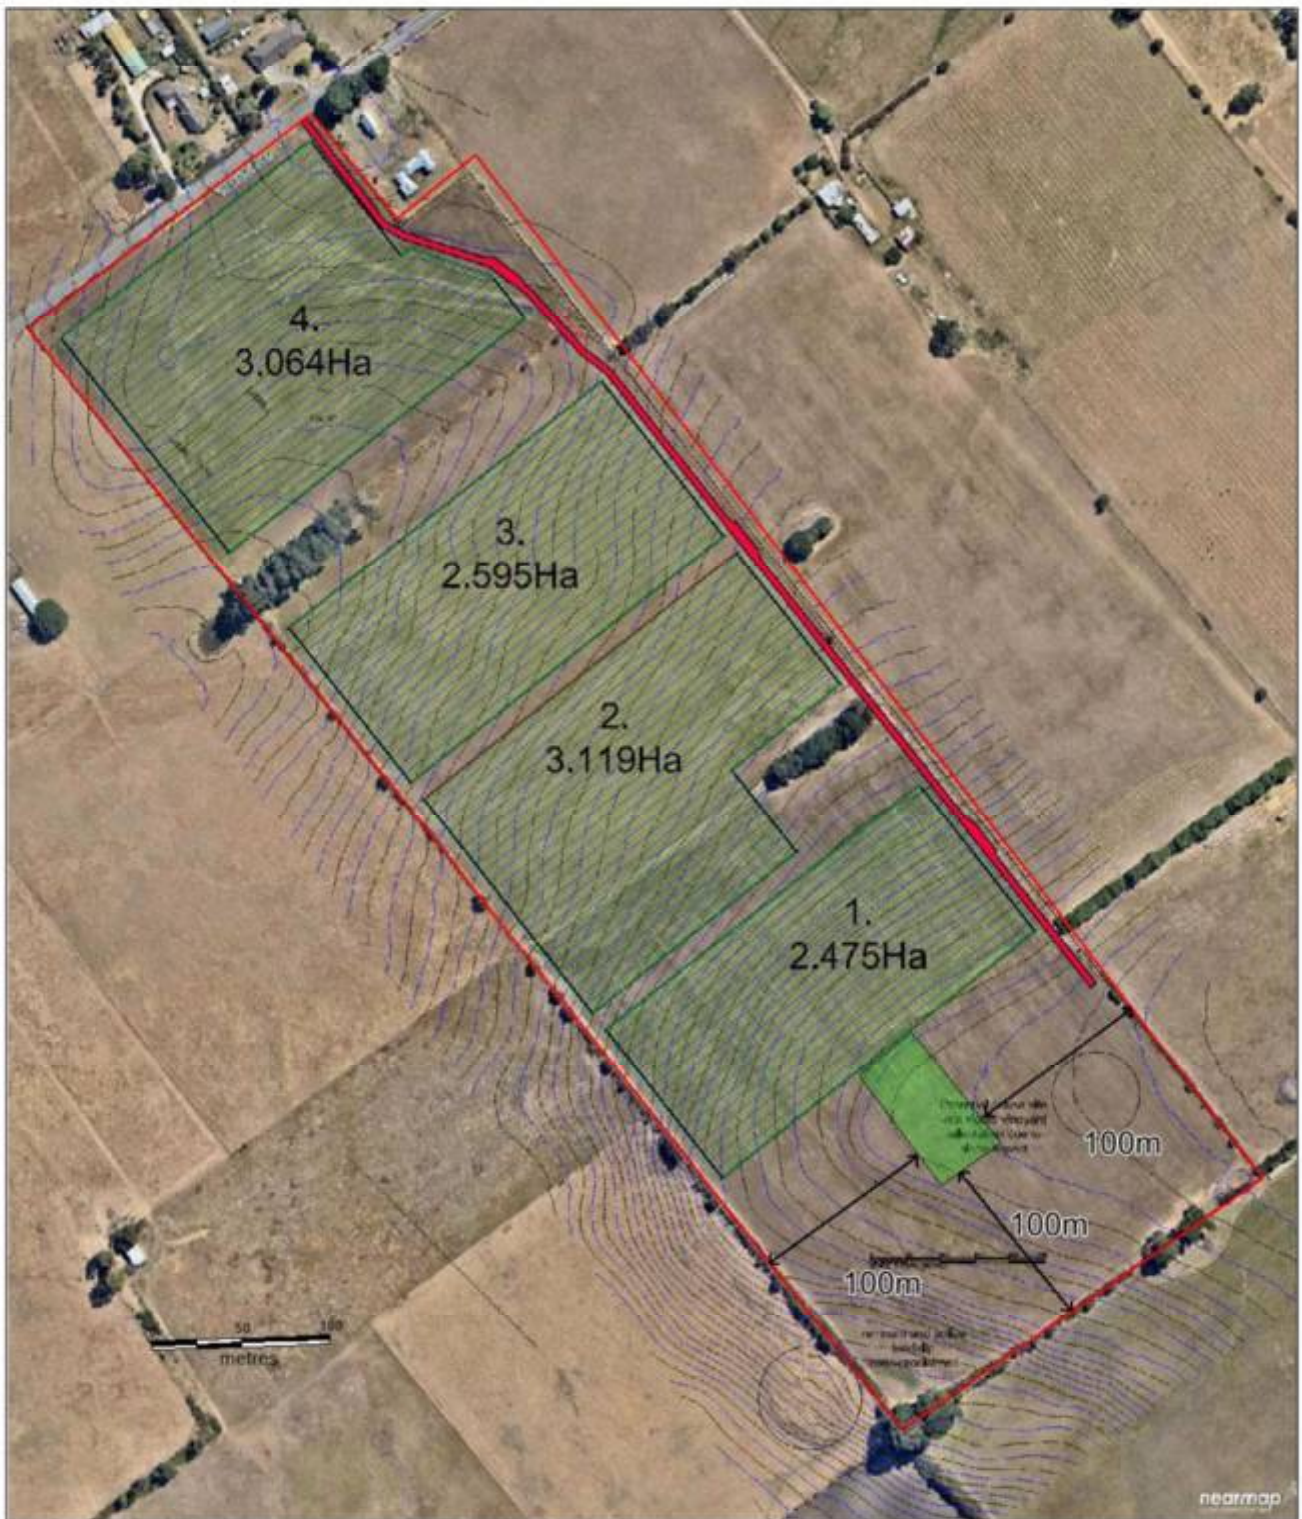
Figure 1 – Site map of proposed vineyard, with proposed building area and setbacks.
