Council Agenda - 21 March 2019
Agenda Item 8.1 - Attachment 2
Plans to be endorsed
24-26 Queechy Road Norwood

Drawing Title :
Site Plan

GEOTON Pty Ltd				client: MR BEICHUAN WANG	
				project: 24-26 QUEECHY ROAD NORWOOD	
date	30/11/2017	drawn	SZ	title: GEOLOGY SHEET	
scale	As shown	approved	TB		
original size	A4	rev		project no: GL17367A	figure no. 1

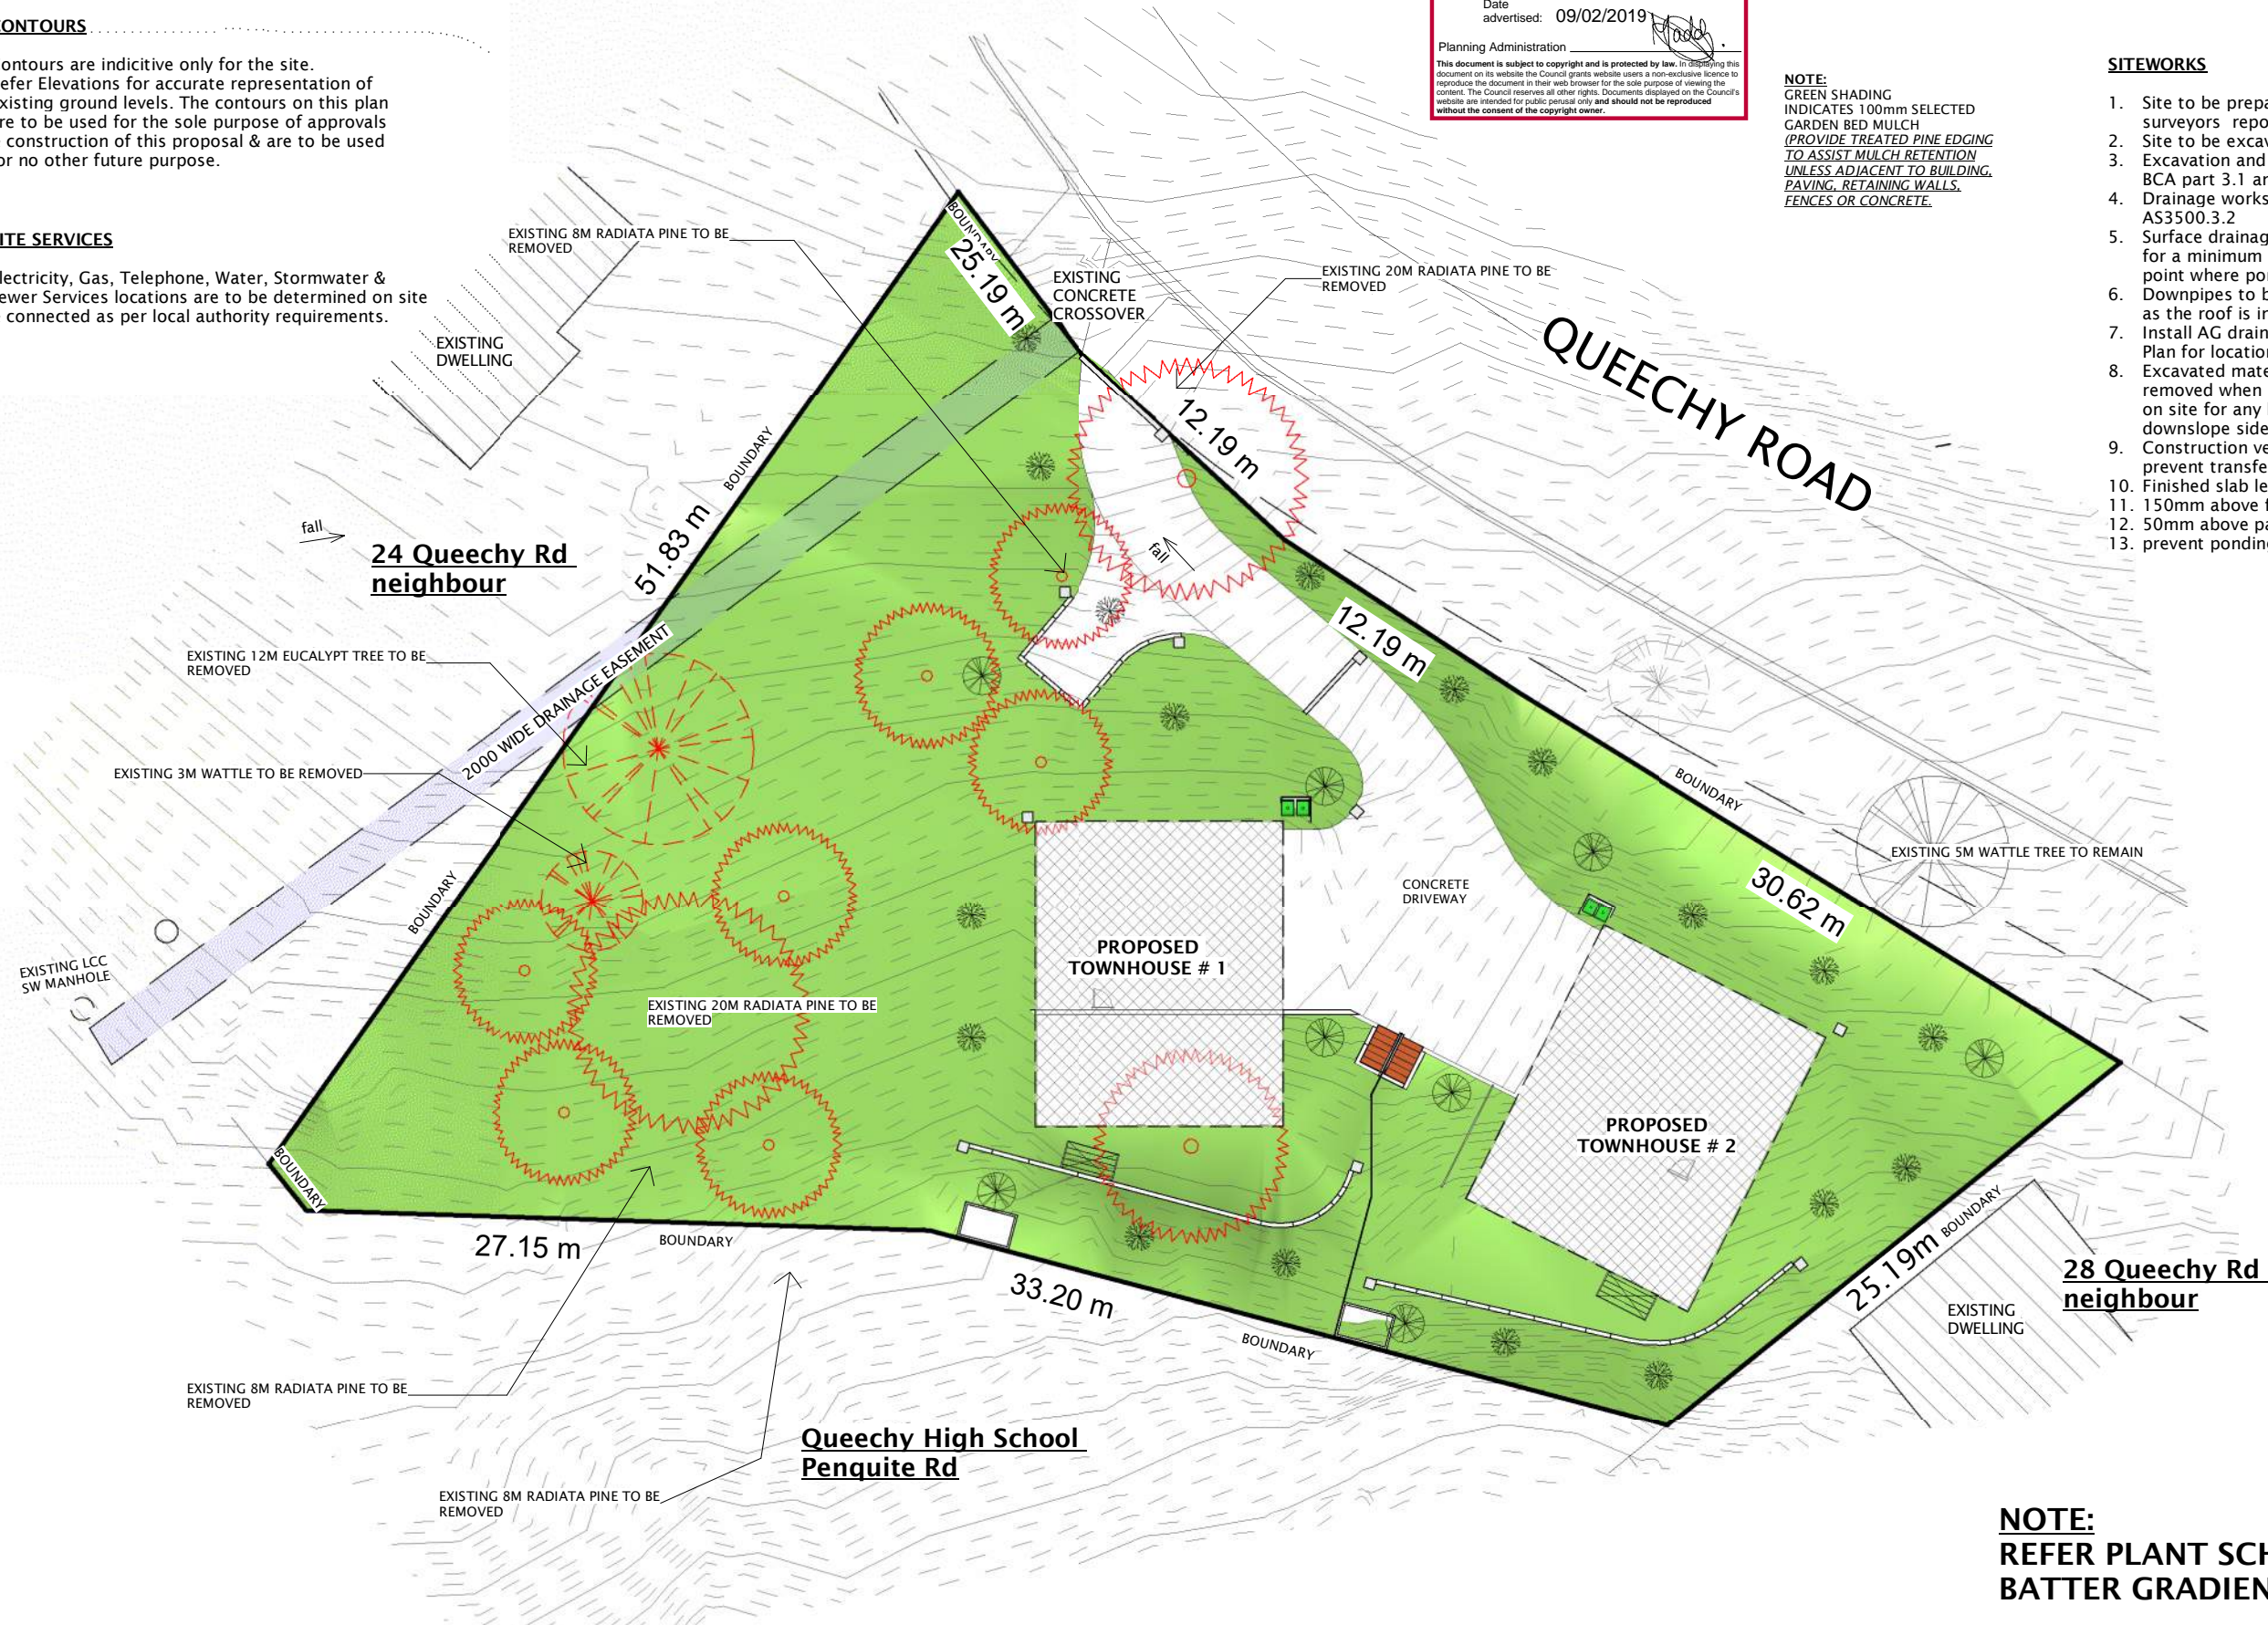
9. Construction vehicles to be parked on the street only, to prevent transferring debris onto the Street.
10. Finished slab level to be:
11. 150mm above finished ground level.

12. 50mm above paved surfaces.
13. prevent ponding of water under suspended floors.

NOTE:
REFER PLANT SCHEDULE & EXCAVATION BATTER GRADIENTS NEXT PAGE.

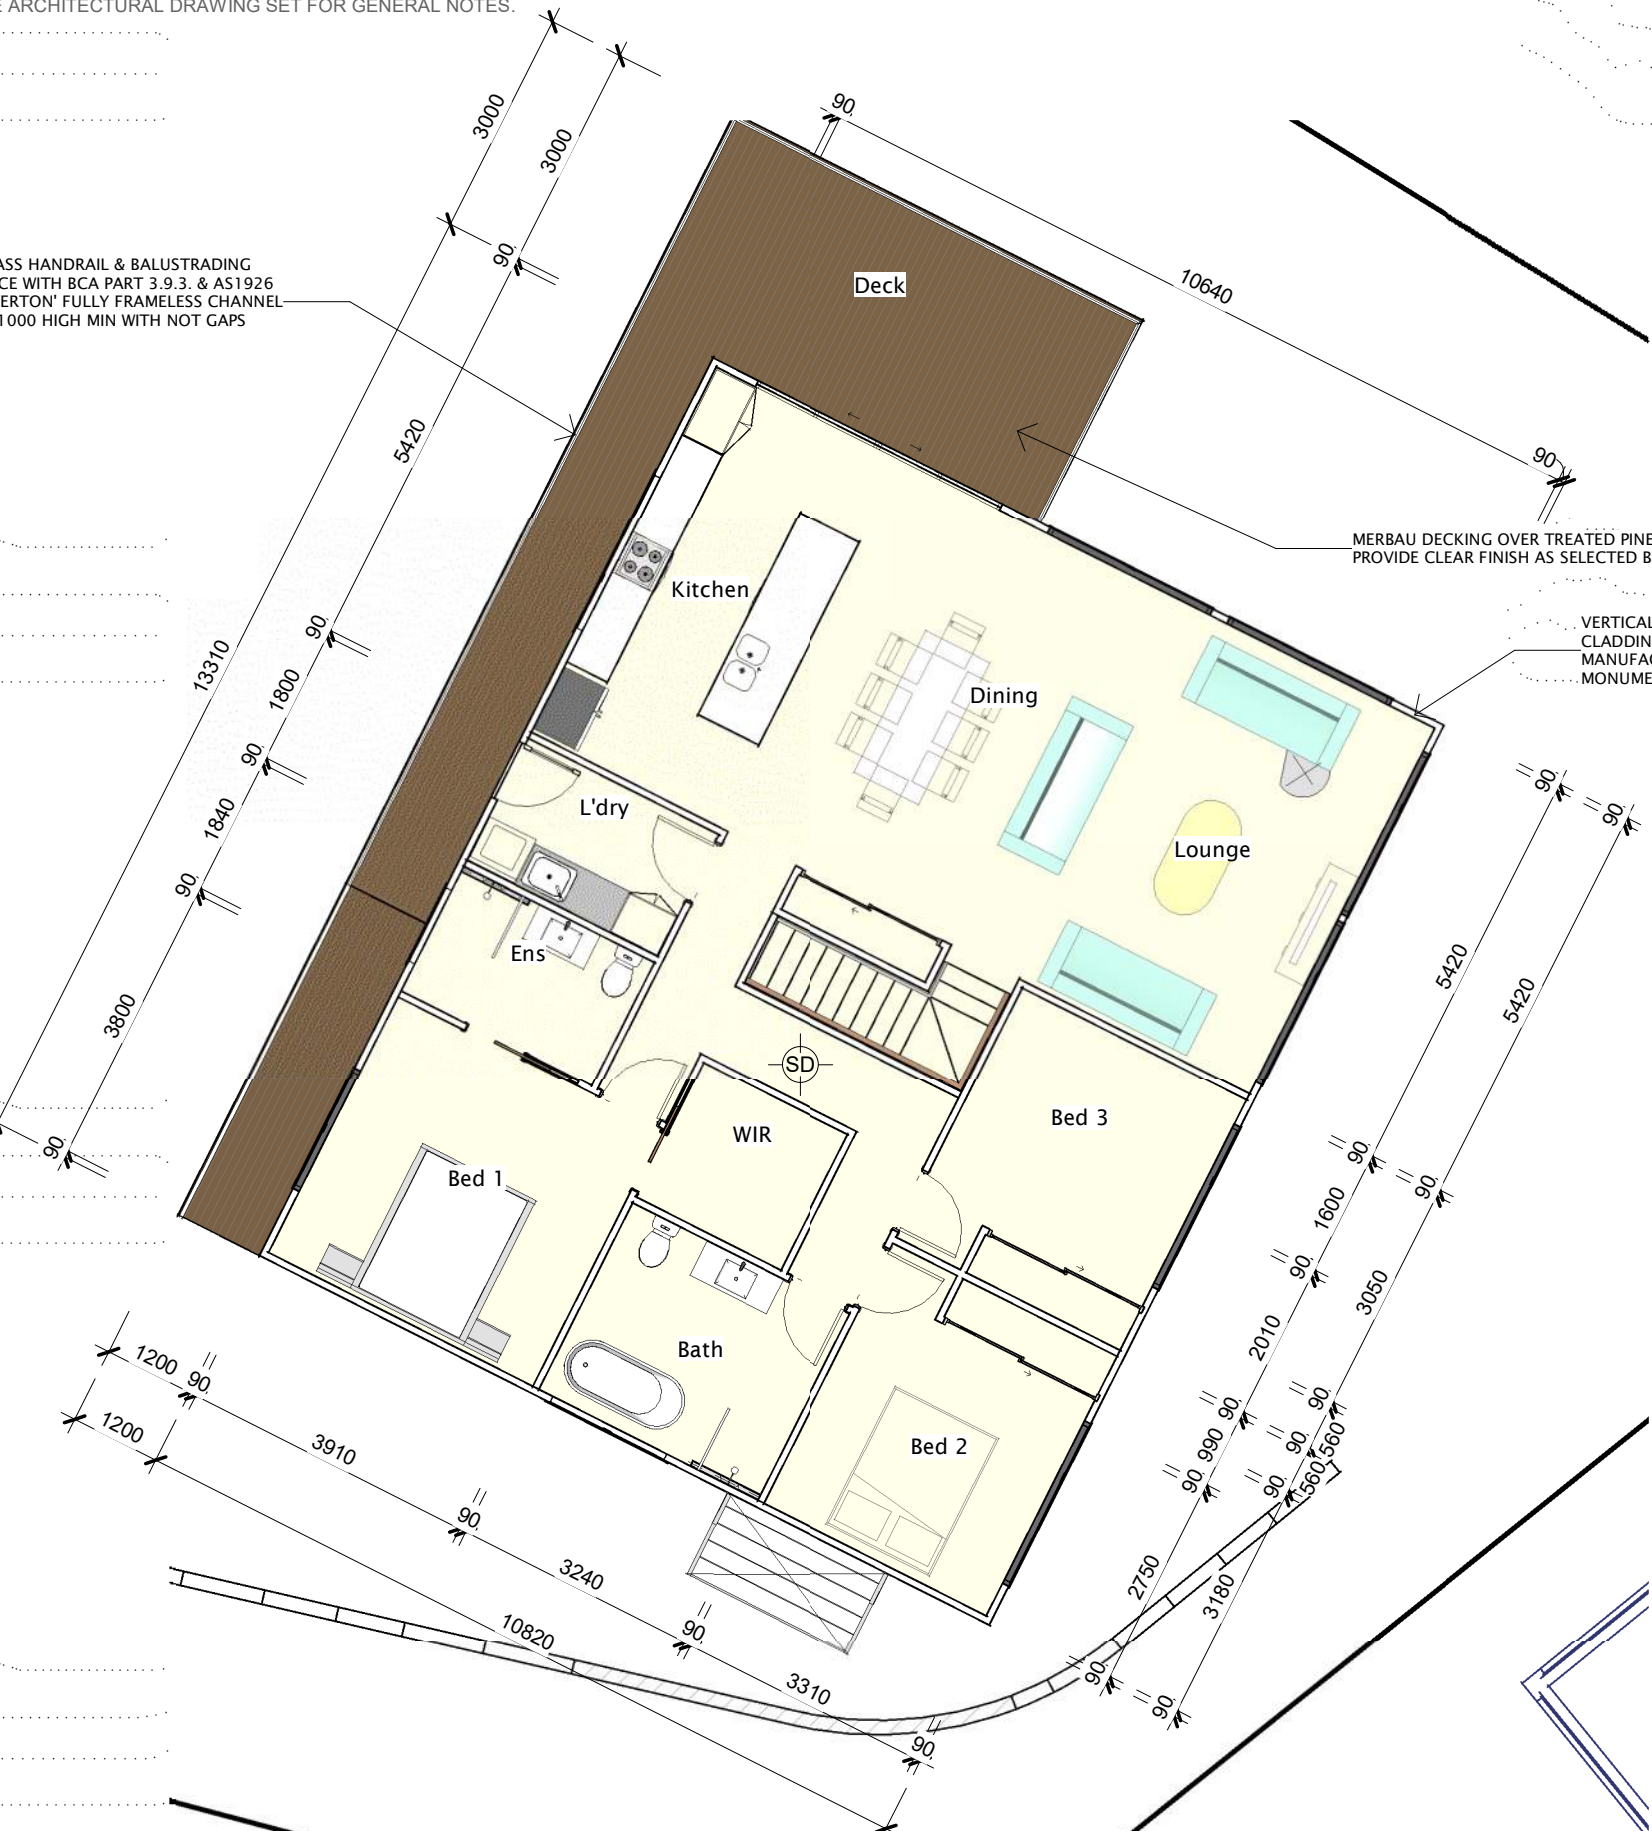
MERBAU DECKING OVER TREATED PINE/STEEL FRAMED DECK.
PROVIDE CLEAR FINISH AS SELECTED BY OWNER.

VERTICAL COLORBOND STEEL 'LYSAGHT ENSEAM' WALL
CLADDING ALL IN ACCORDANCE WITH BCA PART 3.5.3 &
MANUFACTURERS INSTALLATION RECOMMENDATIONS.
MONUMENT COLOUR.

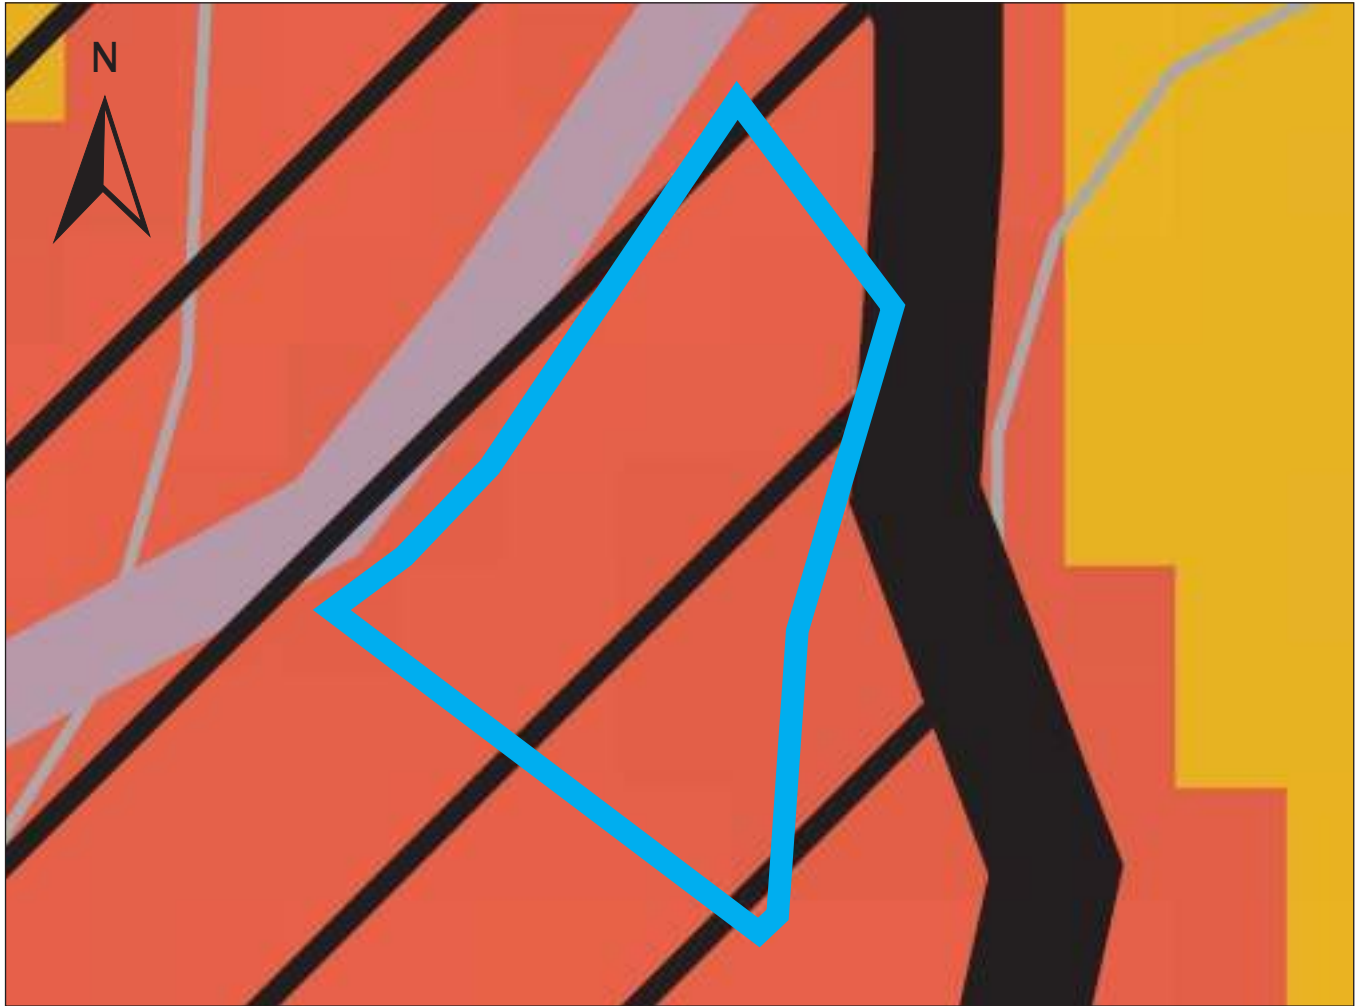
figure no. 4

Examination of the MRT Tasmanian Landslide Hazard series, Launceston – Slide Susceptibility sheet, 1:25,000 scale, indicates that the site is generally mapped within a source area, i.e. an area of hillside with the potential to form a slope failure, identified largely on the basis of slope angle and geology. The sheet also indicates that the site is mapped as a landslide of unknown activity.

Susceptibility Zones for First Time Failure

-   Regression area
-   Source area
-   Runout area

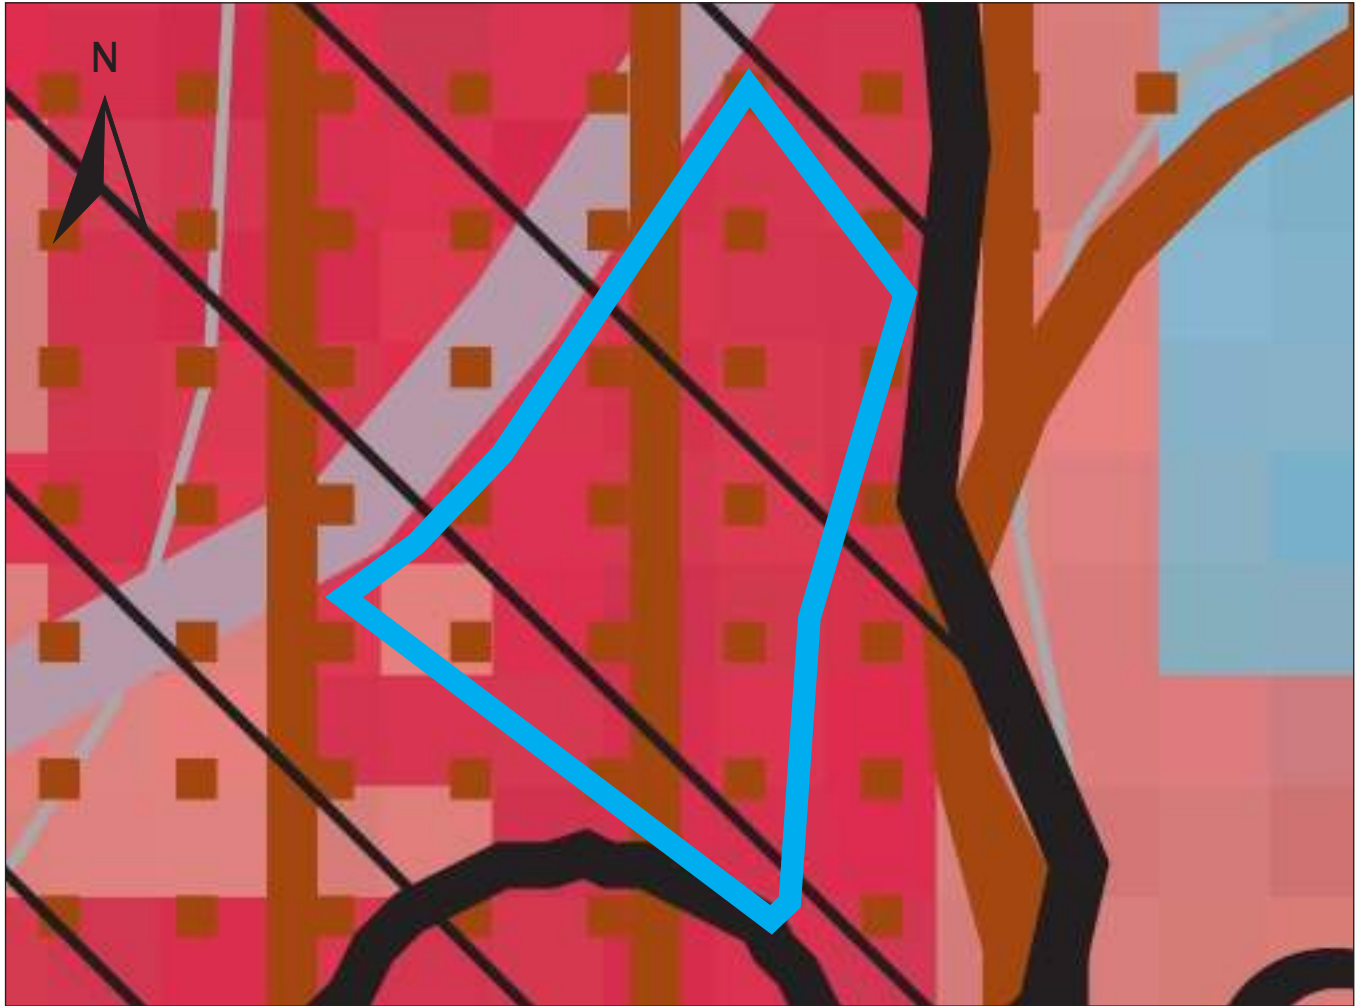
GEOTON Pty Ltd				client:	MR BEICHUAN WANG		
				project:	24-26 QUEECHY ROAD NORWOOD		
date	30/11/2017	drawn	SZ	title:	POTENTIAL LANDSLIDE HAZARDS SHEET		
scale	As shown	approved	TB				
original size	A4	rev		project no:	GL17367A	figure no.	5

Examination of the MRT Tasmanian Landslide Hazard series, Launceston - Potential Landslide Hazards sheet, 1:25,000 scale, indicates that the site is generally mapped as a Tb zone, i.e. “area above higher threshold angle of 12° which is determined that approximately represents a median value at which the landslides in the study area occur”.

An extract of the Potential Landslide Hazards sheet is provided as Figure 5.

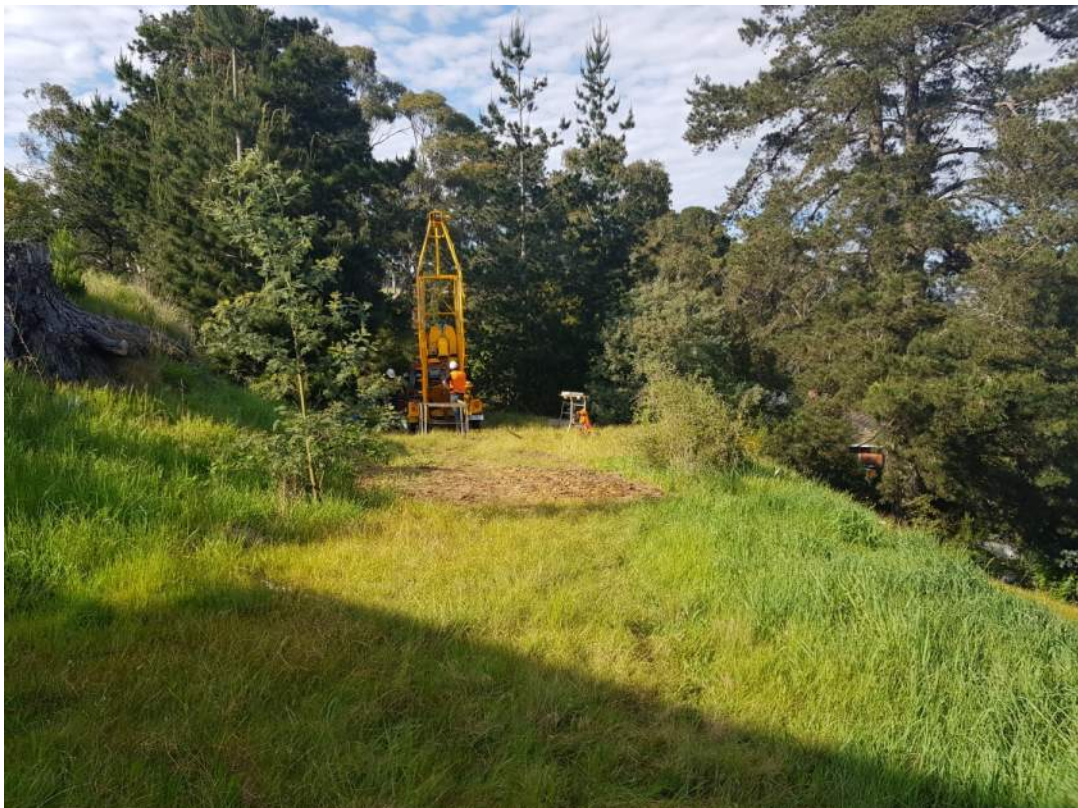
PLATE 2 - THE CUT TO FILL BENCH LOOKING TO THE SOUTH

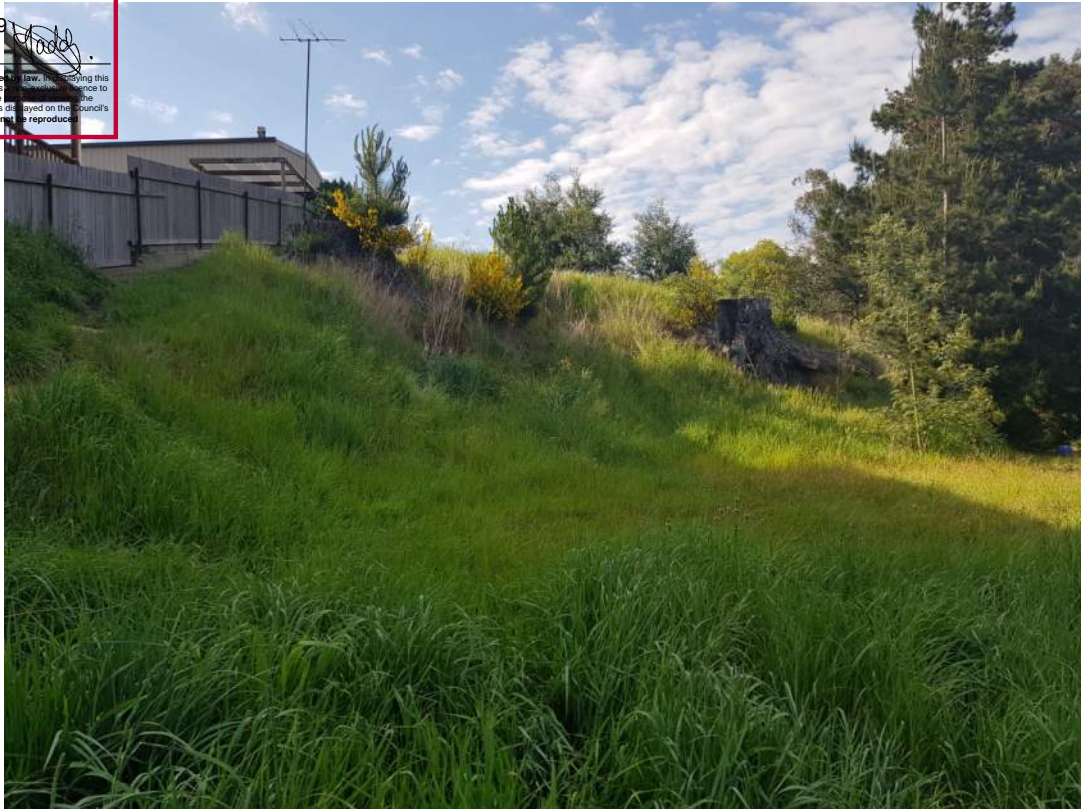
**PLATE 3 - THE SLOPES UPHILL OF THE CUT TO FILL PLATFORM
 LOOKING TO THE SOUTH**

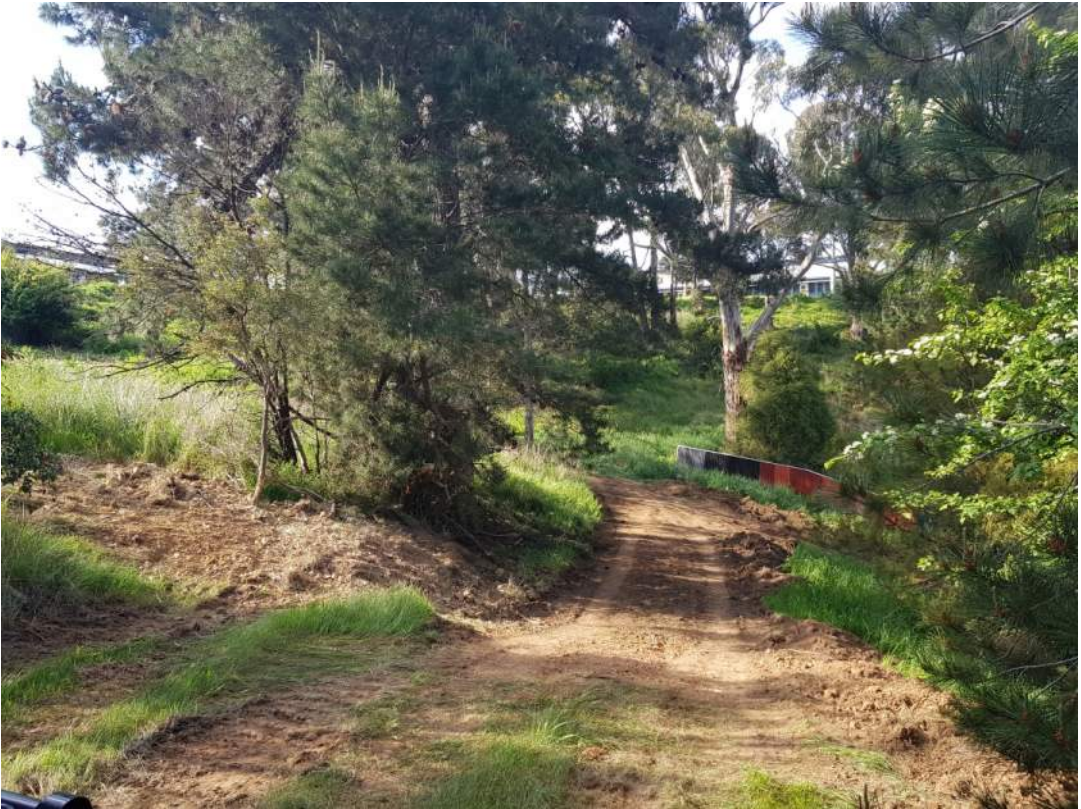
PLATE 4 - THE EXISTING TRACK LOOKING TO THE SOUTH
