RE: Preliminary Site Investigation – 1A Georgetown Rd, Newnham 7248

Preliminary Site Investigation

1A George Town
Rd, Newnham
7248

Project No: 6787
July 2019

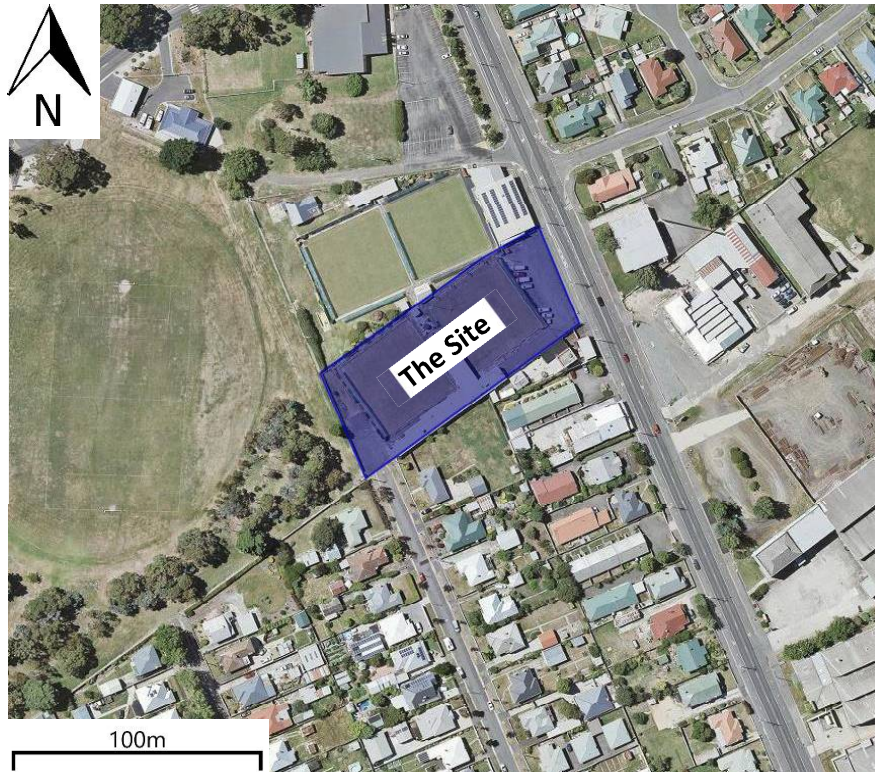
Figure 1: Site Plan

The property at 1A George Town Rd ('The Site,' **Error! Reference source not found.**), the former Mowbray Bowls Club, is owned by the North Launceston Bowls Club who operate from the adjacent property at 1B George Town Road, rendering 1A George Town Rd vacant.

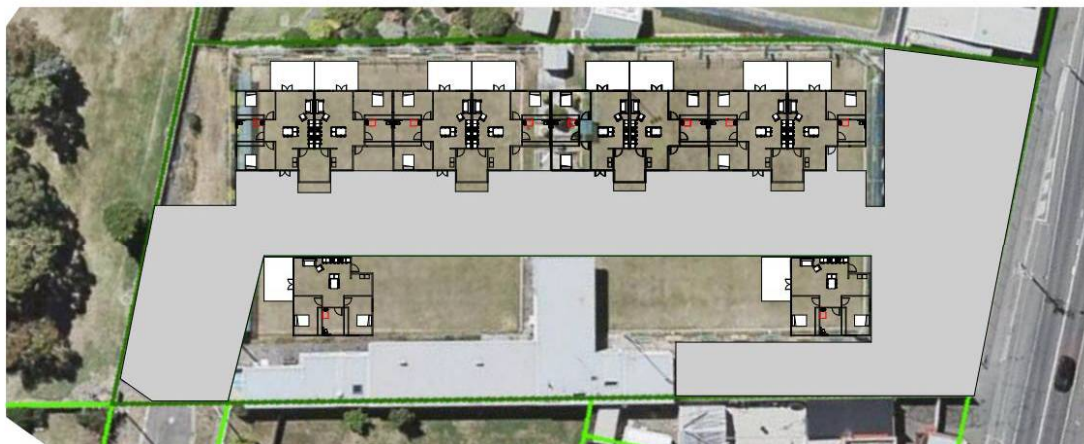
Figure 2: Proposed Development

The proposed development involves the construction of NDIS housing units. A preliminary plan is shown below in Figure 2 (c/o Unify Design, subject to change).

The existing club rooms are to remain on site to be refurbished for use as a day-respite facility or community centre.

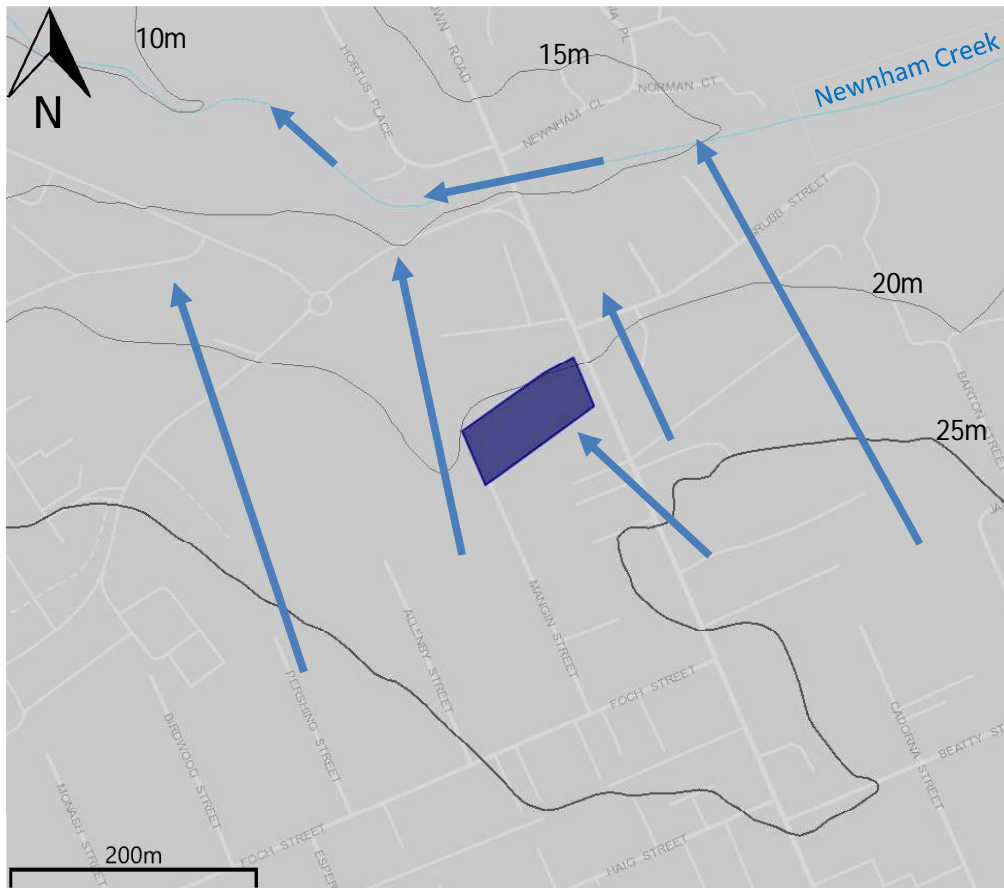
Figure 4: Inferred Groundwater Flow Direction showing AHD contours

A review of Google Earth and the LIST (Land Information System Tasmania) indicate that The Site slopes gently towards the Newnham Creek north with elevations between 25-20m (Figure 4).

Contours indicate that groundwater likely flows north or northwest towards Newnham Creek. (Figure 4). Groundwater is not extracted for drinking purposes in the area, as water is supplied from TasWater infrastructure.

Actual groundwater flow direction can only be determined with water table elevation measurements from a series of wells, however, the contours in Figure 4 show that the general direction must be N/NW towards Newnham Creek. Figure 20 shows that if the groundwater travels anywhere between 270° W to $\sim 10^{\circ}$ NE under the Site, any contamination at the former HEC substation will be carried onto the Site.

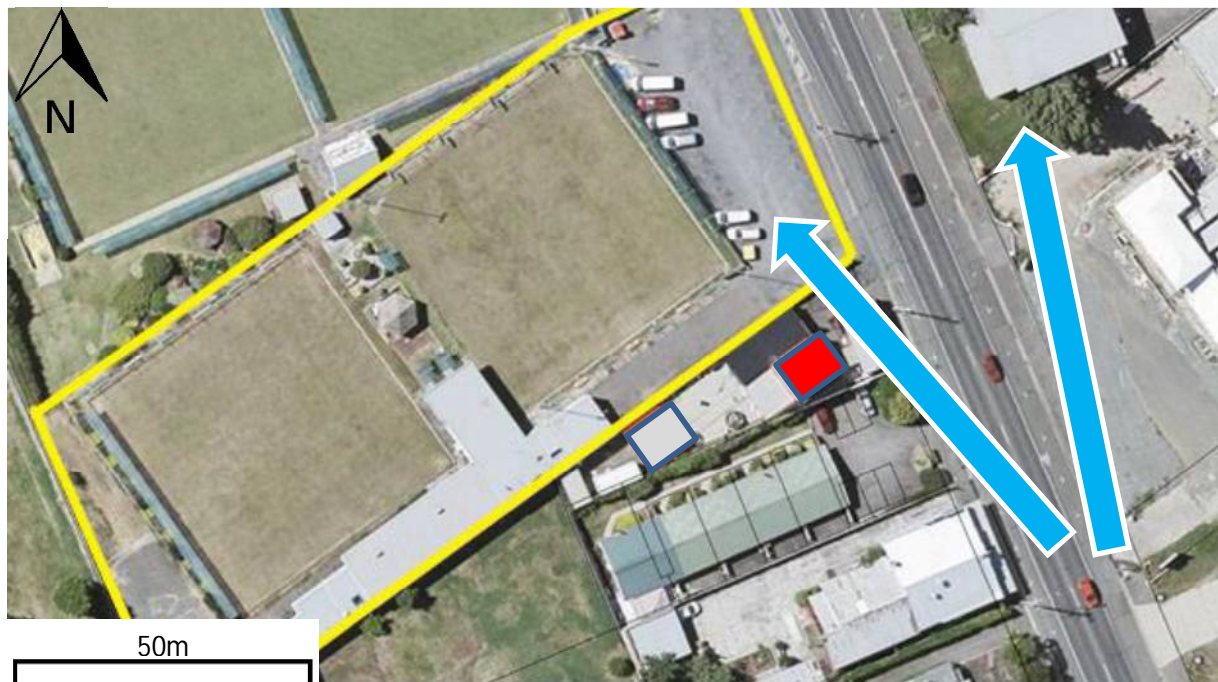
Figure 20: HEC substation location

The HEC transformer on the other hand presents a contamination risk. It would've been in operation during the time of the trolley bus service, c.1952-1968, and would have contained PCB's (Poly Chlorinated Biphenyls). PCBs are toxic, persistent and bio-accumulative organic

liquids/resins which were used in transformers until their phase out in 1975 (npi.gov.au). The HEC substation is directly adjacent to the Site and upgradient, so any PCB spillage would have reached the Site, see Figure 20.

Substation location is shown in red, site boundary in yellow, possible inferred groundwater directions in blue.

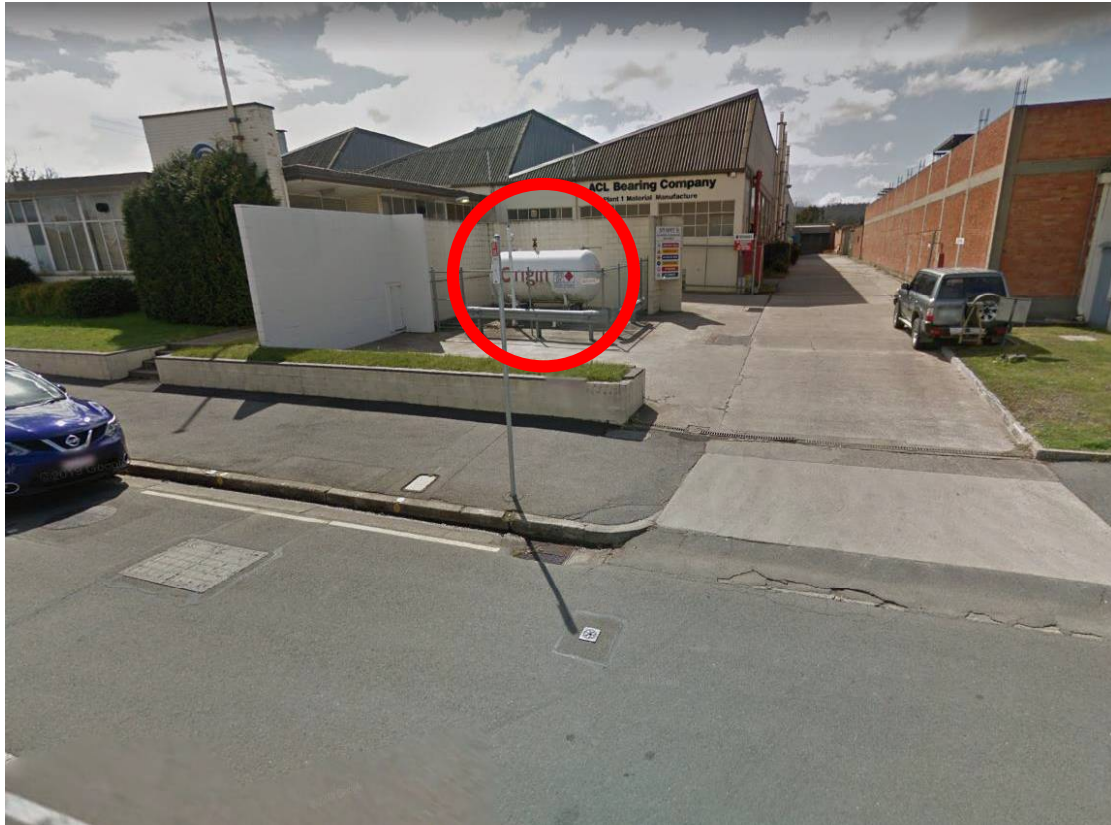
Figure 21: LPG gas tank at ACL Bearings

Current tenants of the site are the civil plant, labour and truck hire company Streetwise Developments at 298-308 Invermay Rd, and automotive engine bearing manufacturers ACL Bearings at 310-314 Invermay Rd. Contaminating activities have the potential to be undertaken at both sites. Additionally, an Origin gas tank is located next to the Invermay Rd entrance to ACL Bearings, see Figure 21.

From Google Maps Street View, 2018.

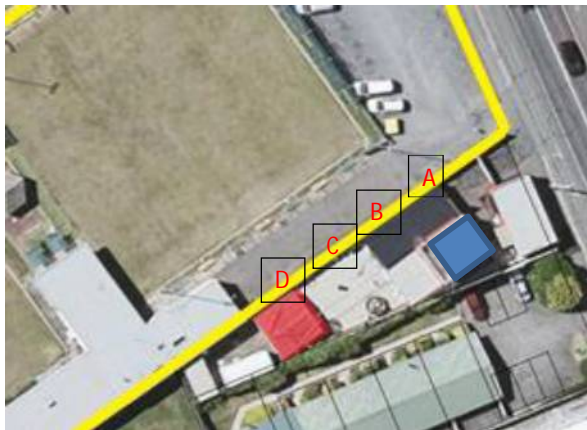
Figure 22 Sample Points

PCB contamination is possible and being up gradient and close to the Site needs to be investigated. The transformer building was reviewed and found to have a solid floor with no cracks or leakage points. The properties of PCB s suggest that should there have been a spill, the oil would fix to the soil and move laterally and potentially vertically. A hotspot would form, experience being that it would be more laterally than vertical once the oil contacts moist soil the oil fixes and moves laterally. There are several Canadian studies comparing sand and clay soils.

Sample points (Figure 22) close to the transformer building were selected down gradient and deep enough to detect any old oil (300 mm). This selection was effective as the soil samples did detect low levels of heavy oils.

Samples were taken to meet the (Australian Standards) NEPM guidelines and placed in laboratory supplied sample jars. Samples were placed on ice and dispatched to a NATA laboratory.

Results confirm that although there was low level contamination with heavier oils, PCB's were below detection limits. PCB levels in the impacted soil are not above HSL.
