**PROPOSED REAR RESIDENCE - ADDITION TO EXISTING GARAGE
 59-61 FREDERICK ST. LAUNCESTON - MR. & MRS. L. PENZES**

RE : DEVELOPMENT APPLICATION - DA0672/2019
59 Frederick St. Launceston

Preliminary Site Investigation

59-61 Frederick St,
Launceston 7250

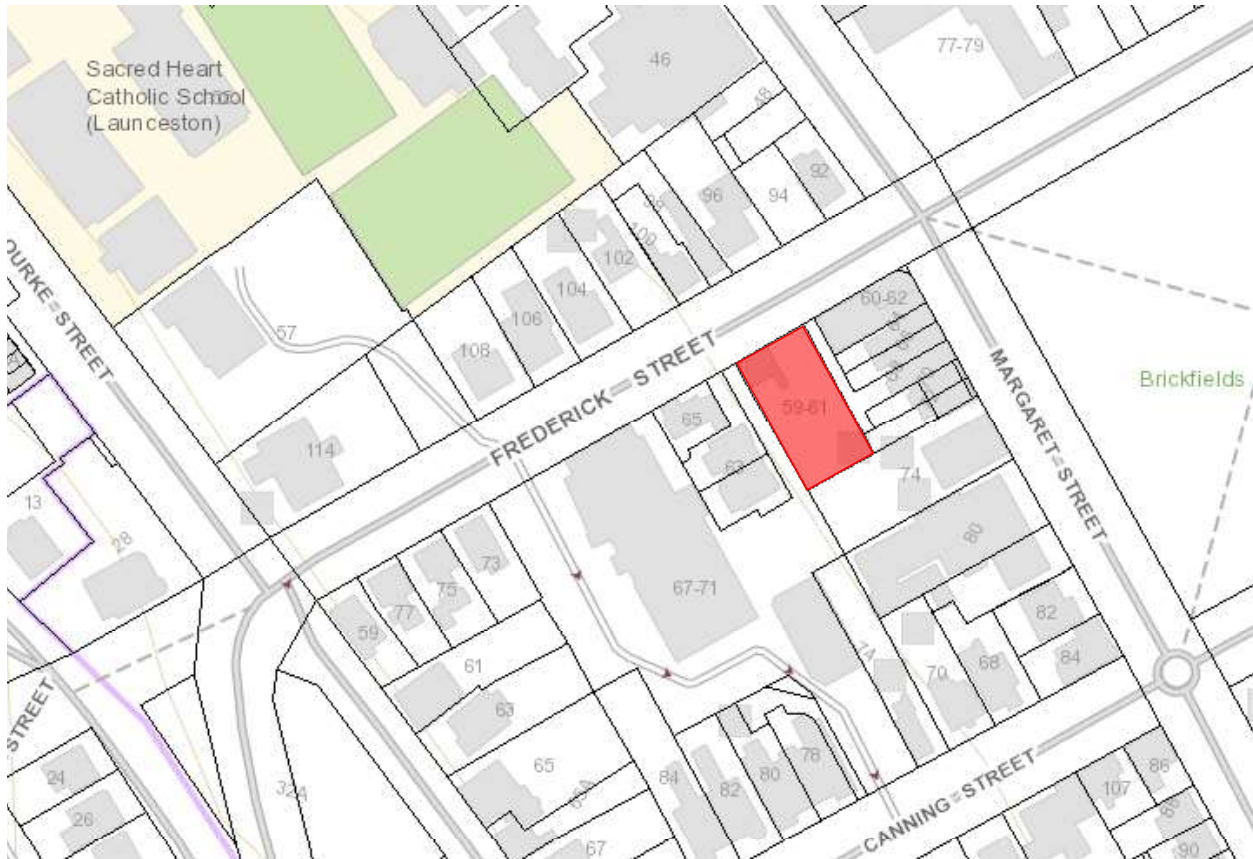
Figure 2: Site location

The site is located at 59-61 Frederick St, Launceston. Property ID 6676853, Title reference 152142/1.

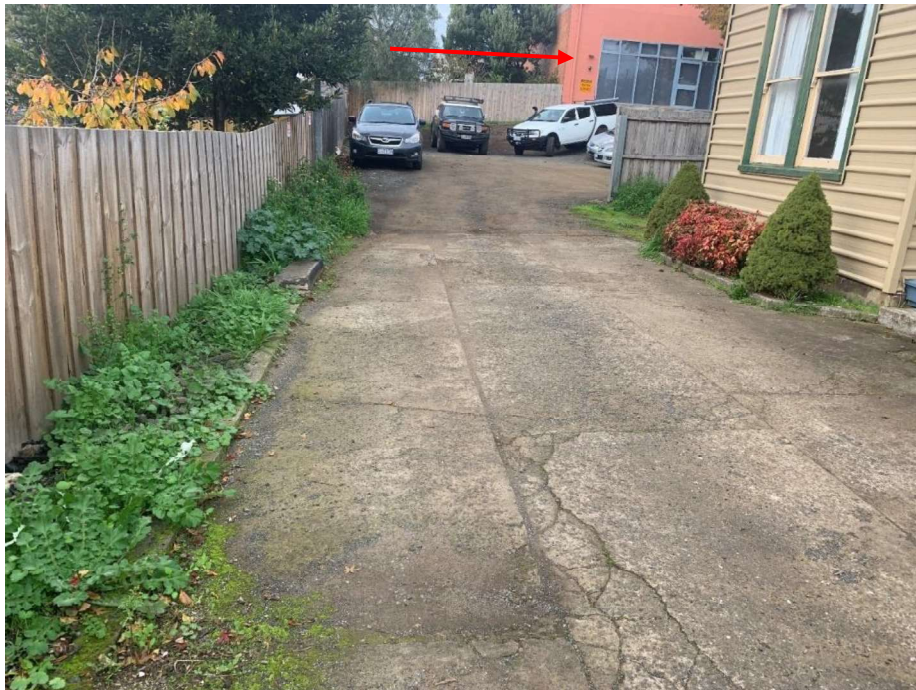
This site is currently occupied by Launceston Pathology. The property was formerly owned by Prime Autos. A workshop is located south of the main building and was used for engine repairs among other activities. 63 Frederick St abuts the former workshop on the Launceston Pathology property along the rear boundary. A one metre high cutting against the workshop shows no evidence of hydrocarbons or other contamination emanating from the building towards the north east (Fig. 9, 10).

Figure 9: Driveway of 63 Frederick St showing old workshop (pink) and location of cutting

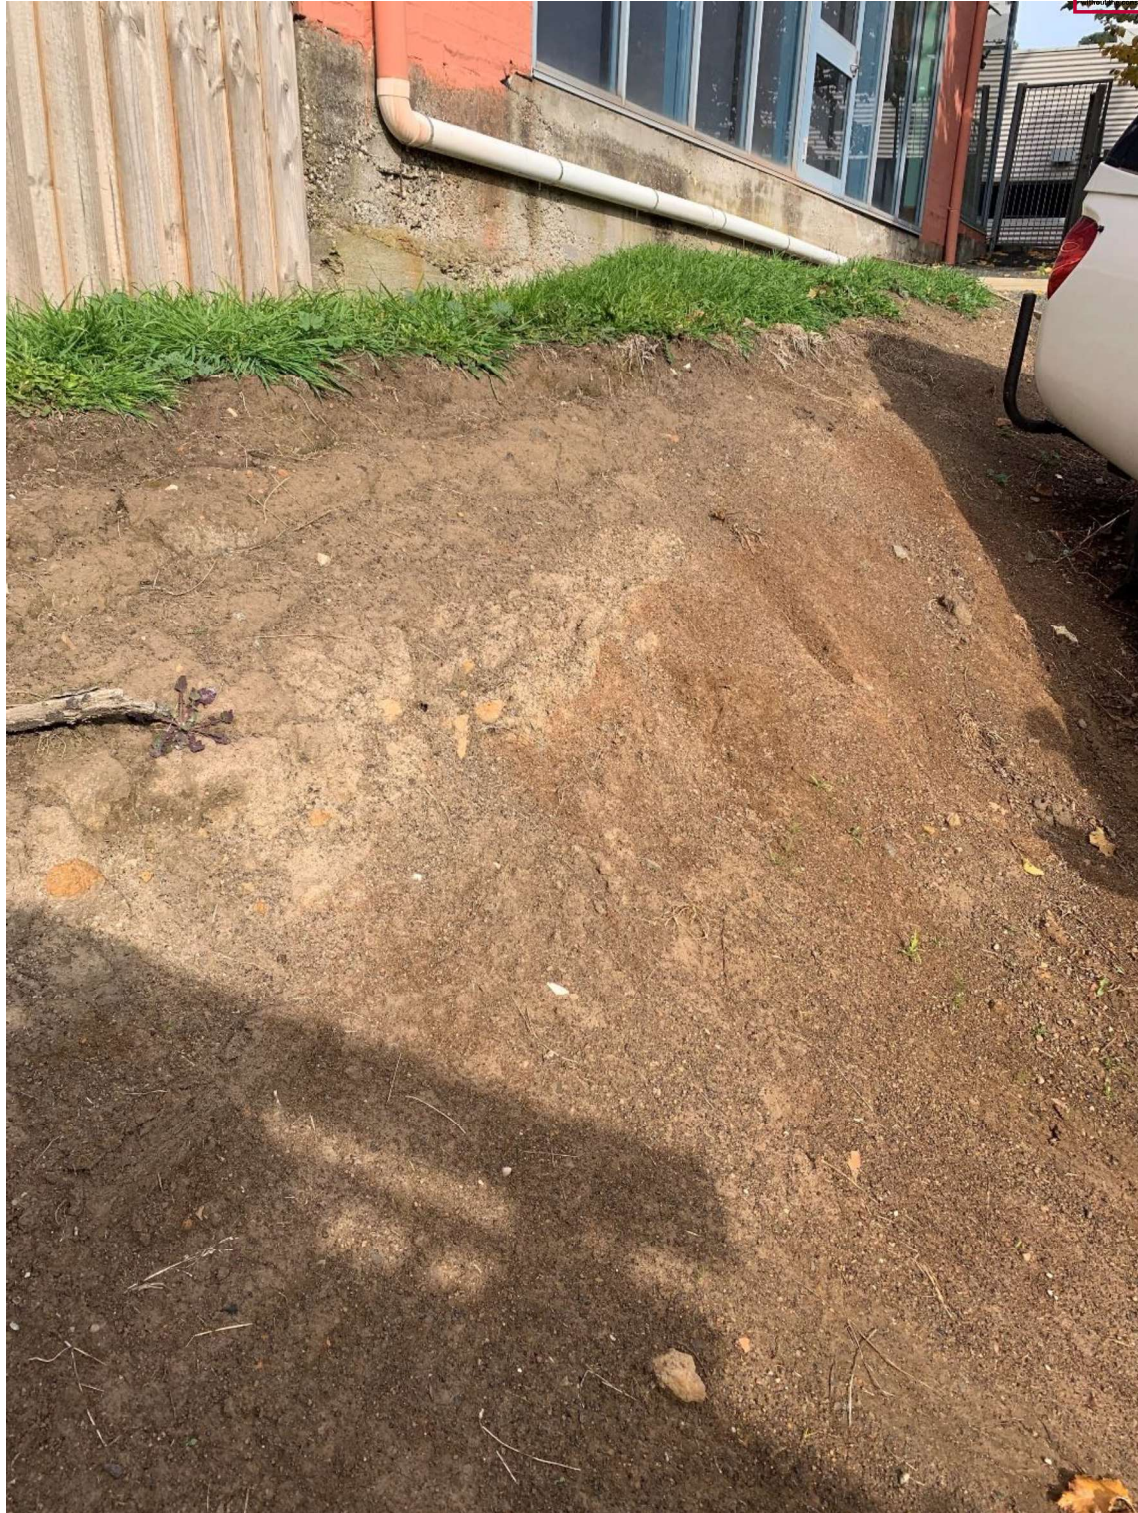
Figure 10: Cutting in front of former workshop

The site visit concluded that the figure 10 evidence confirms beyond doubt any contamination emanating from the old workshop either does not exist, or flows away from the Site. There was no staining nor odour below the surface of the cutting that was approximately 2.0 meters below the workshop and between the workshop and the Site.

Visual assessment of the Site, in considering all evidence including geology allows me to conclude that there is no potential contamination on the site where development is planned. No management measures are required to manage risk in relation to the proposed development. This includes the disturbance of soil for the development.
