RE: Preliminary Site Investigation – 4-6 Boland Street Launceston

Preliminary Site Investigation

Project No: 6830

Remediation and Validation Plan

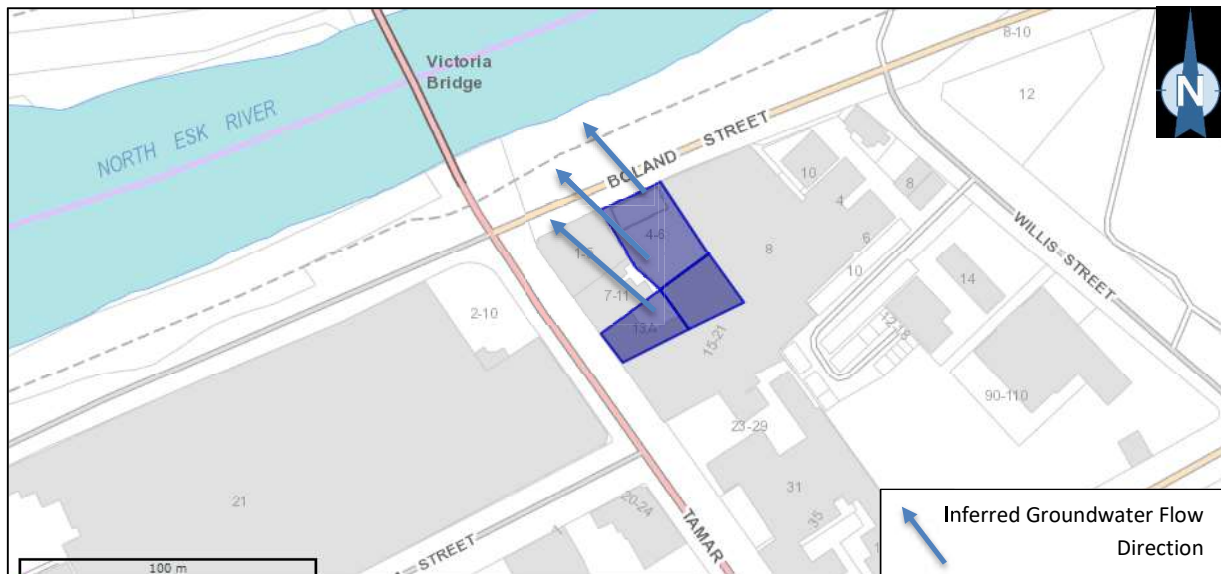
Figure 3: Inferred Groundwater Flow Direction

Groundwater is likely to flow towards the North Esk River. A representation of likely groundwater flow direction according to changes in topography is presented in Figure 3. Reference to the Department of Primary Industries, Parks, Water and Environment (DPIPWE) Groundwater Information Access Portal indicates there are no registered bores within 500m of the site. Groundwater is not extracted for drinking purposes in the area, water is supplied to the area from TasWater infrastructure.

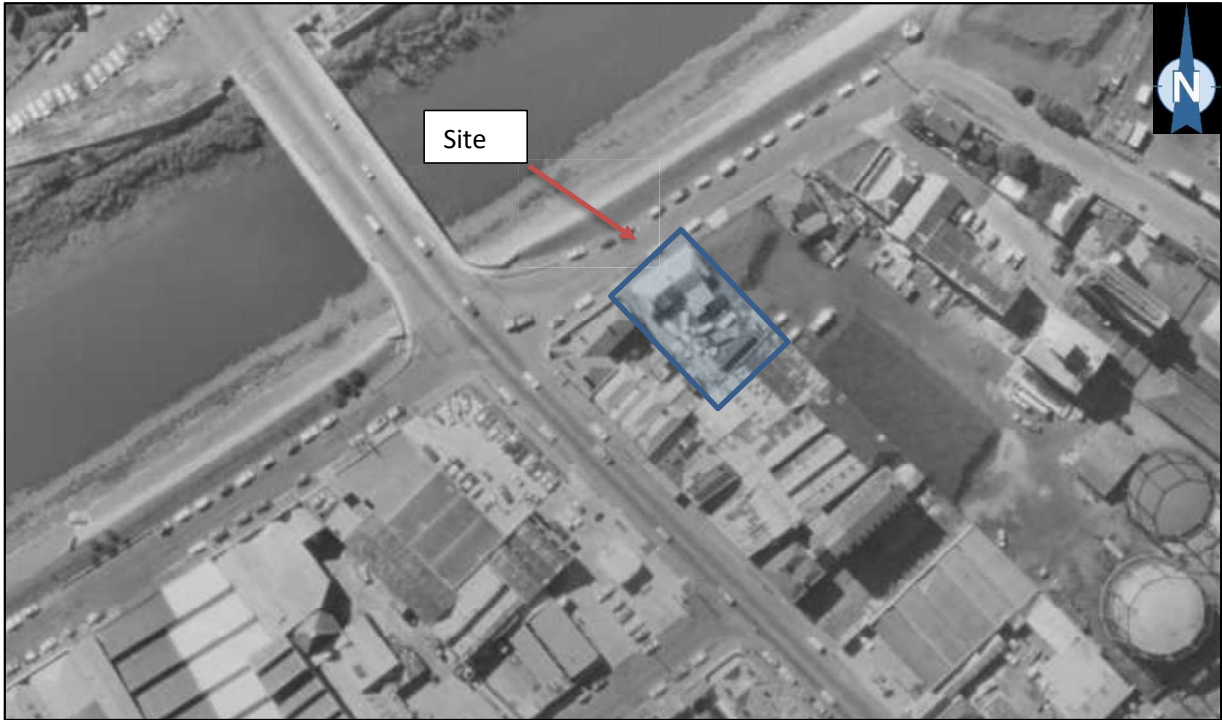
Figure 4: Aerial 1976 (Source: TheLIST)

A review of historical aerial photographs available on the LIST and Google Earth was undertaken to identify any historical potentially contaminating land uses in the area. Photos from 1976, 1982, 1991, 2008 and 2018 are shown in Figure 4-Figure 8 below.

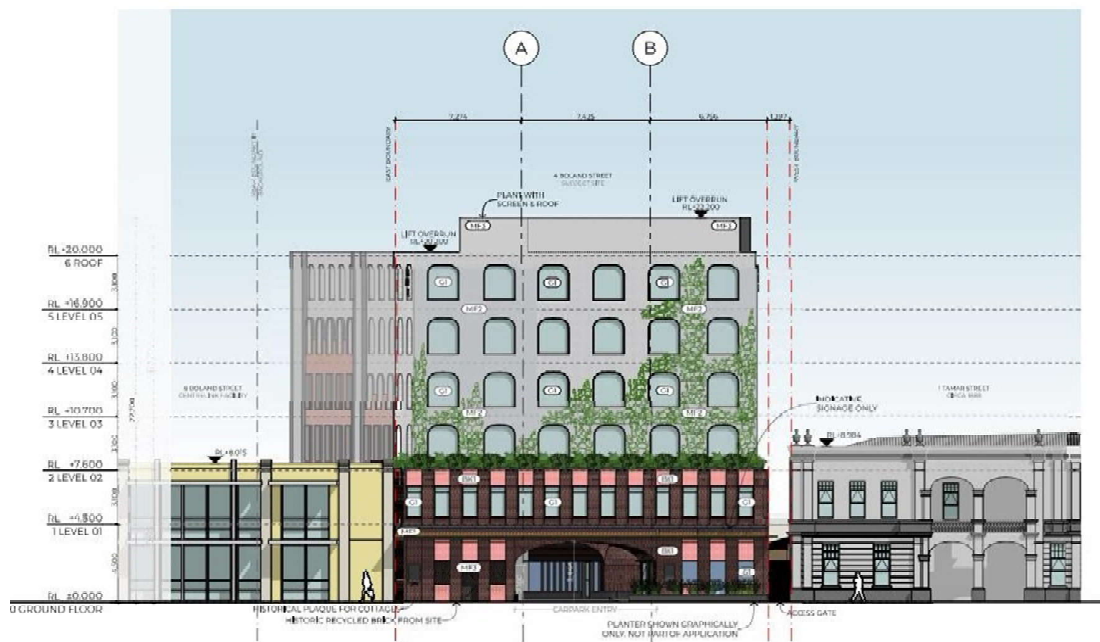
Image taken from Boland St Hotel Development Application, by Telha Clarke, 25 Mar 2021
 – Drawing TP.2.10

The main impact on significance on the State and Local listed buildings adjoining relates specifically to the height of the proposal at six (6) levels (the seventh level being generally open roof space) compared to essentially two (2) levels of the significant buildings. The two levels, however, have high floor to floor distances along with a deep parapet around a high-pitched roof which equates the total height at the parapet being 8.984m. This does, consequently, visually reduce the disparity with the new building at 20m along the front edge of the roof down to approximately 1:2.2 roughly from views more distant up to those closer. Some moderation of this is given by the proposed new building maintaining a line equating to the modern building and thereby maintaining a two-storey boundary façade nearly 1.0m lower than the former Bridge Hotel with the upper levels set back marginally. From very close pedestrian level, and view, the proposed building will therefore appear less imposing and the roof over the pathway at the lower level will also help to moderate the disparity. Refer to comments under Section E13.6 'Development Standards'.

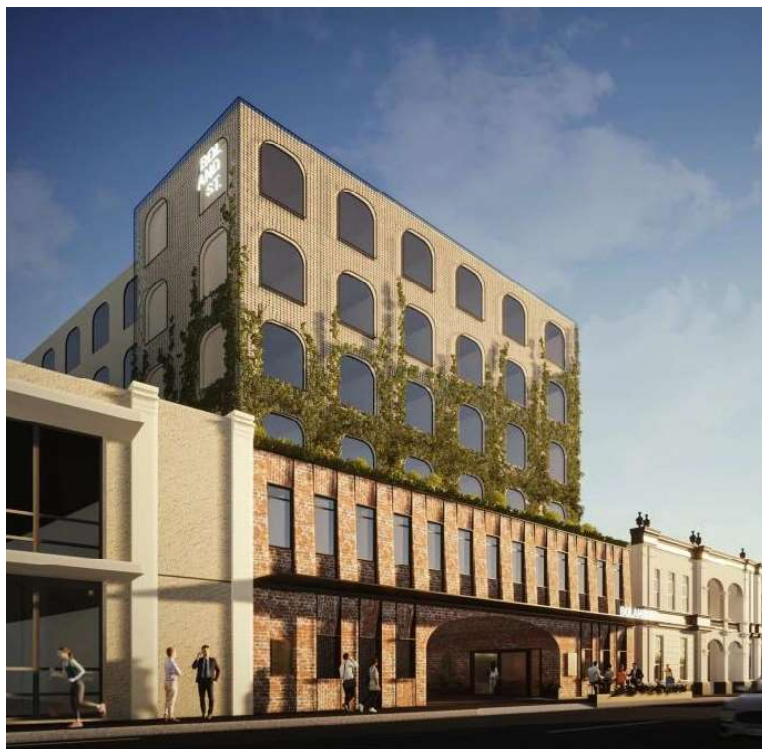
Image taken from Boland St Hotel Development Application, by Telha Clarke, 25 Mar 2021 – Pg 12

The brick architectural interpretation of the façade, paying homage to the Boland Street cottages formerly on the site, allows the lower section of the proposal to be aesthetically more diminutive in scale and context with the adjoining former bridge Hotel. The use of lighter colours, repetitive window/fenestration and living wall ensures that the higher levels appear as a recessive/diminutive element despite the bulk/scale.
