Launceston Youth at Risk

31 Brisbane Street Launceston Communities Tasmania

Planning Application

Environmental Site Assessment

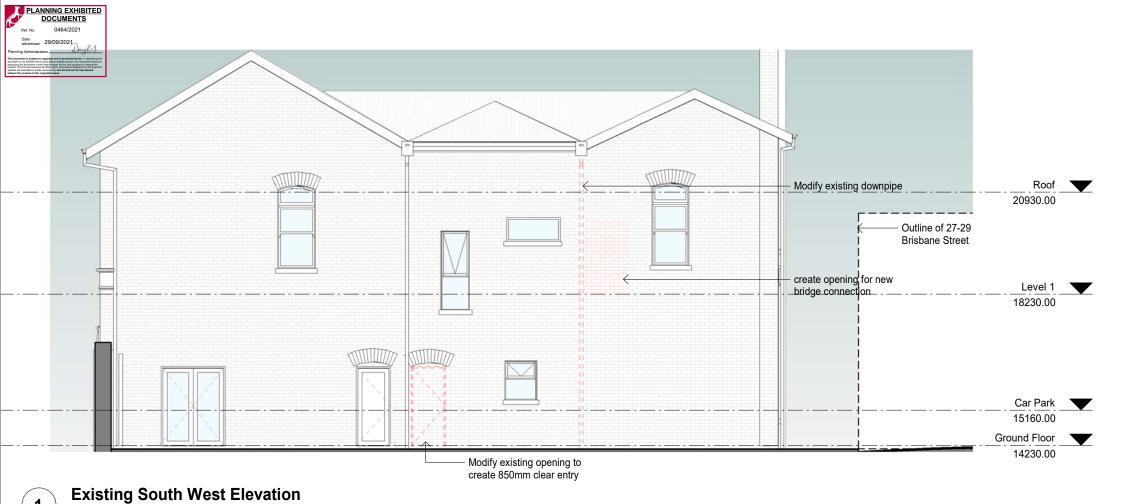
Existing North East Elevation 2

Roof 🔻 20930.00 Outline of 27-29 Brisbane Street Demolition of existing garage Level 1 18230.00 Car Park ____ 15160.00 Ground Floor 14230.00

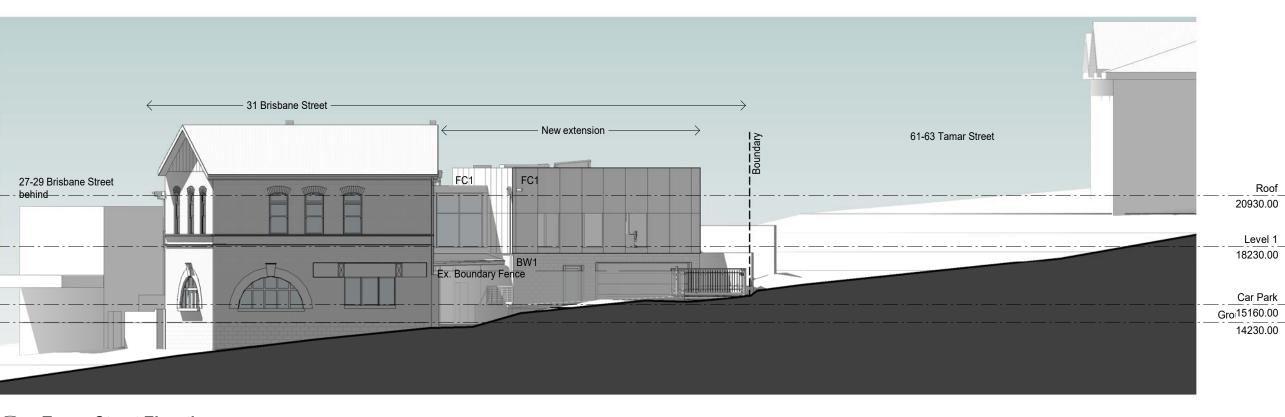
Tamar Street Elevation 1:200

Finishes

FC1 CSR Cemintel "Barestone"

BW1 Coloured Concrete Block - dark grey

BW2 Plain Concrete Block

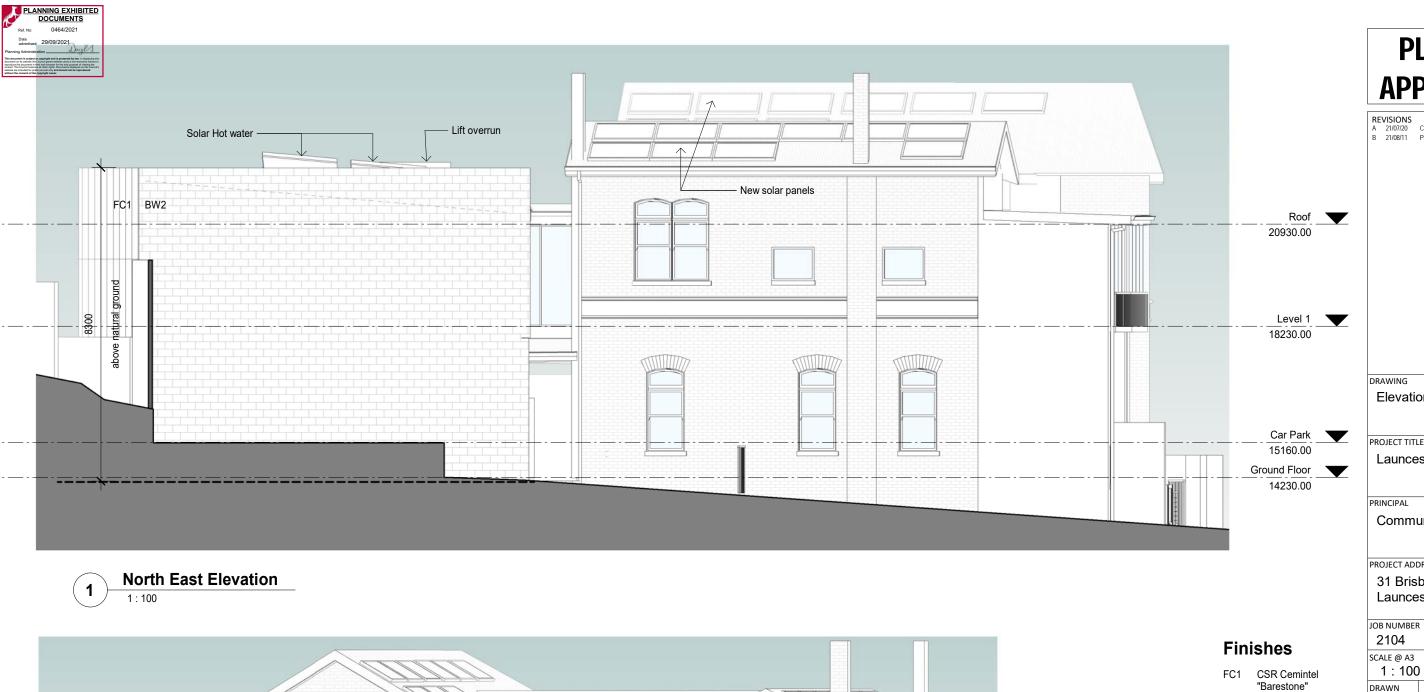
South East Elevation

Neighbouring screen

BW1 Coloured Concrete Block - dark grey

BW2 Plain Concrete Block

Existing Boundary Fence

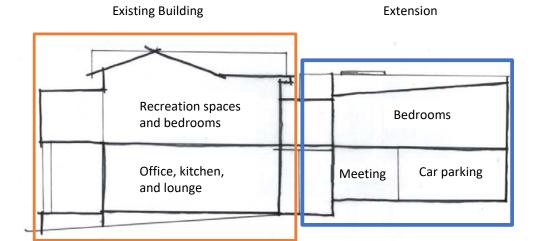
Long Cross Section (not to scale)

The proposed new building (extension) to the rear of the site, is built up to the northern and eastern boundaries. There are no windows or openings on these elevations. The bedrooms in the extension have windows that face south towards Tamar Street.

The adjacent property 61-63 Tamar street has a shared boundary wall with 31 Brisbane street. This wall is retaining earth from 61-63 Tamar. As part of this development this wall will be replaced.

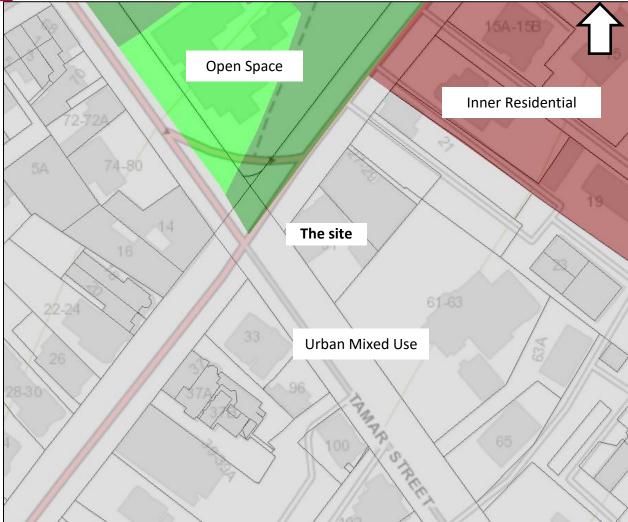
Figure 2: Zoning

The site is zoned Urban Mixed Use. Inner Residential zoning exists to the northeast and Open Space to the north (Figure 2). Launceston Interim Planning Scheme 2015 zoning will not change with the development.

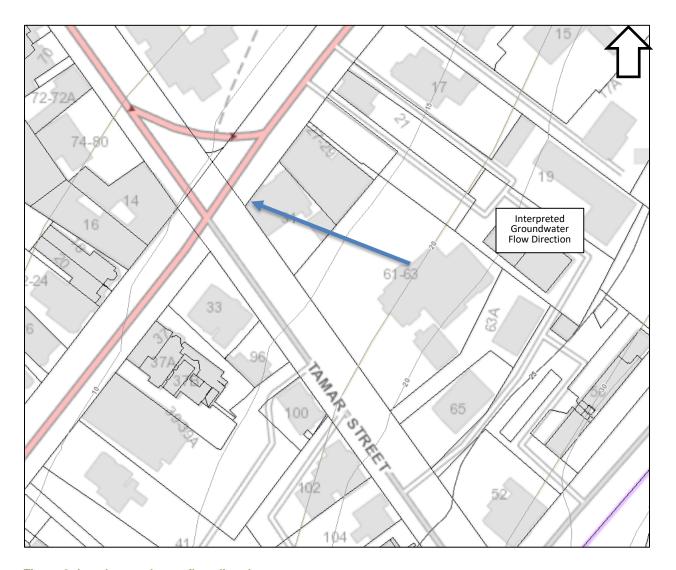
Figure 3: Local groundwater flow direction

Localised groundwater flow beneath the site is interpreted to reflect the surface topography, flowing in a north-westerly direction (Figure 3). Reference to the Department of Primary Industries, Parks, Water and Environment (DPIPWE) Groundwater Information Access Portal indicates there are no registered bores within 500m of the site. Groundwater is not extracted for drinking purposes in the area, water is reticulated to the area via TasWater infrastructure.

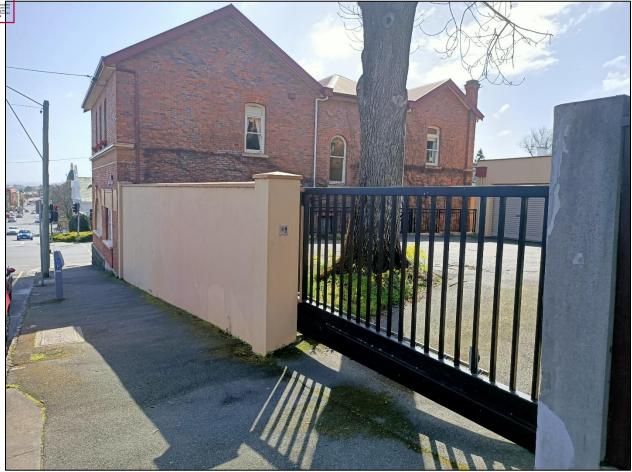
Figure 11: 31 Brisbane Street, showing local topography

The site slopes southeast to northwest. The site inspection found no evidence of physical contamination at the property. A chemist and financial investment service company now occupy the neighbouring site to the west (Figure 12). There was no evidence of a UPSS remaining on the site. A large residential property exists directly upgradient to the south.
