Reference No. GL23301Ab Rev.01

**RE: Preliminary On-site Wastewater Disposal Evaluation
40768 Tasman Highway, Waverley**

At the request of Mr Garry & Ms Lesley Dawkins, Geoton Pty Ltd has carried out a limited scope investigation at the site of a proposed 23-Lot residential subdivision at 40768 Tasman Highway, Waverley.

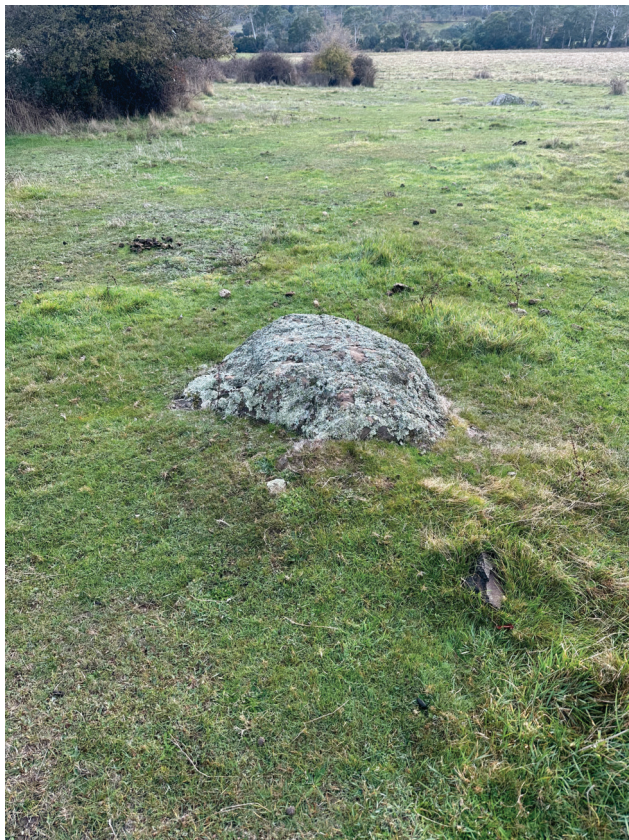
PLATE 3 - View of exposed dolerite boulder within the site

The MRT Digital Geological Atlas 1:25,000 Series, indicates that the majority of the site is mapped as being underlain by Jurassic period dolerite or dolerite beneath soil or Cainozoic deposit, with the northeastern portion of the site mapped as Quaternary period sediments and area within the western portion of the site mapped as Cretaceous – Quaternary Period moderately-consolidated dolerite conglomerate.

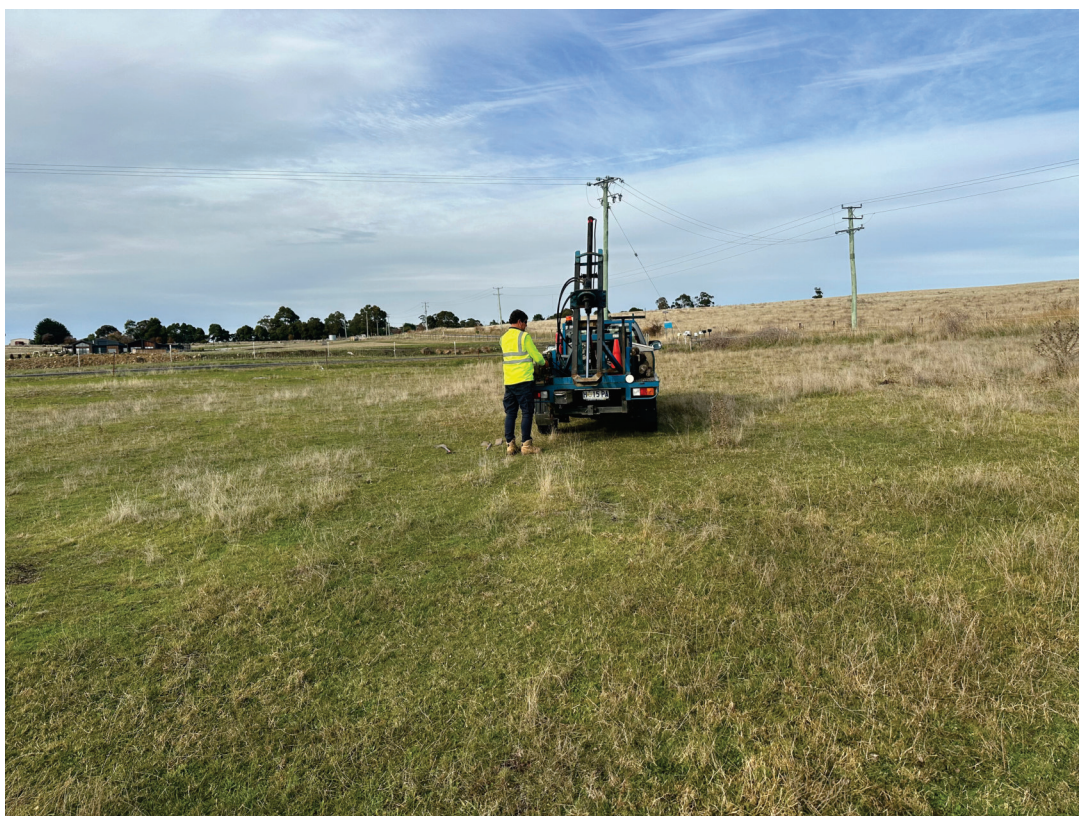
PLATE 4 - view of site looking to the south

The ground surface across the site generally has a gentle fall of 1° to 5° towards the northwest.
