**Prepared & published by:** ES&D Consulting  
**Version:** FINAL  
**File:** 9142C  
**Contact name:** Royce Aldred  
**Contact number:** 0429 335 664  
**Prepared for:** 6ty°

6ty° engaged ES&D to conduct an environmental site assessment (preliminary site investigation – PSI) at 215 Wellington Street Launceston (the Site). The proposed development of the site is for a hospital development. The development will include a three-level building with multiple theatres, beds, and other facilities that are included in the development application.

Preliminary Site Investigation

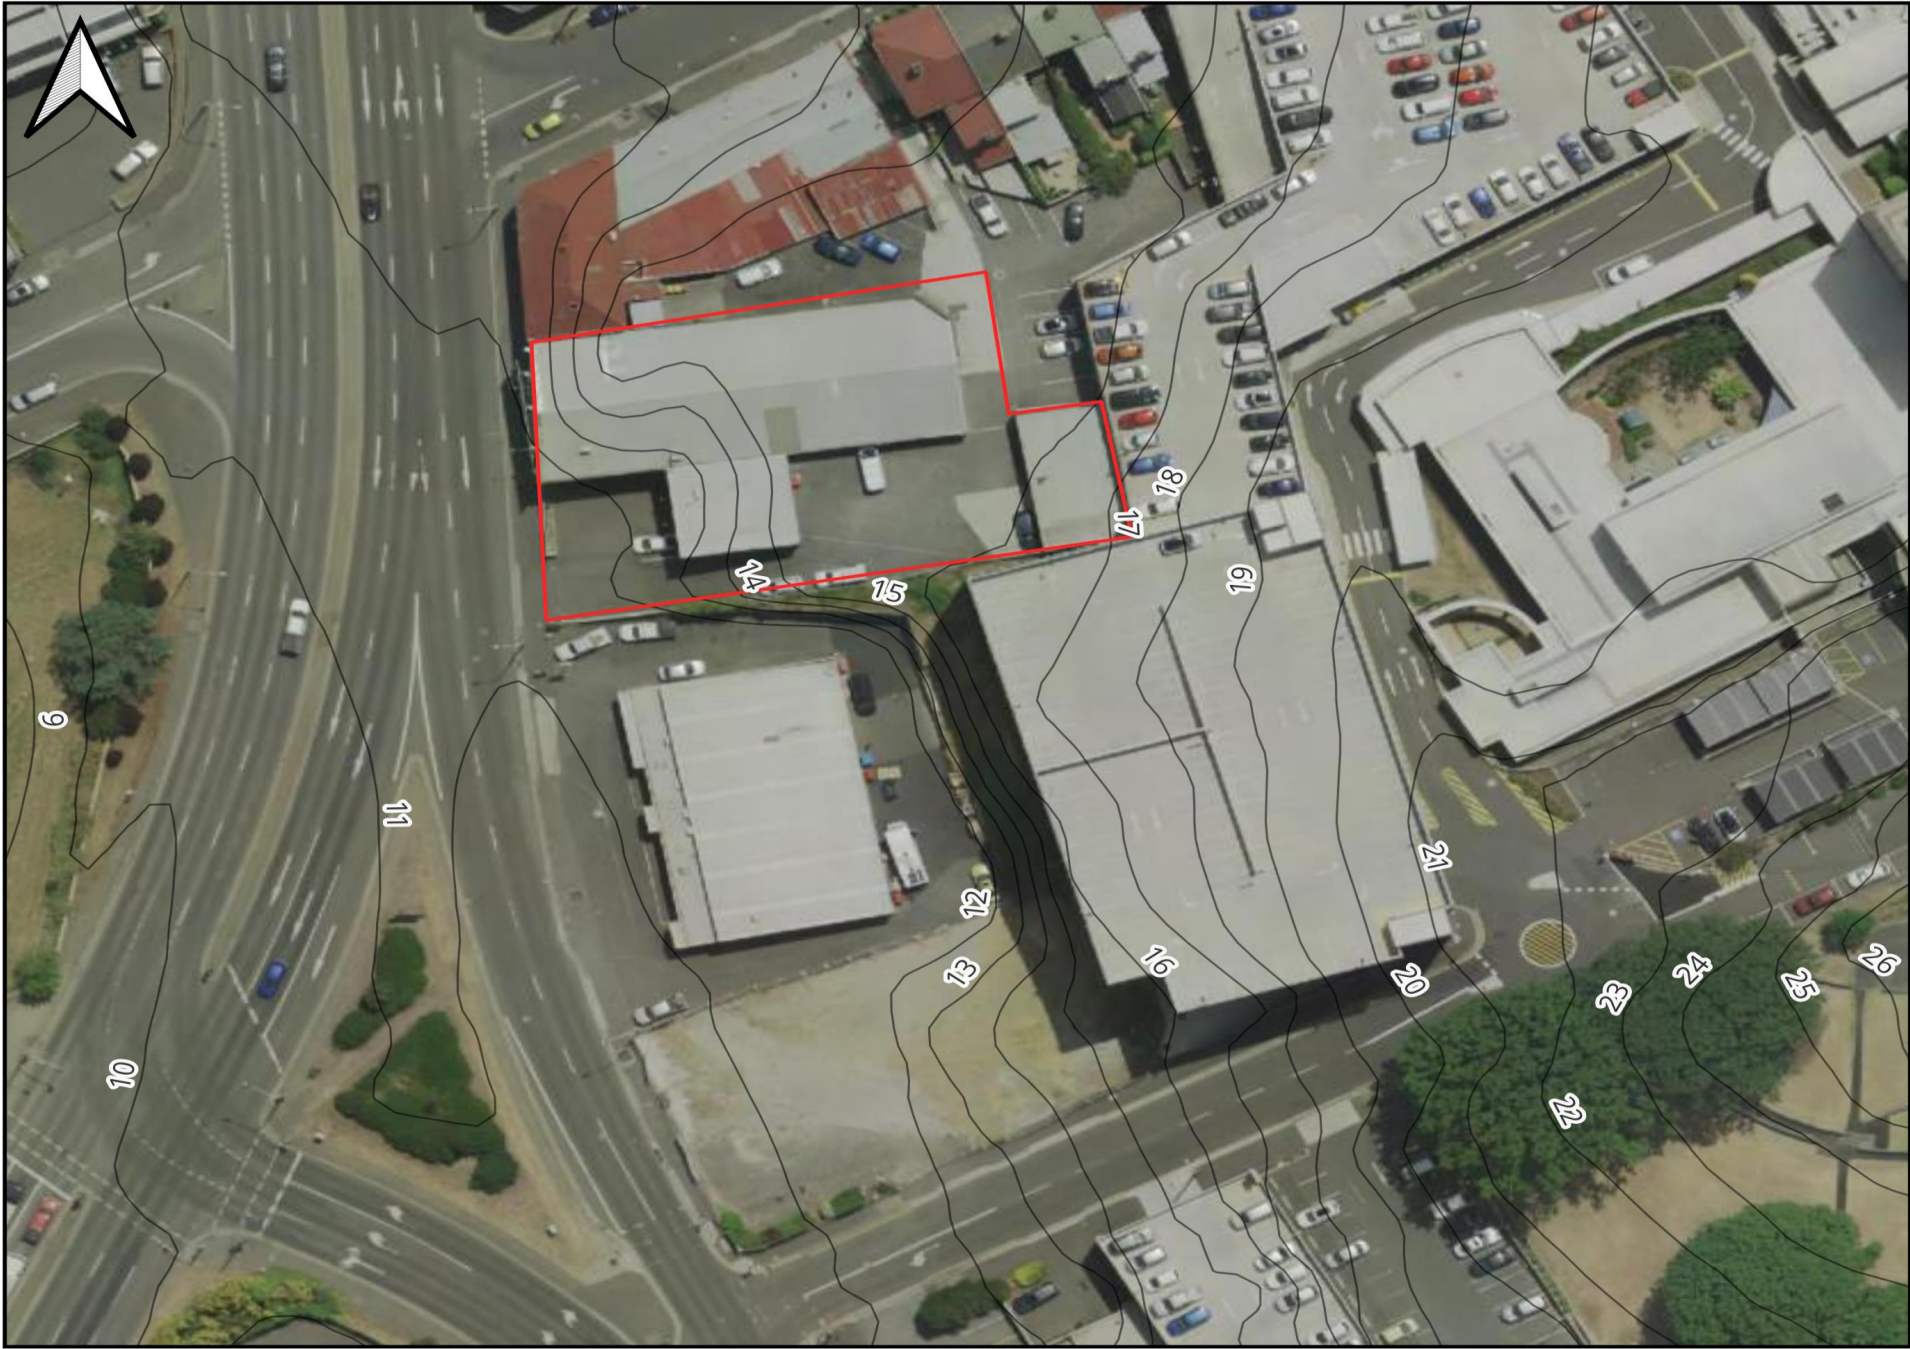
Figure 1: The Site

The property is privately owned, and the details are included in Table 1 and Figure 1. The property is zoned *Commercial*.

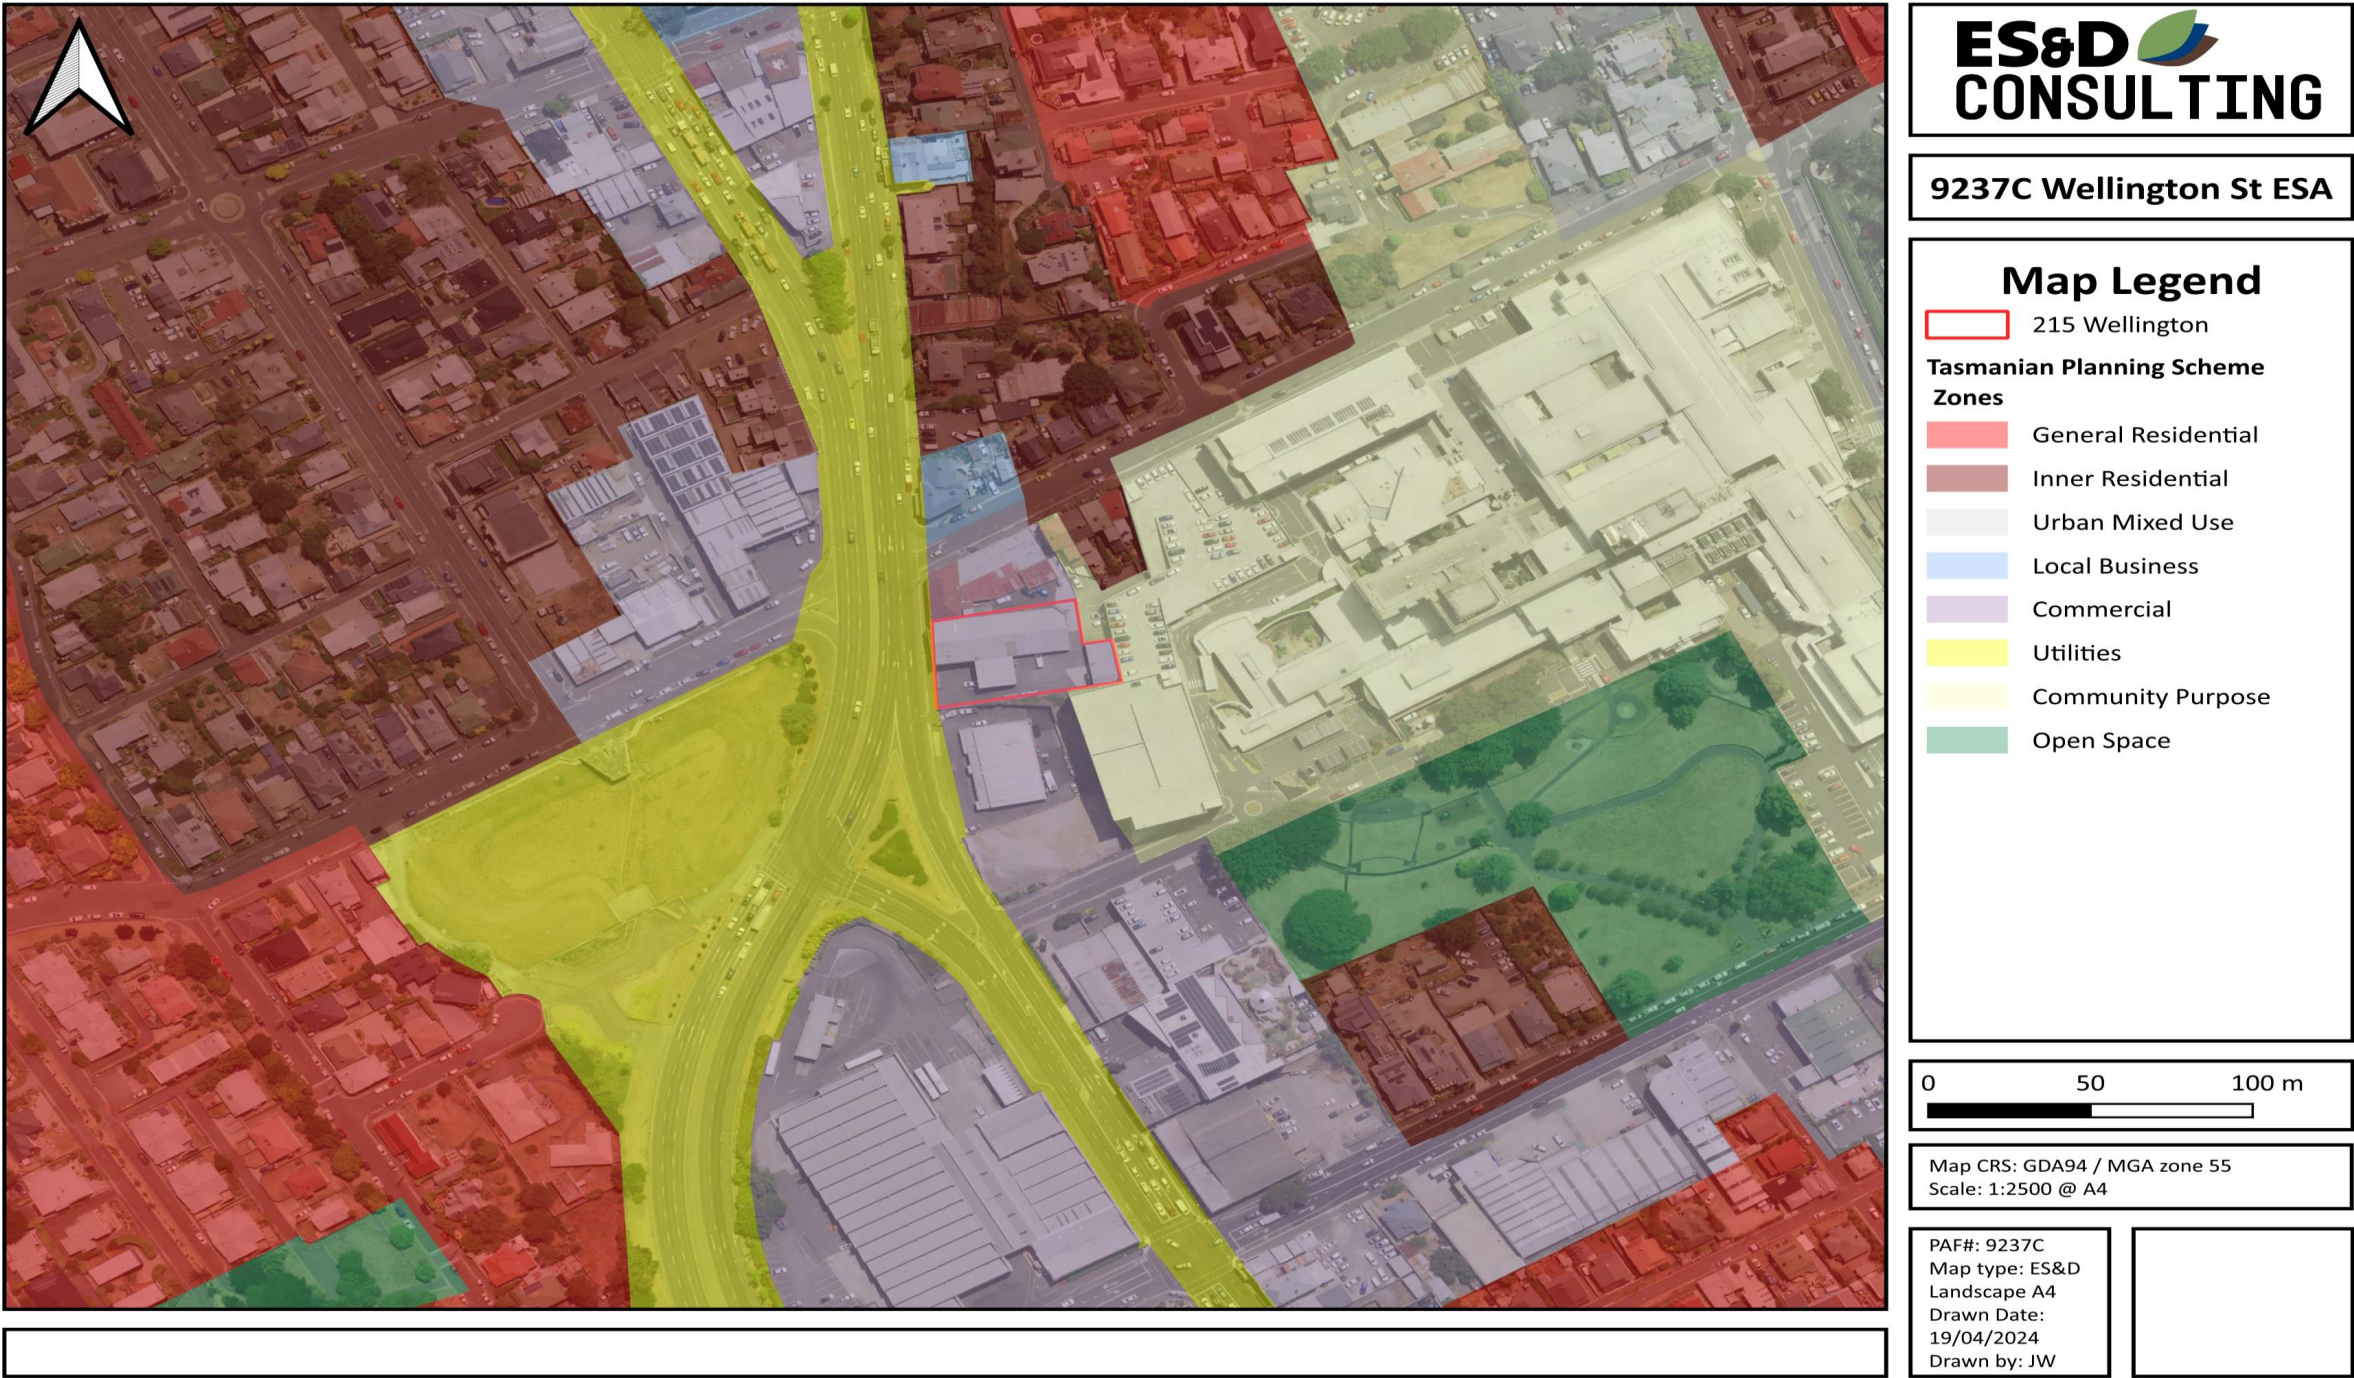
Figure 2: Tasmanian planning scheme – Zoning.

The surrounding area has multiple uses and zonings, including commercial, local business and inner residential areas (see Figure 2).

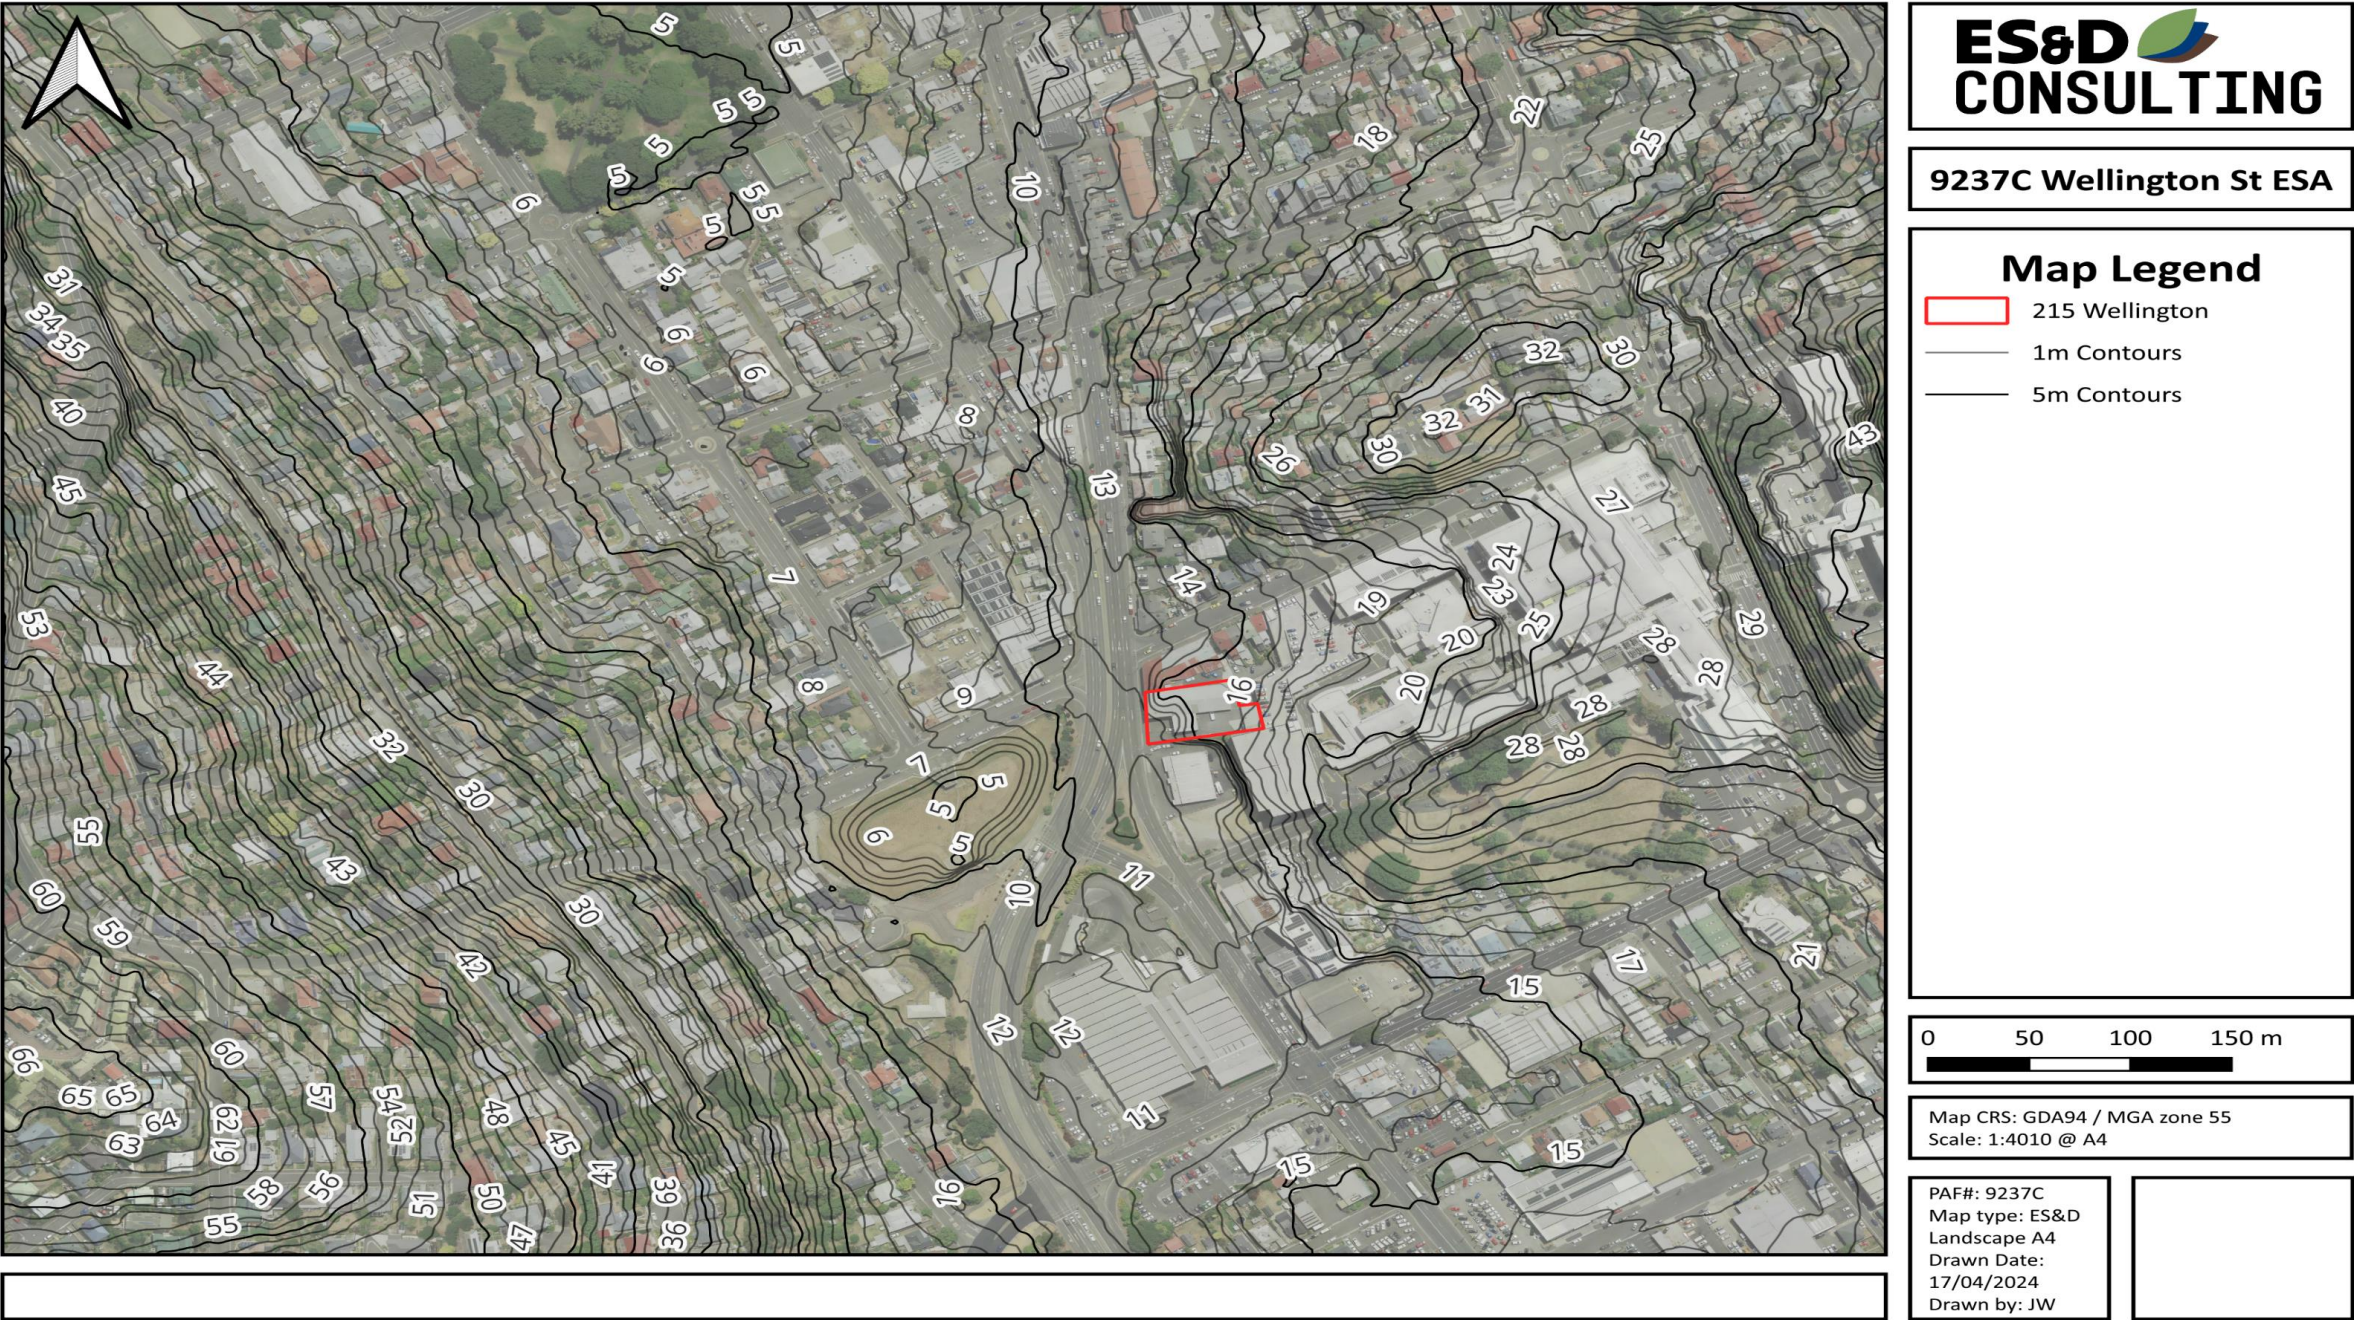
Figure 4: Contours

A review of the LISTmap contours indicates that the site is slopes steeply from East to West, with an elevation of approximately 11-16 m AHD.

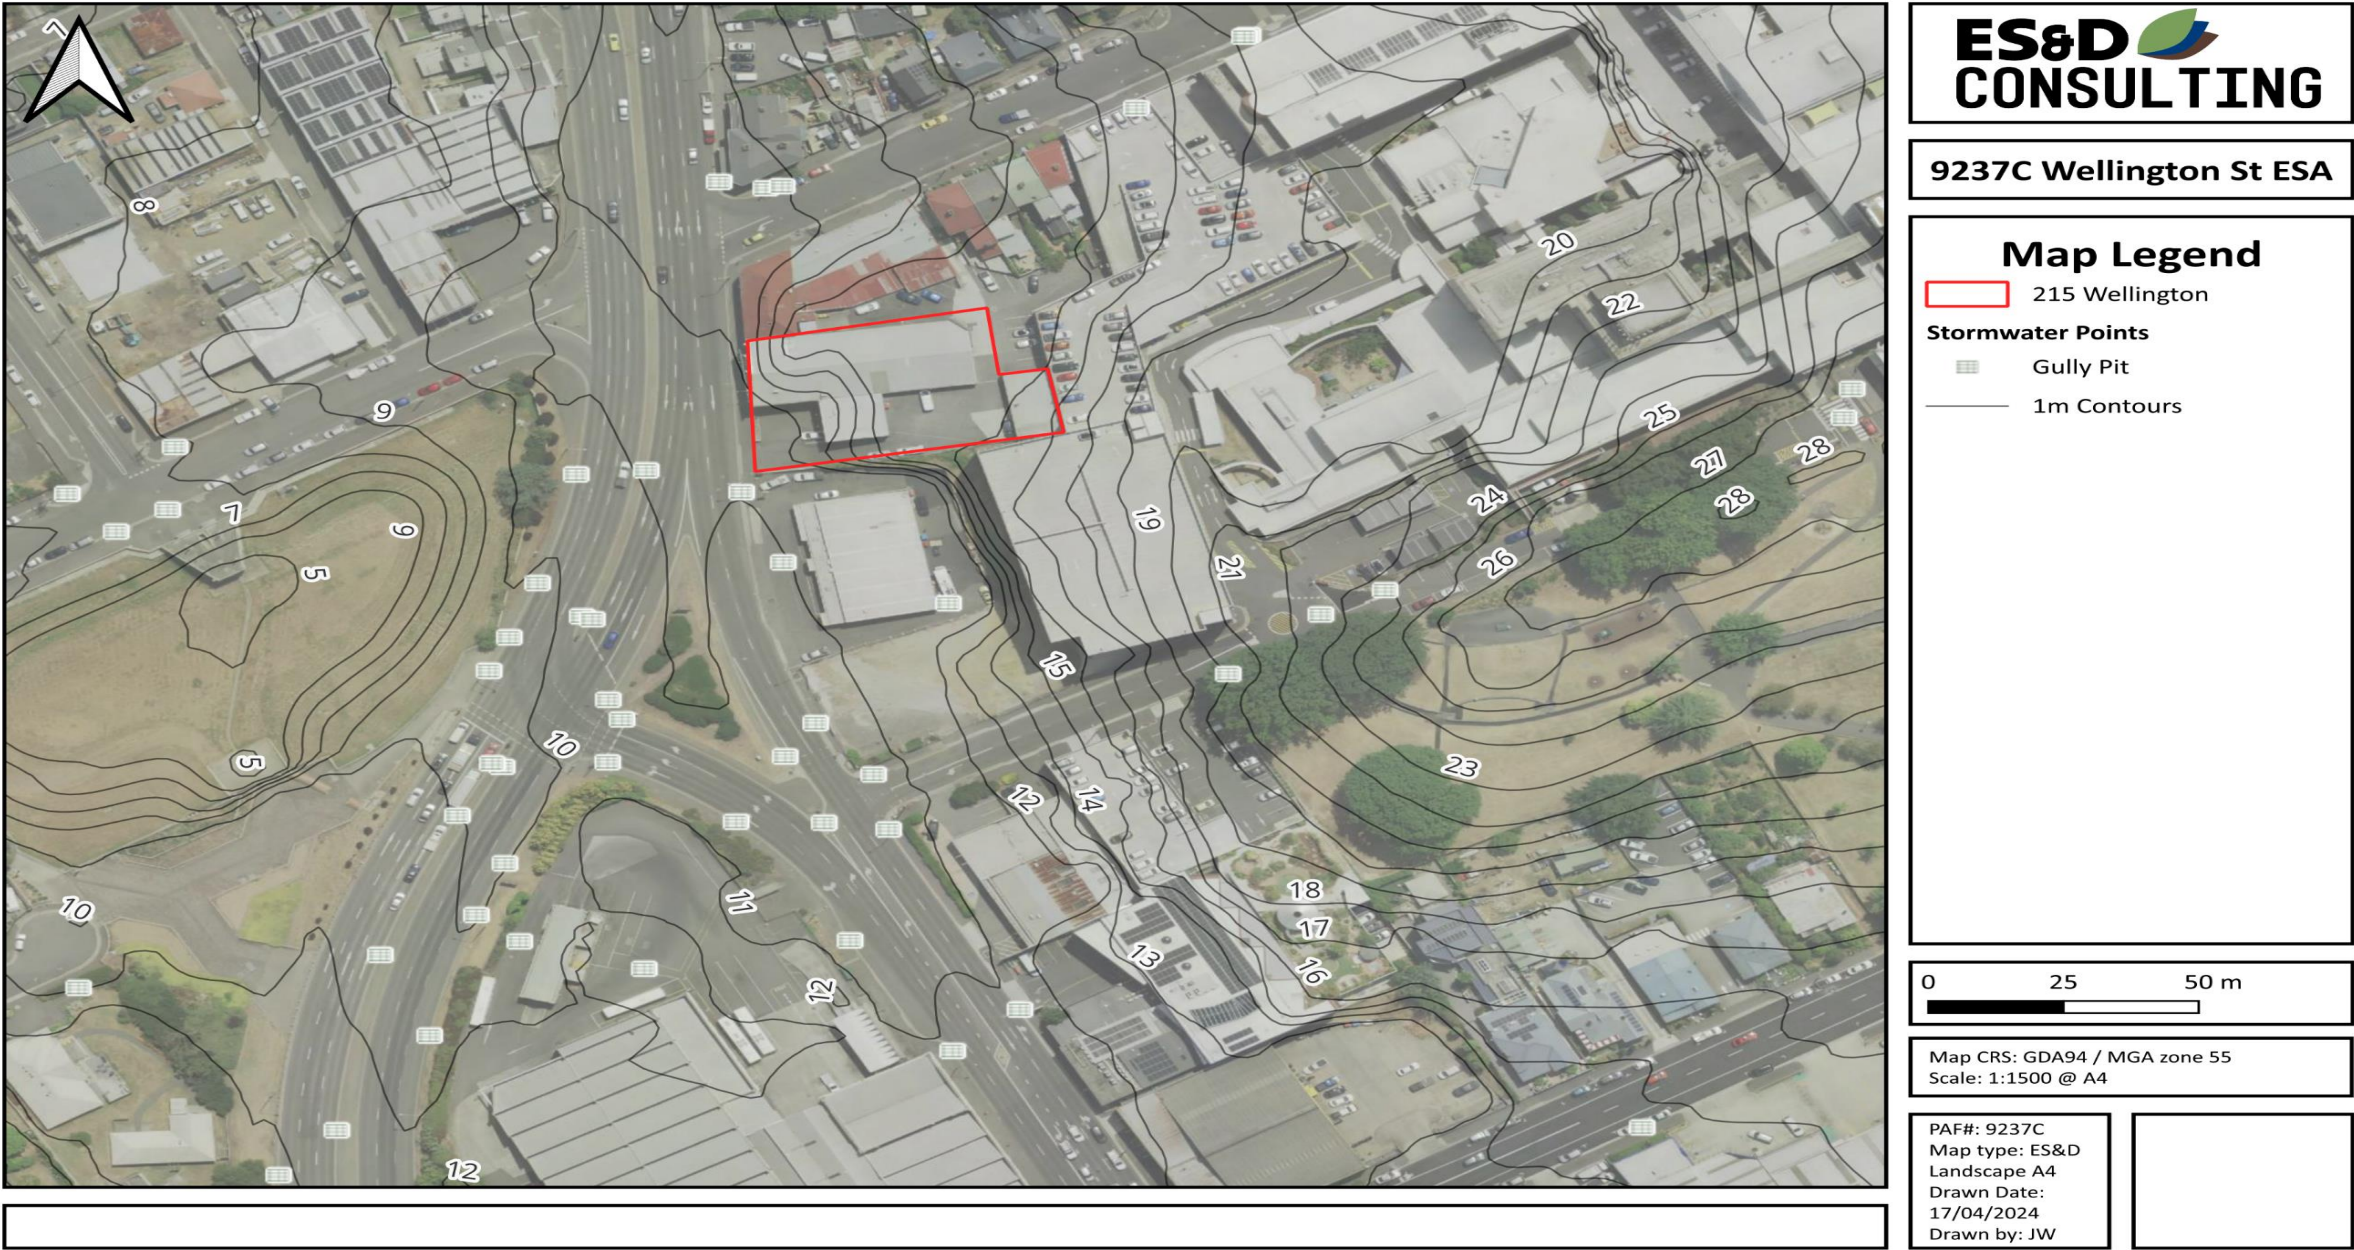
Figure 5: Surface water

The nearest surface water body is the South Esk River, located approximately 1.2 km to the northwest.

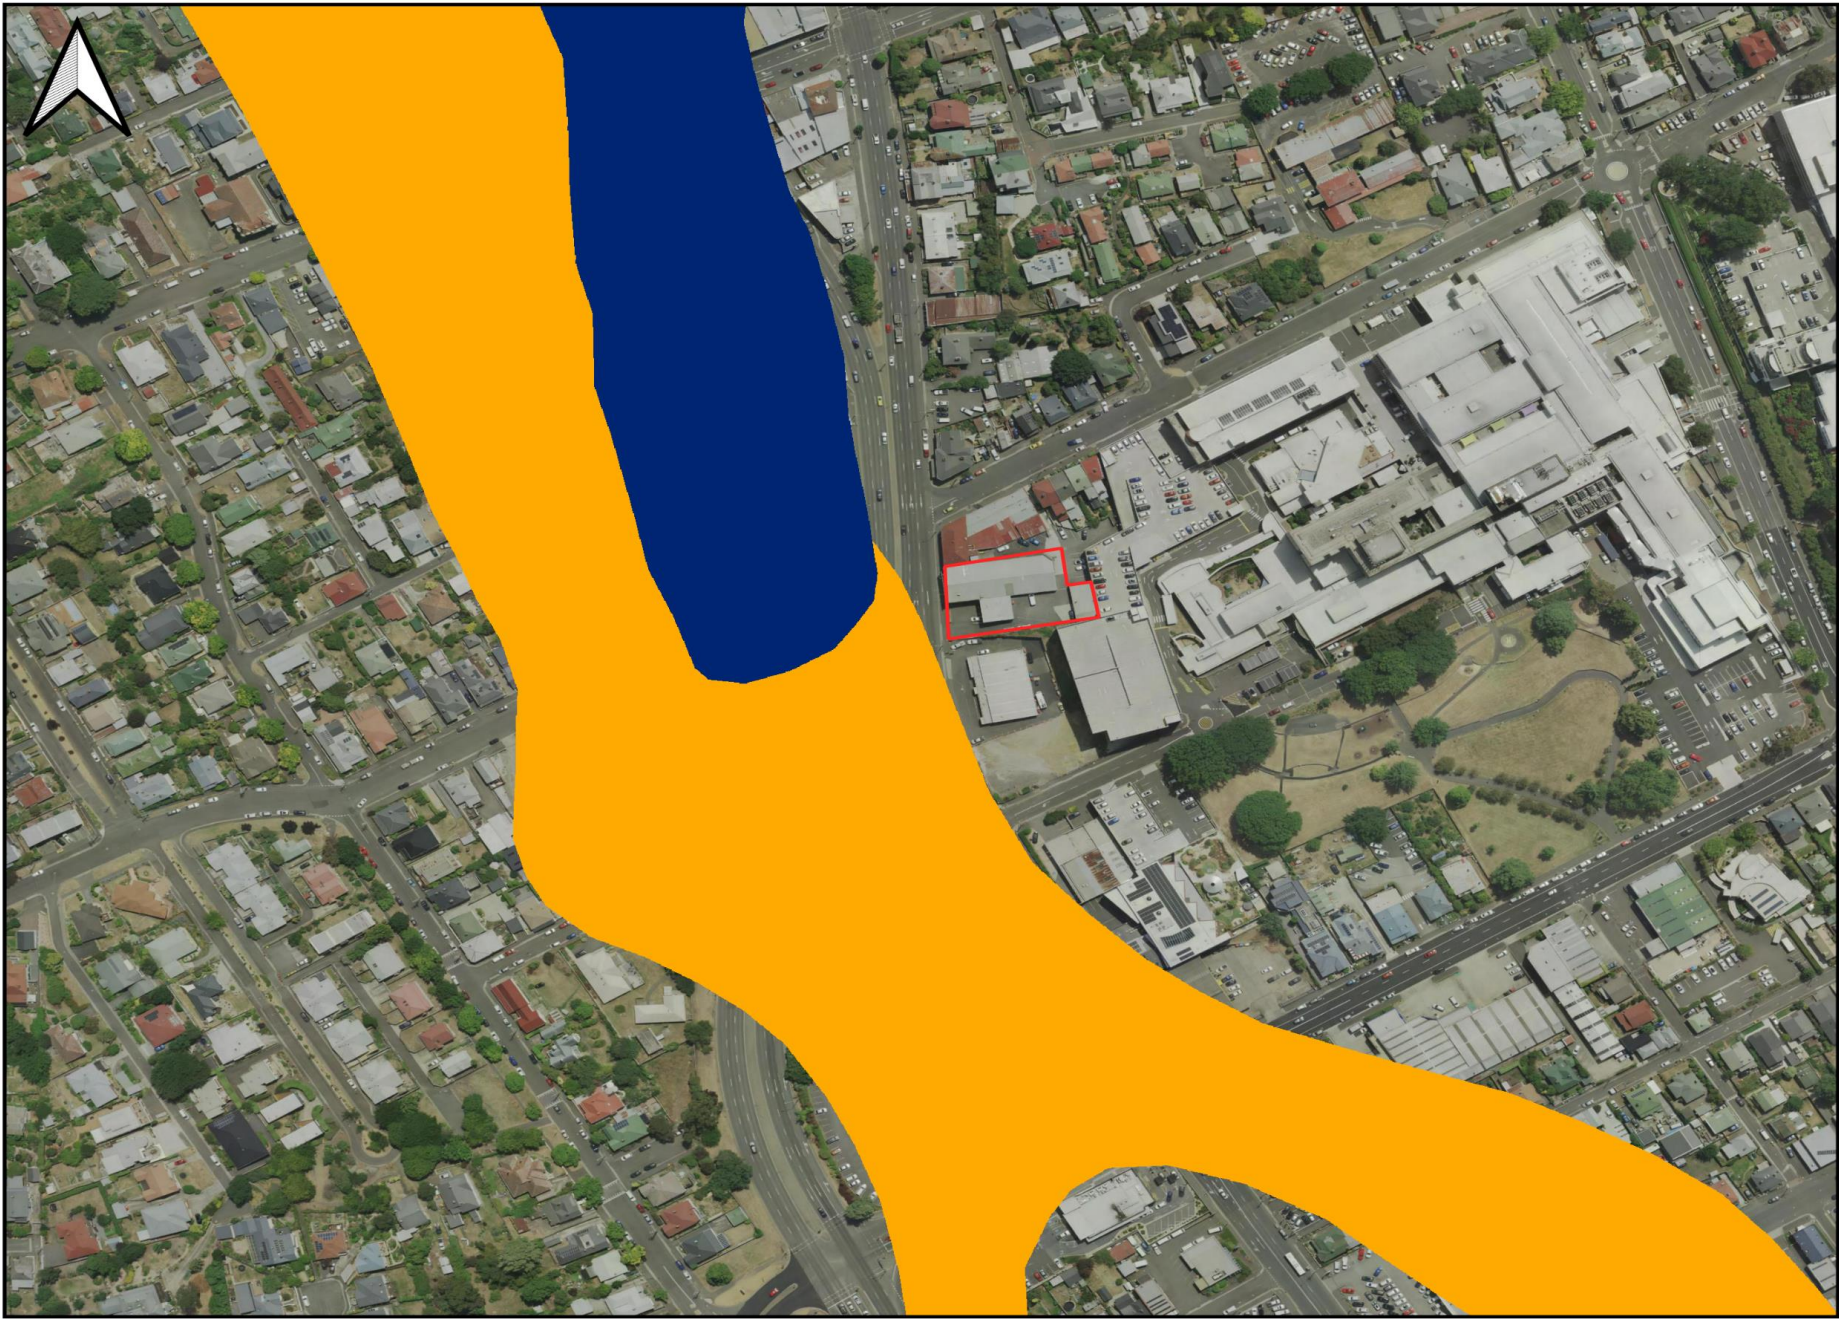
Figure 6: Coastal Acid Sulphate Soil

According to the LIST, there are no acid sulphate soils on the site.

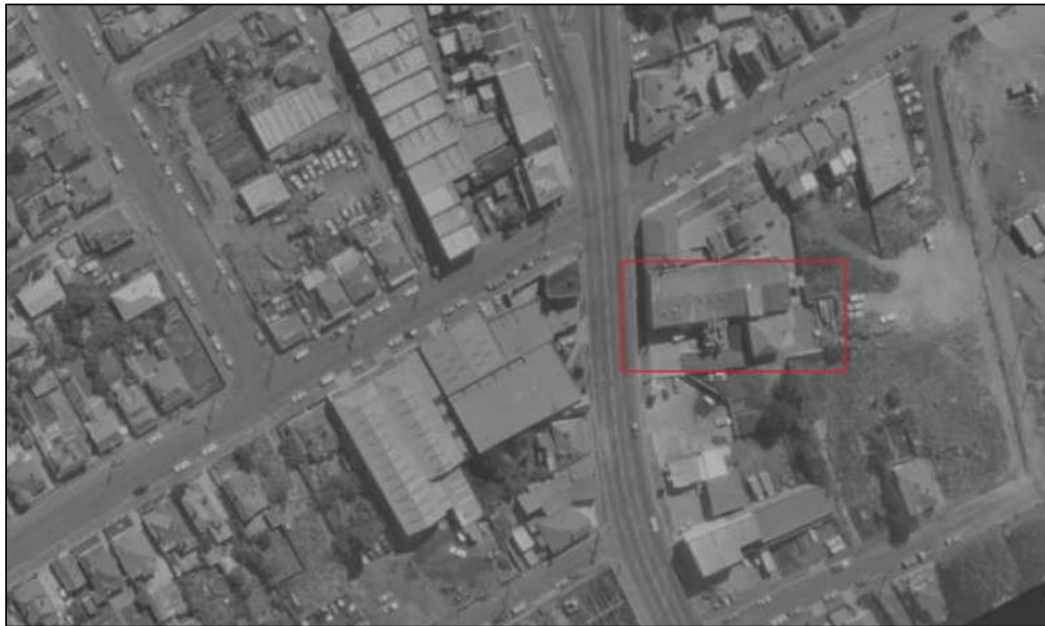
Figure 7: Aerial photo-1986

The site currently has a hospital operating. Aerial Photos Tasmania shows that the presence of the current structure did not have any major changes from 1986 (see Figure 7 and Figure 8).

The site has a similar structure from 1986 (see Figure 7, Figure 8) The present state is unlikely to cause environmental risk.

A review of historical aerial photographs was undertaken to identify any potentially contaminating land uses in the area. Aerial images are below. Aerial photographs were sourced back to 1986. However, it is likely that the property has been in the current configuration for more than 35 years.
