Landslip Hazard Assessment

Landslip Hazard Report for Proposed Rezoning and Planning Permit Application at Invermay

**GEOTECHNICAL INVESTIGATION
PROPOSED COMMERCIAL DEVELOPMENT
MONTAGU STREET, INVERMAY**

Document Reference: TG22172/1 - 01report

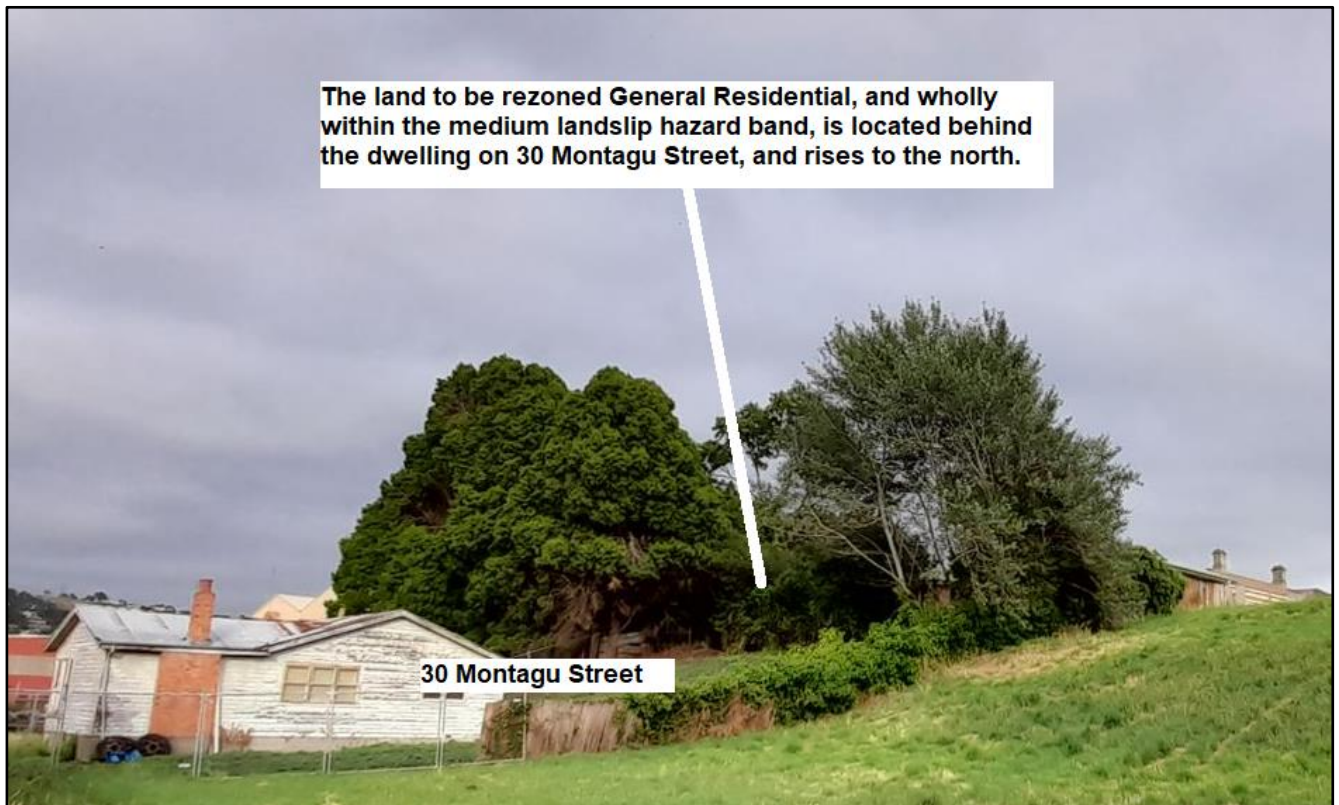
Image 4: Looking towards 30 Montagu Street from the rear of 14 Howard Street

As shown in Image 4 below, the land to be rezoned General Residential, and wholly within the medium landslip hazard band, is located behind the dwelling on 30 Montagu Street, and rises to the north.

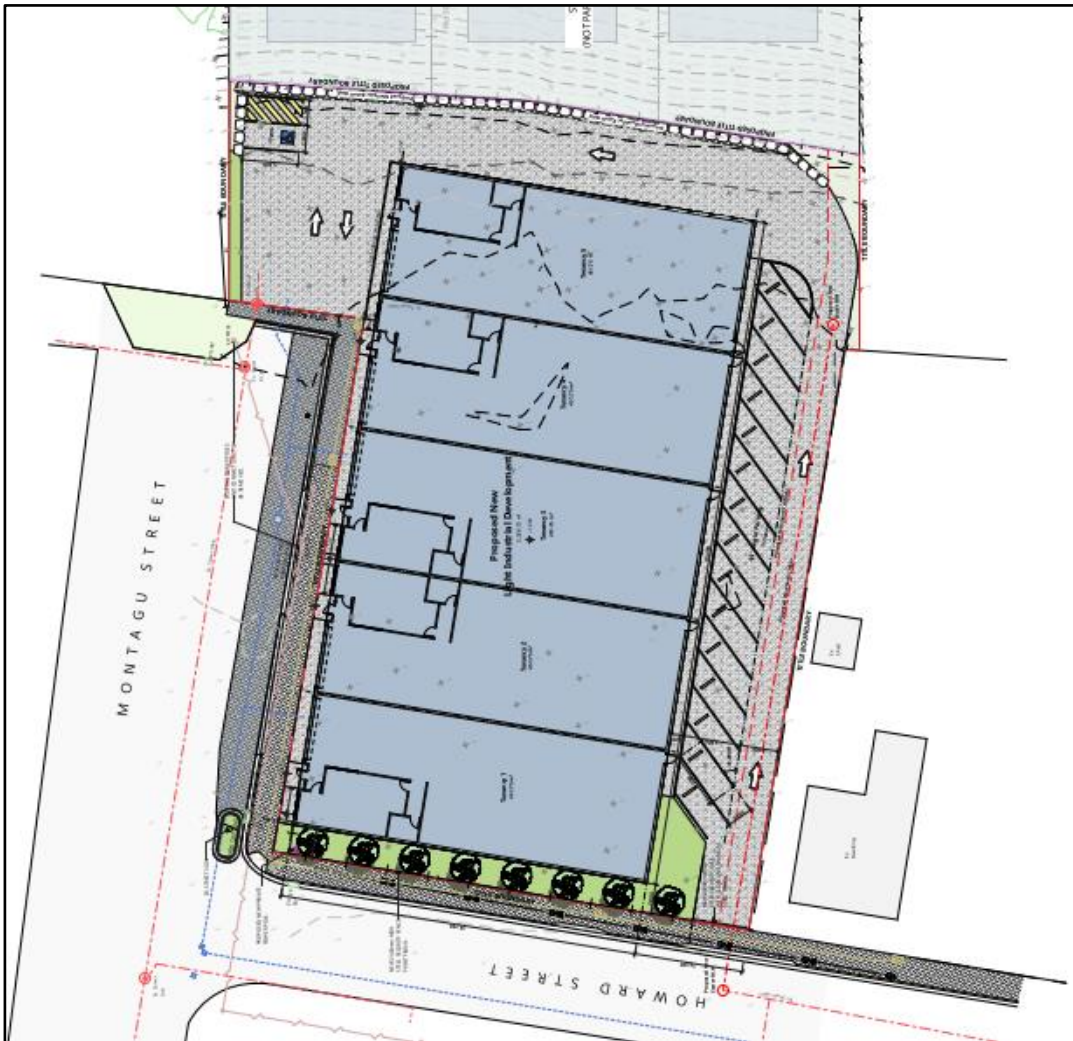
Image 5: Development area for the proposed Storage use

The proposed Storage use will occur in the proposed light industrial building's development area (building, access and parking areas), as shown in Image 5 below. Only the northern portion of the development area is in the low and medium landslip hazard bands.

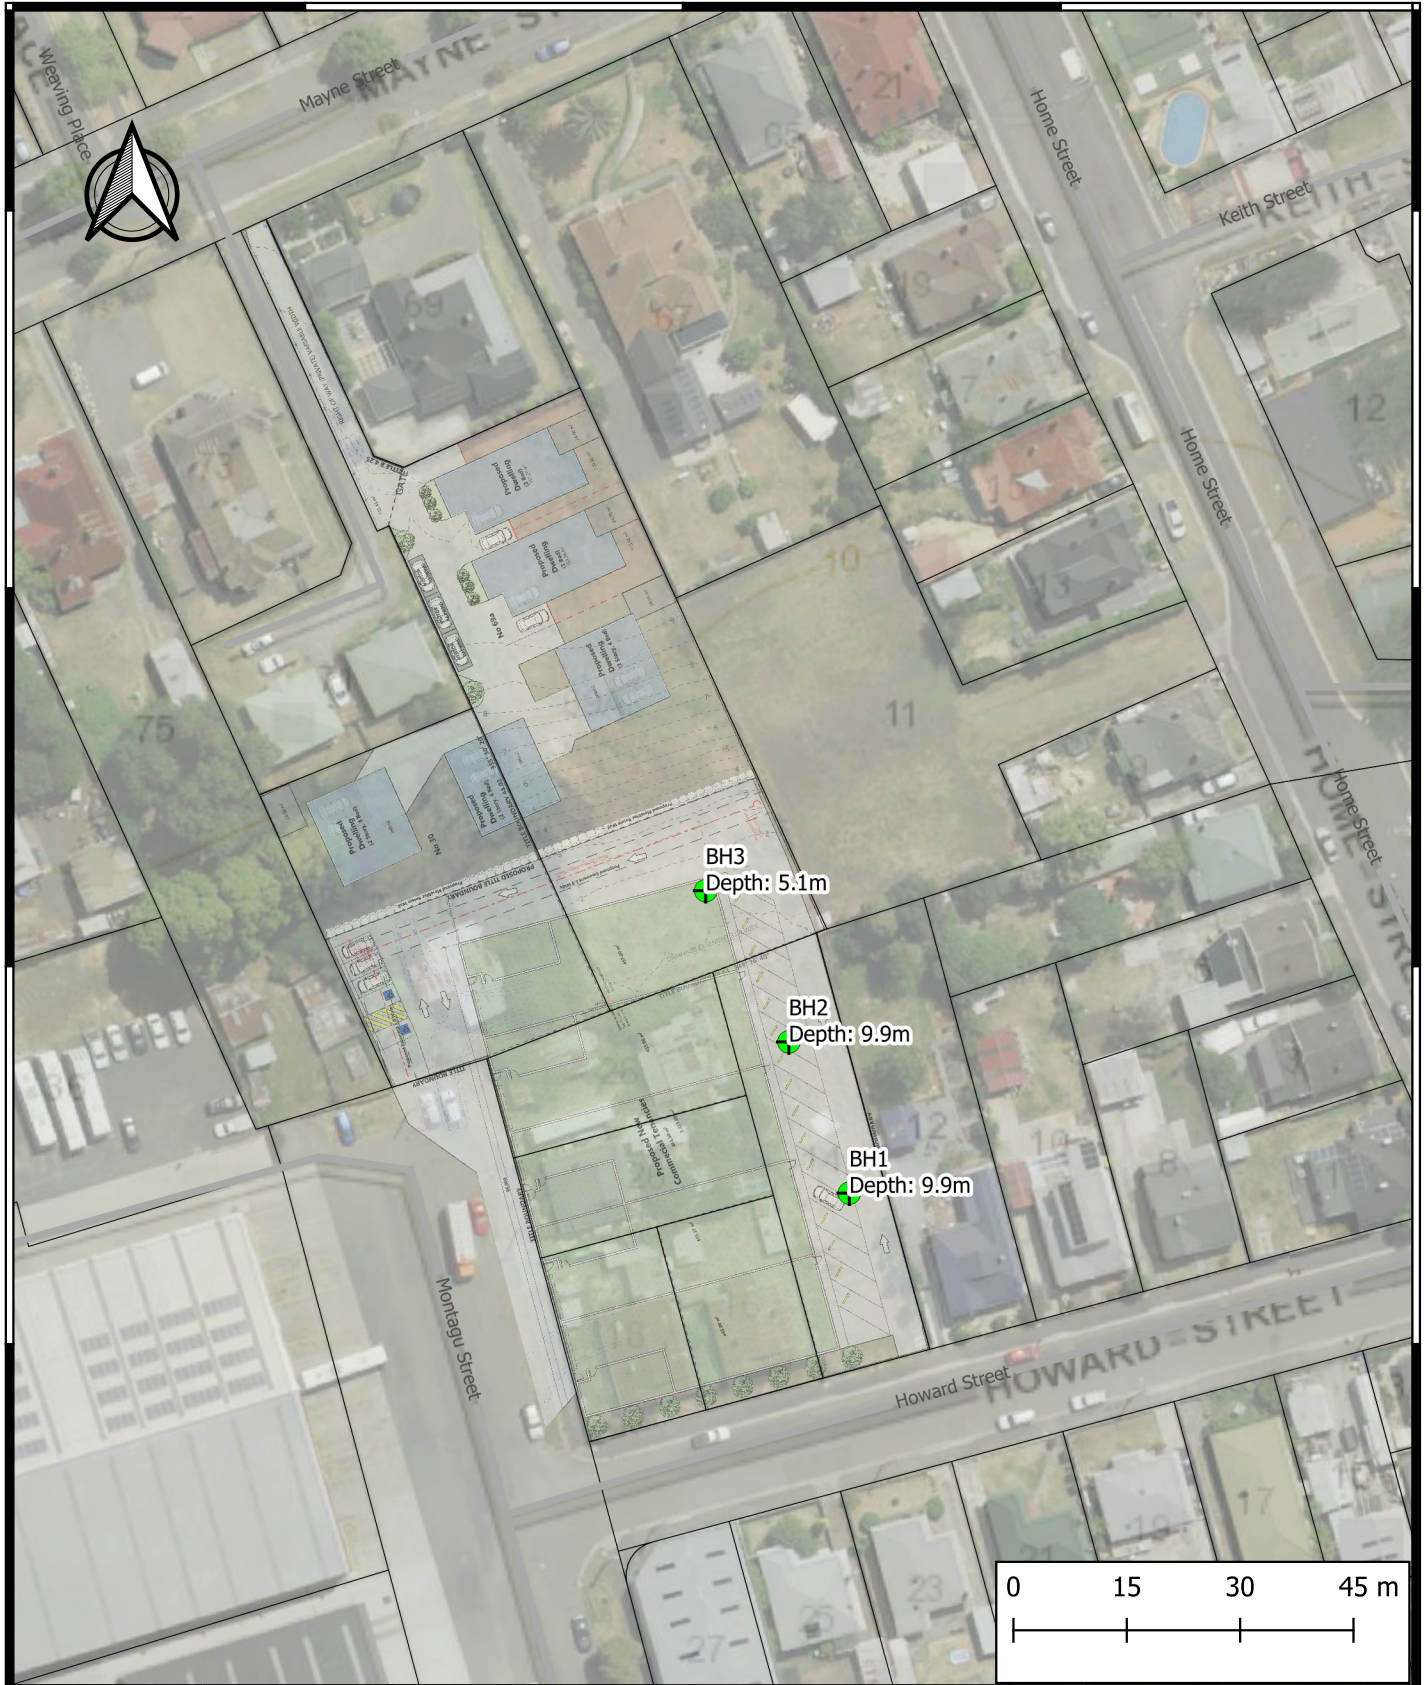
The engineering borehole logs are presented in Appendix A and the locations of the boreholes are shown on Figure 1. The tip resistance from the PANDA probe is shown in Appendix B.
