Council Agenda - Agenda Item 8.2
Attachment 2 - Plans to be Endorsed - 341-349 Hobart Road, Youngtown

SERVICES & EASEMENTS PLAN

Preliminary Site Investigation

341-349 Hobart
Road Youngtown
7249

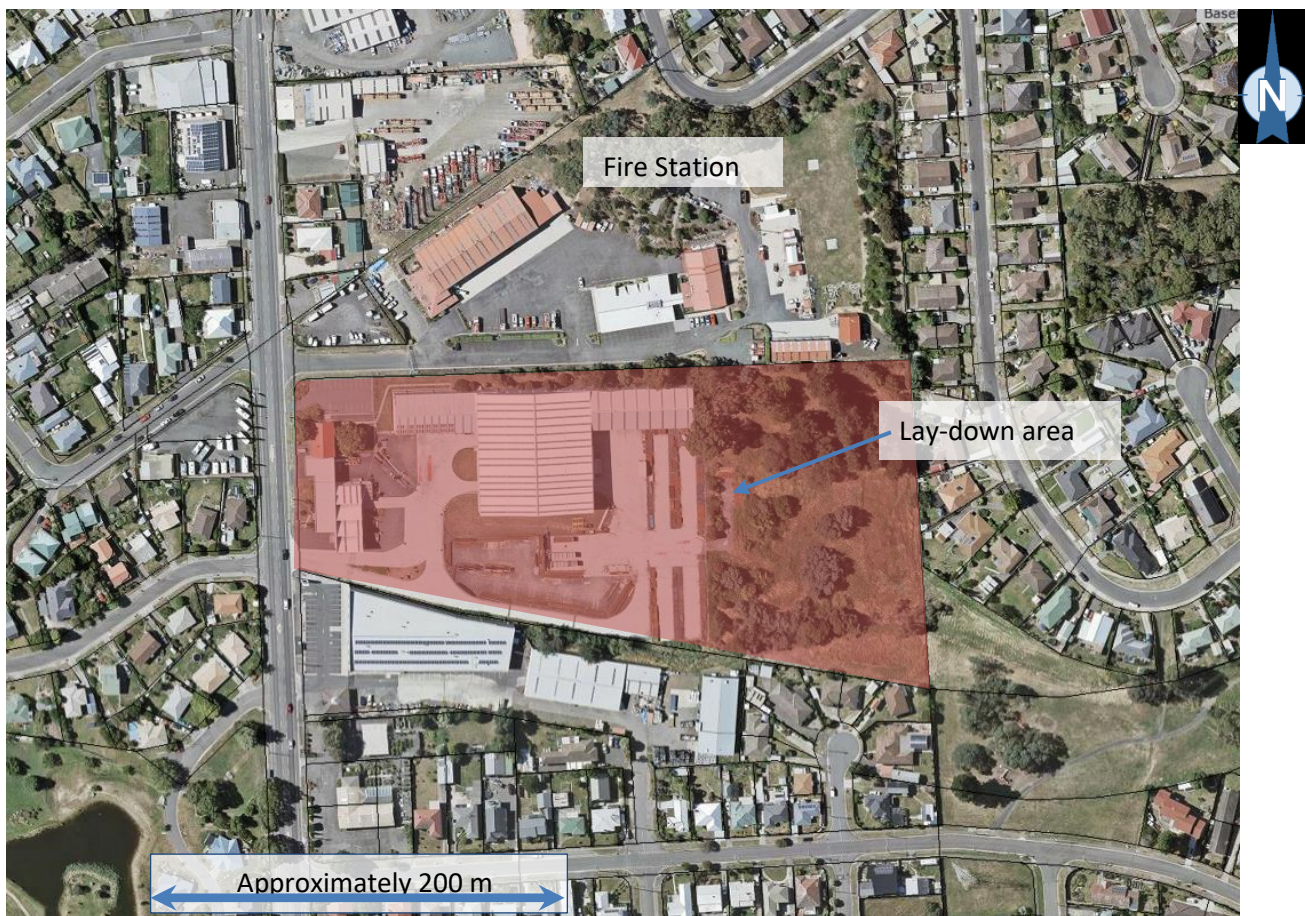
Figure 1: Site Plan (Site in red shade)

The property at 341-349 Hobart Road Youngtown (the site; Figure 1) is owned by Sandhurst Trustees Limited. The site is surrounded by residential dwellings to the east, west and south and a fire station is located immediately to the north. There is a commercial building to the south of the property and a caravan sales depot on the opposite side of Hobart Road.

No major site works are planned at this stage, and the site will continue to operate as a single business; however, some land was cleared for a lay-down area on Lot 1 (location of lay-down area shown on Figure 1). The hardstand will be reinforced with suitable materials and it will be landscaped to meet engineering standards. This PSI is relevant to this scope of work, which will result in no significant change to land use.

The Youngtown fire station is located adjacent to the site at 339 Hobart Road, Youngtown (Figure 1). The Tasmanian Fire Service used perchlorinated compounds (PFASs) in their fire-fighting foams. PFASs “are emerging as contaminants of global concern because they do not break down naturally (environmentally persistent), have the ability to bioaccumulate, and are potentially toxic” (EPA, 2018 - <http://epa.tas.gov.au/regulation/contaminated-sites/identification-and-assessment-of-contaminated-land/contaminated-land-issues/pfas-contamination>).

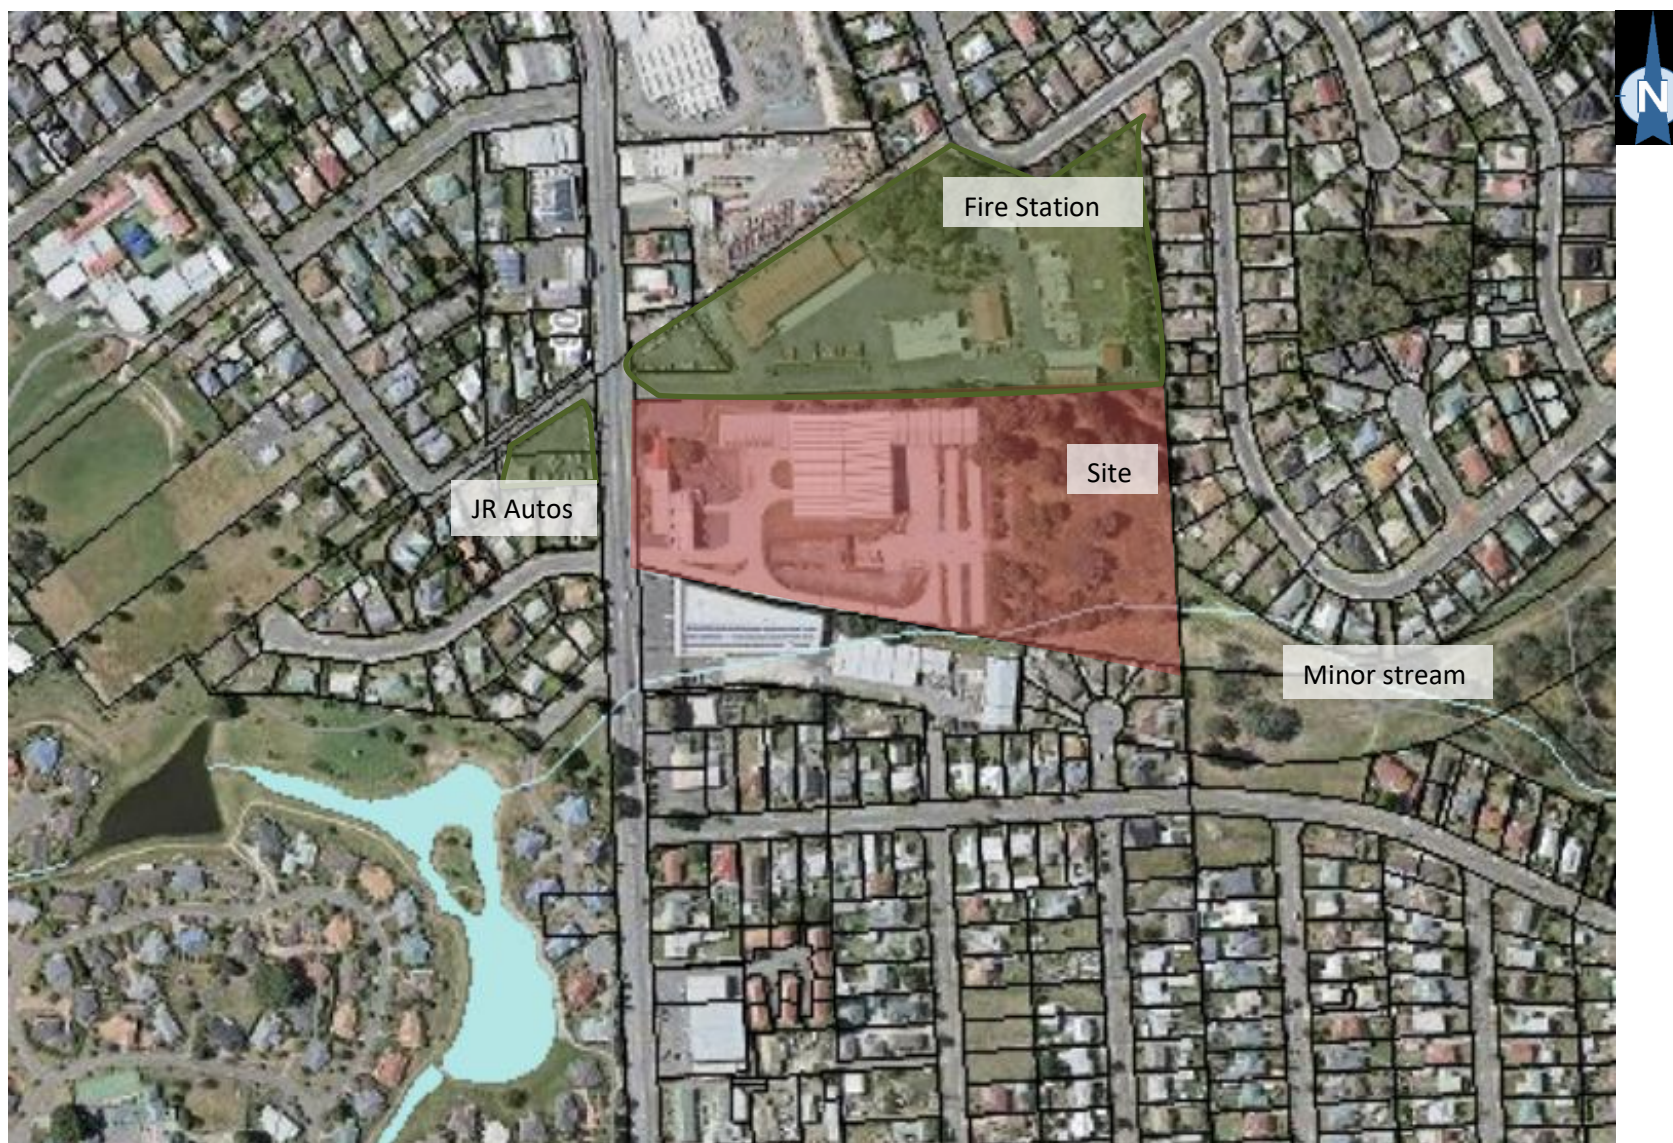
Figure 5: Location of the site in relation to nearby potential contamination sources

pers. Comm., 5 June). The Youngtown fire station borders the site to the north and there are residential properties to the east and west. There is a commercial property to the south of the property that is owned by City Mission. JR Autos are located on the opposite side of Hobart Road, to the west of the site.

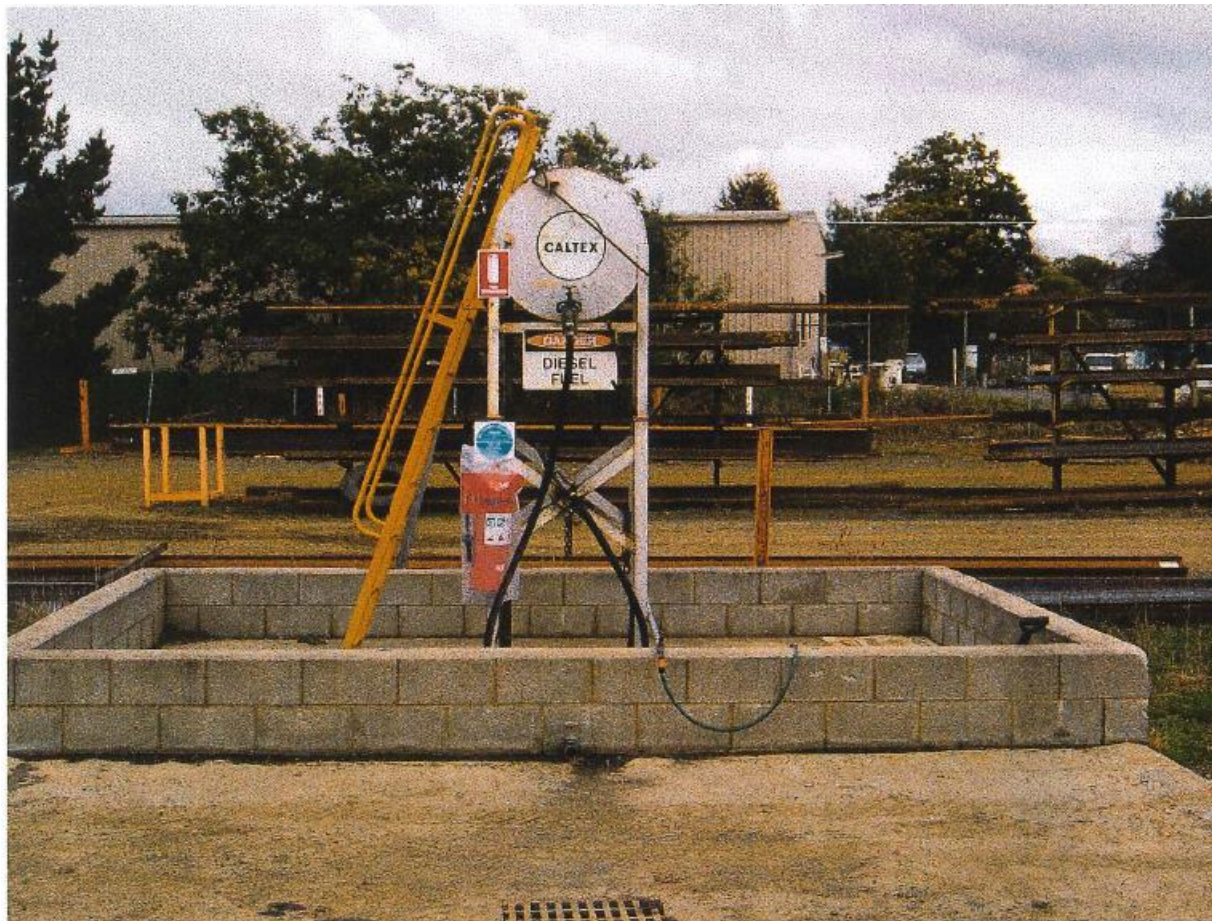
Figure 6: Photograph of the above ground storage tank in 1986 (c/o WorkSafe Tasmania, issued 29/6/2018). Site visit evidence and interview on site suggest the tank may not have been moved from the original position. (Site Manager, 2018, pers. Comm., 5 June)

Documentation from 2004 shows that there was an above ground, 600 litre capacity diesel tank on-site at this time (refer to photograph on Figure 6). The plans from 2004 (Figure 7) show that the above ground tank was located near the centre of the site, in an area that is now concreted. The plans also show that a new diesel tank was proposed for the area adjacent to the boundary between Lot 1 and Lot 2.

Existing above ground diesel storage 600 litres

The Worksafe search also identified a proposed new location for the diesel tank, although there was no documentation of the construction of the proposed new diesel tank, and on-site personnel did not mention it during the site visit. It should be noted that no dangerous goods license was required for the development of the proposed new diesel tank, so the WorkSafe records would not necessarily include the relevant documentation. No other potential contamination sources were identified on-site. Although potential contaminants are bought on site, it is not in a form that can cause risk or impact the environment, work standards and OH&S practices are conducted at a high level on the site, reducing risk of impact.

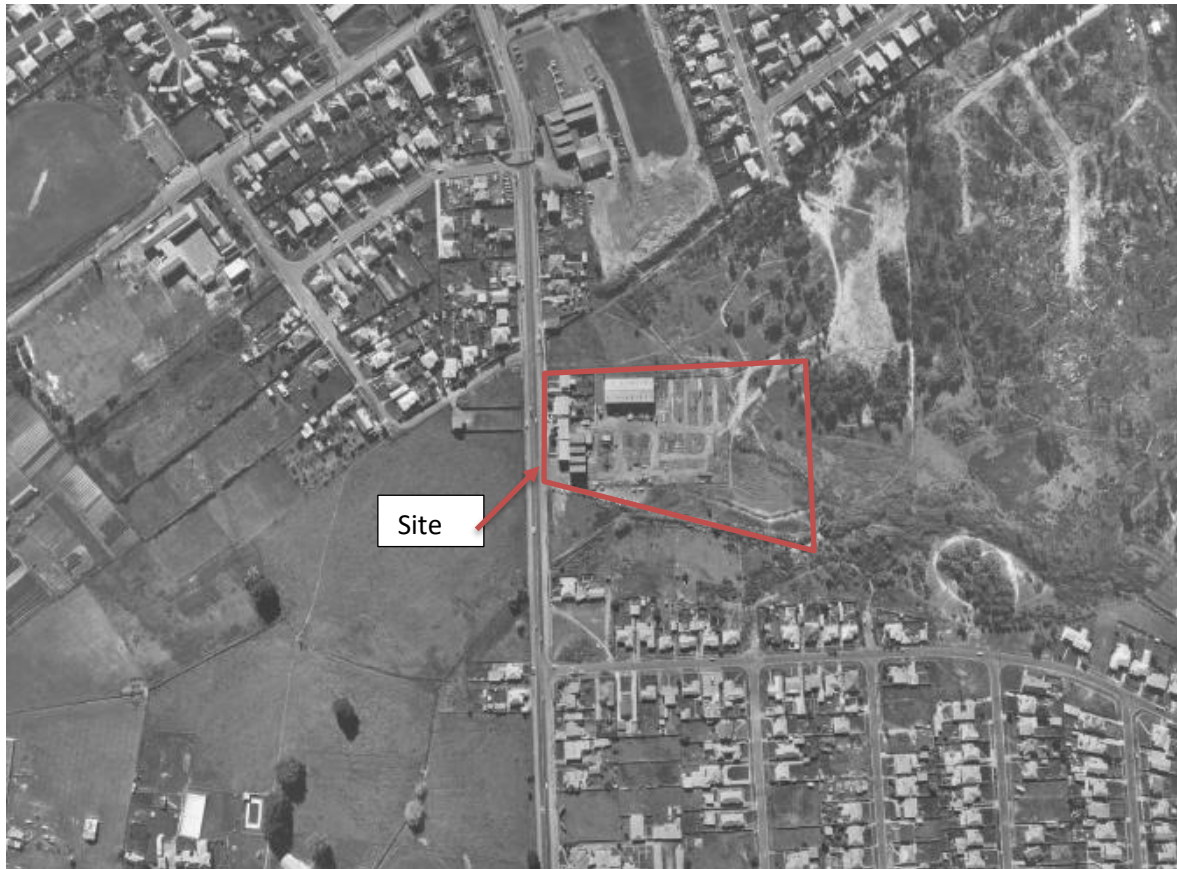
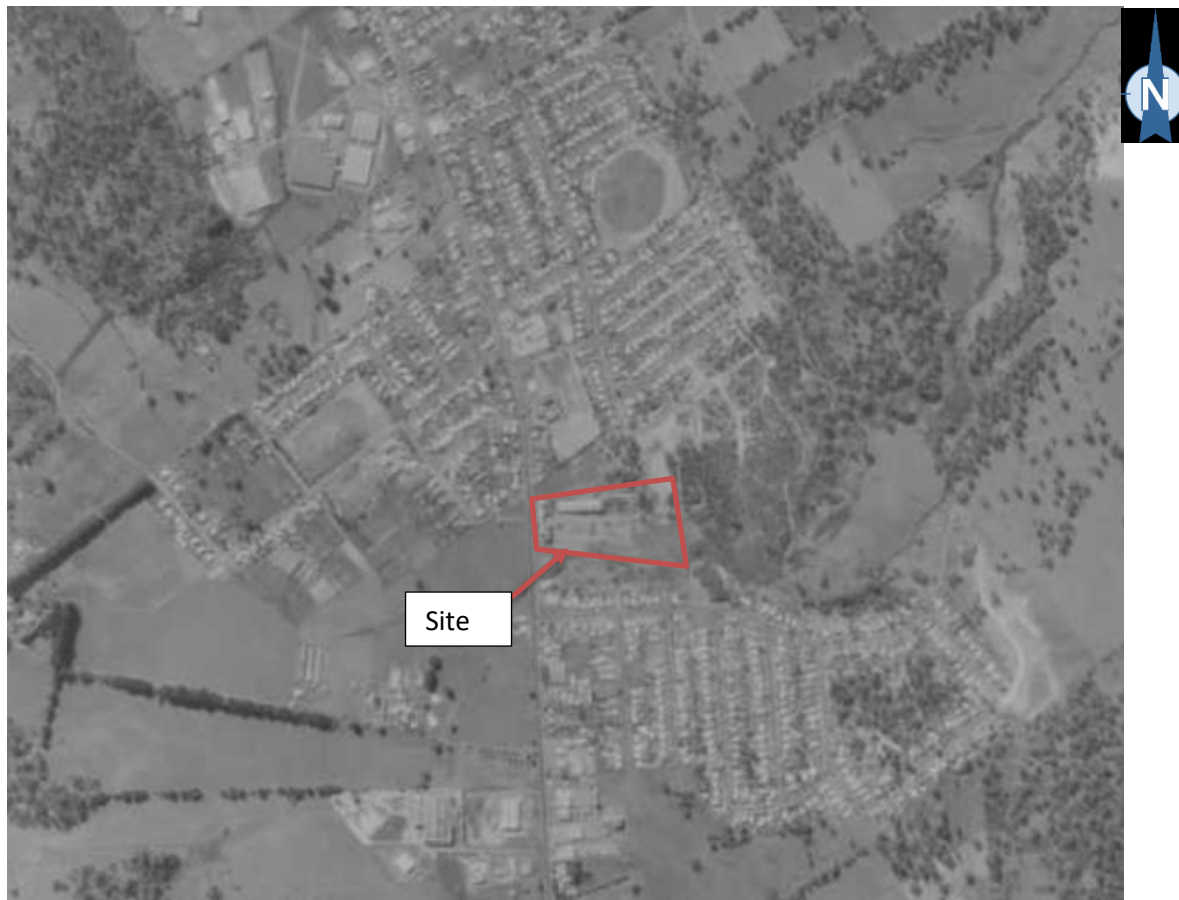
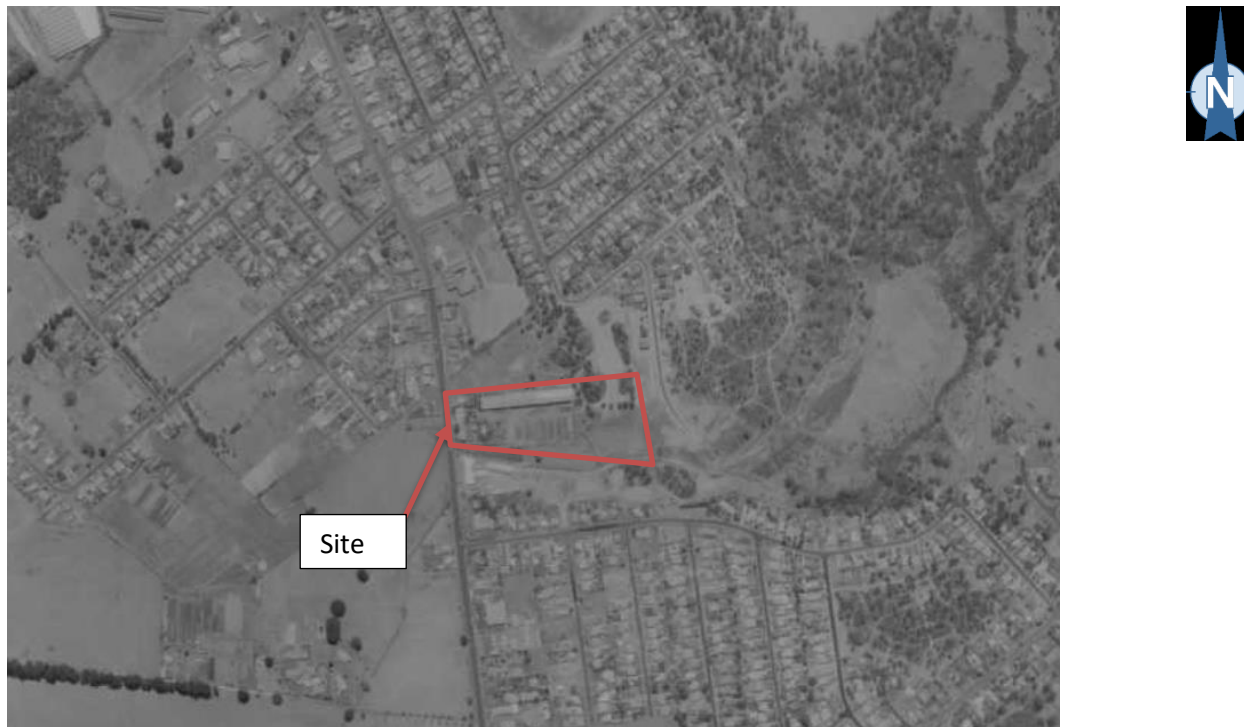
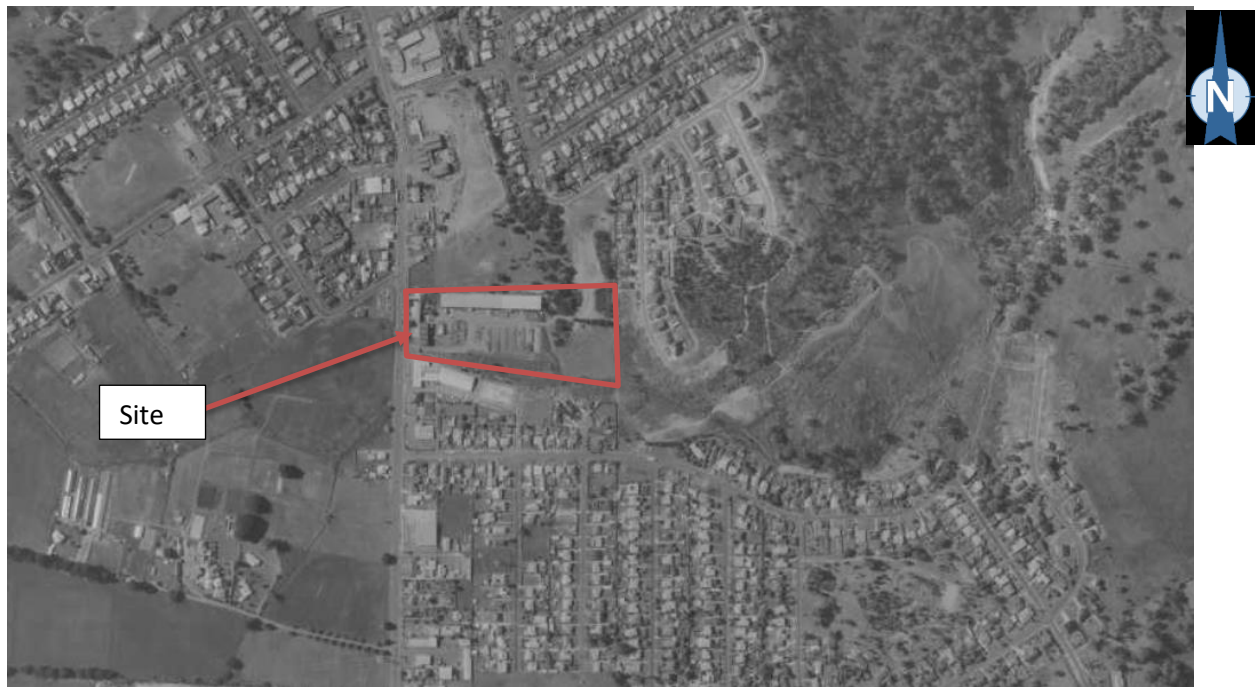
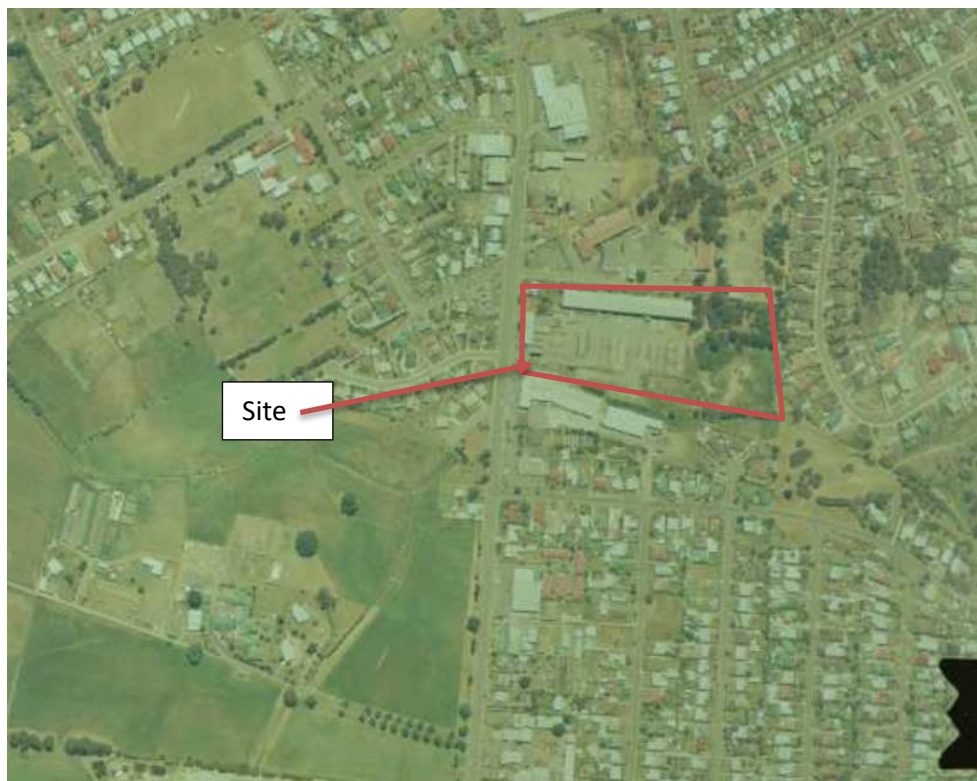
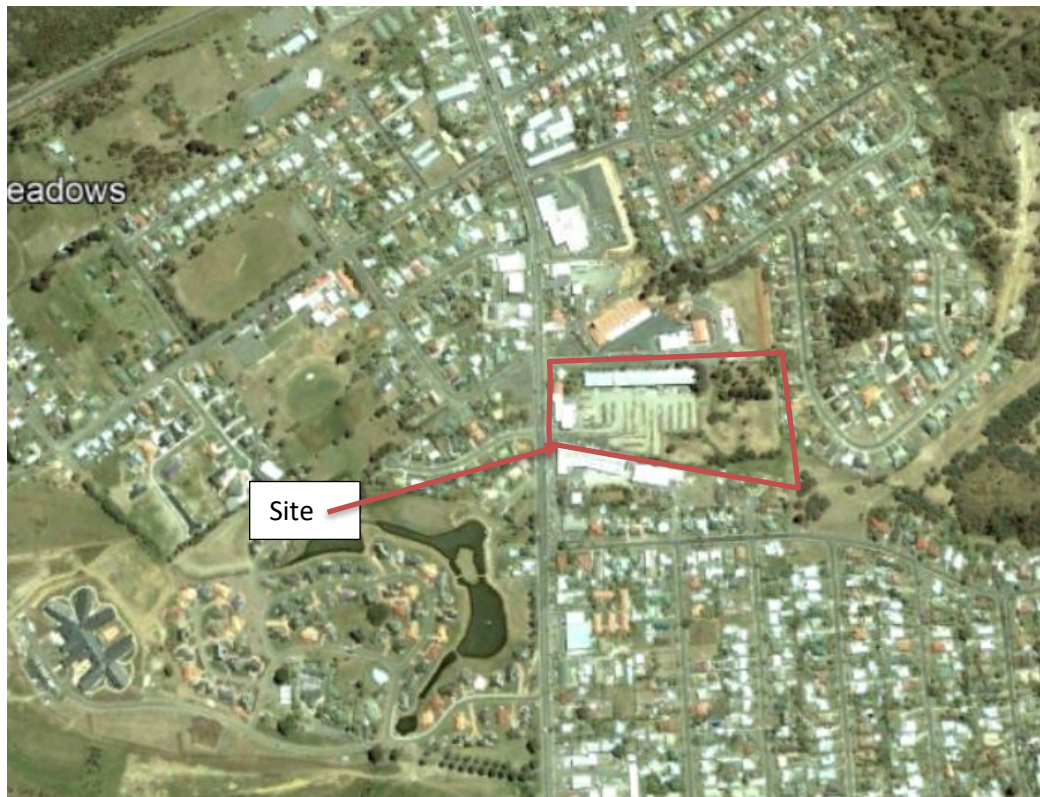
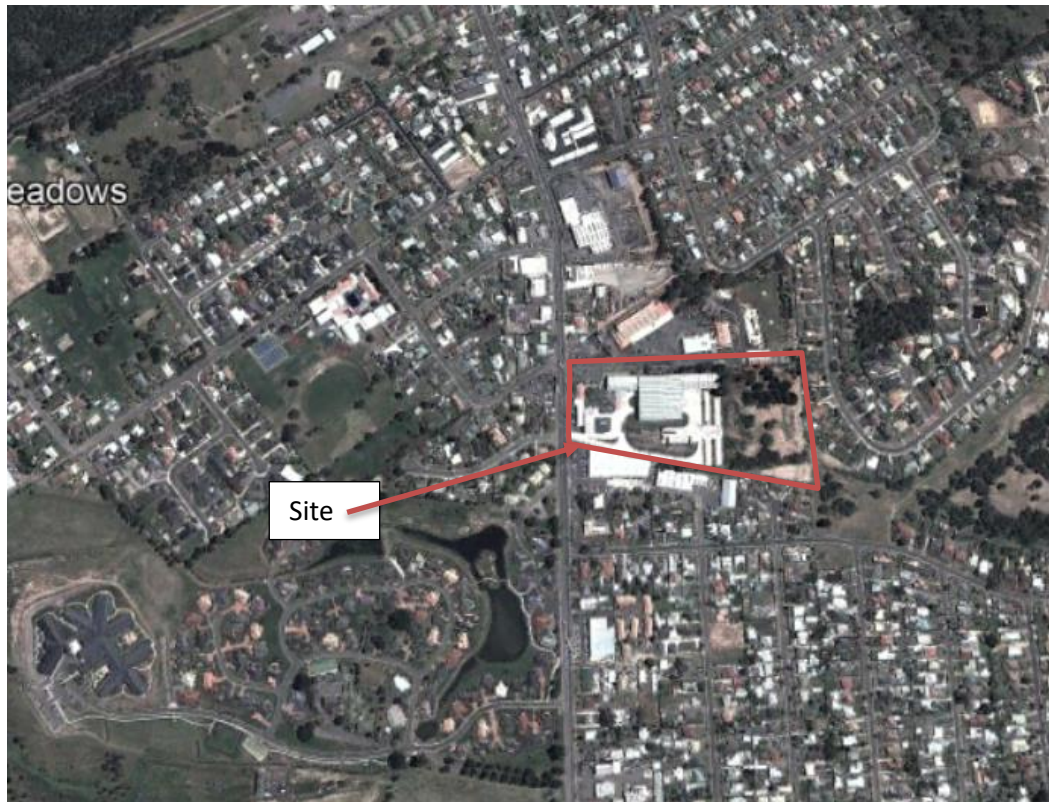
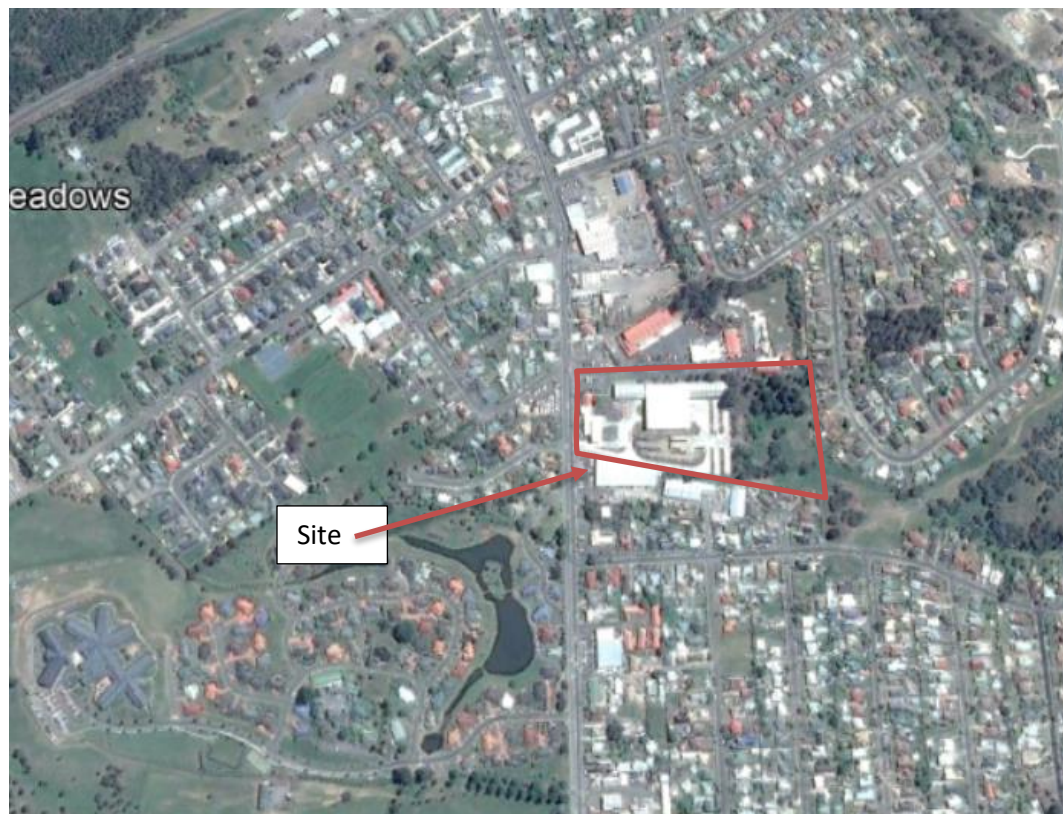
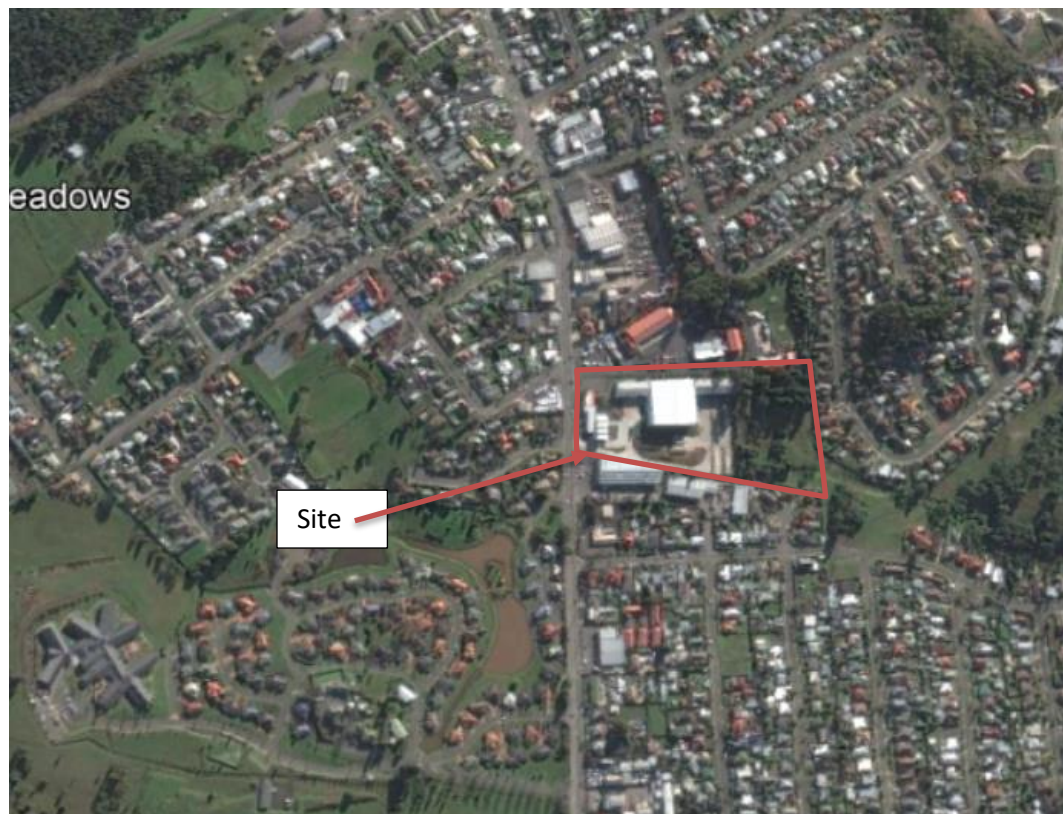
A review of historical aerial photographs available on the LIST and Google Earth was undertaken to identify any historical potentially contaminating land uses in the area. Photographs from 1974, 1978, 1983, 1986, 1997 (the LIST), 2004, 2011, 2015 and 2016 (Google Earth) are shown in Figures 5-13 below. Most site activities appear to have been conducted on the area that is proposed as Lot 2, closer to Hobart Road.

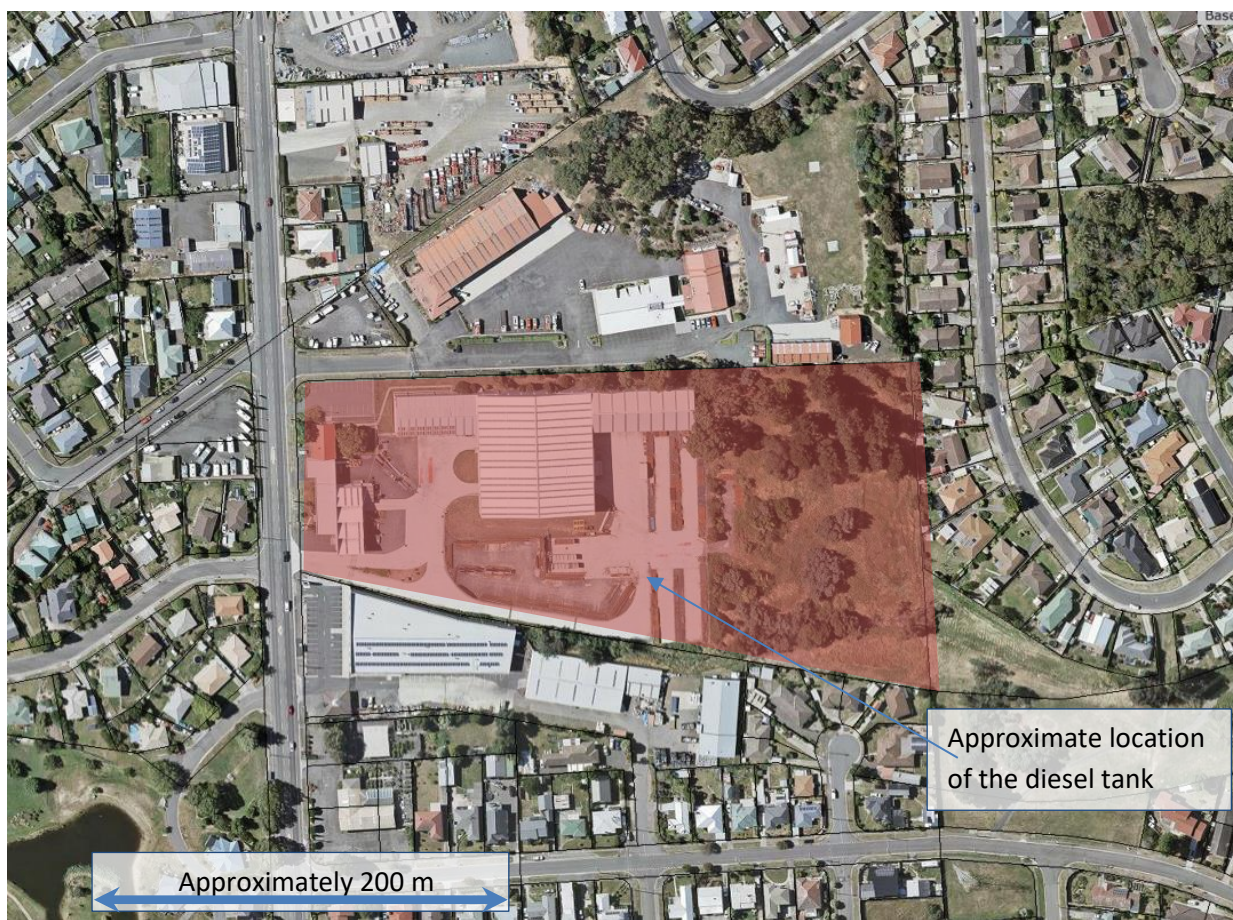
Figure 17: Site Plan (Site in red shade)

The site visit outlined no potential contamination sources on the site. However, on-site personnel mentioned that a petroleum storage system was removed from the site around 30 years ago (location shown on Figure 17). This location corresponds with the location of the 600 L diesel tank that was on-site in 2004, as identified in WorkSafe records (Figure 7). It is worth noting that the diesel tank is contained in a bunded area and the risk of significant soil and/or groundwater contamination is low.

The groundwater flow direction has not been investigated, but it is likely towards the south / southeast / east following the topography. If this is the case, groundwater near the southwest of Lot 1 could potentially contain hydrocarbons from the diesel tank that existed in 2004 or the proposed new diesel tank (if it was constructed). No significant excavation is proposed for the current development and it is unlikely to intercept groundwater, so the risk to workers and the environment is low and **above all** there is no increased risk to workers due to the development. However, dermal and eye protection should be worn whilst conducting earthworks at the site as normal OH&S practice would require. We also recommend maintenance of the capping layer in the laydown area.

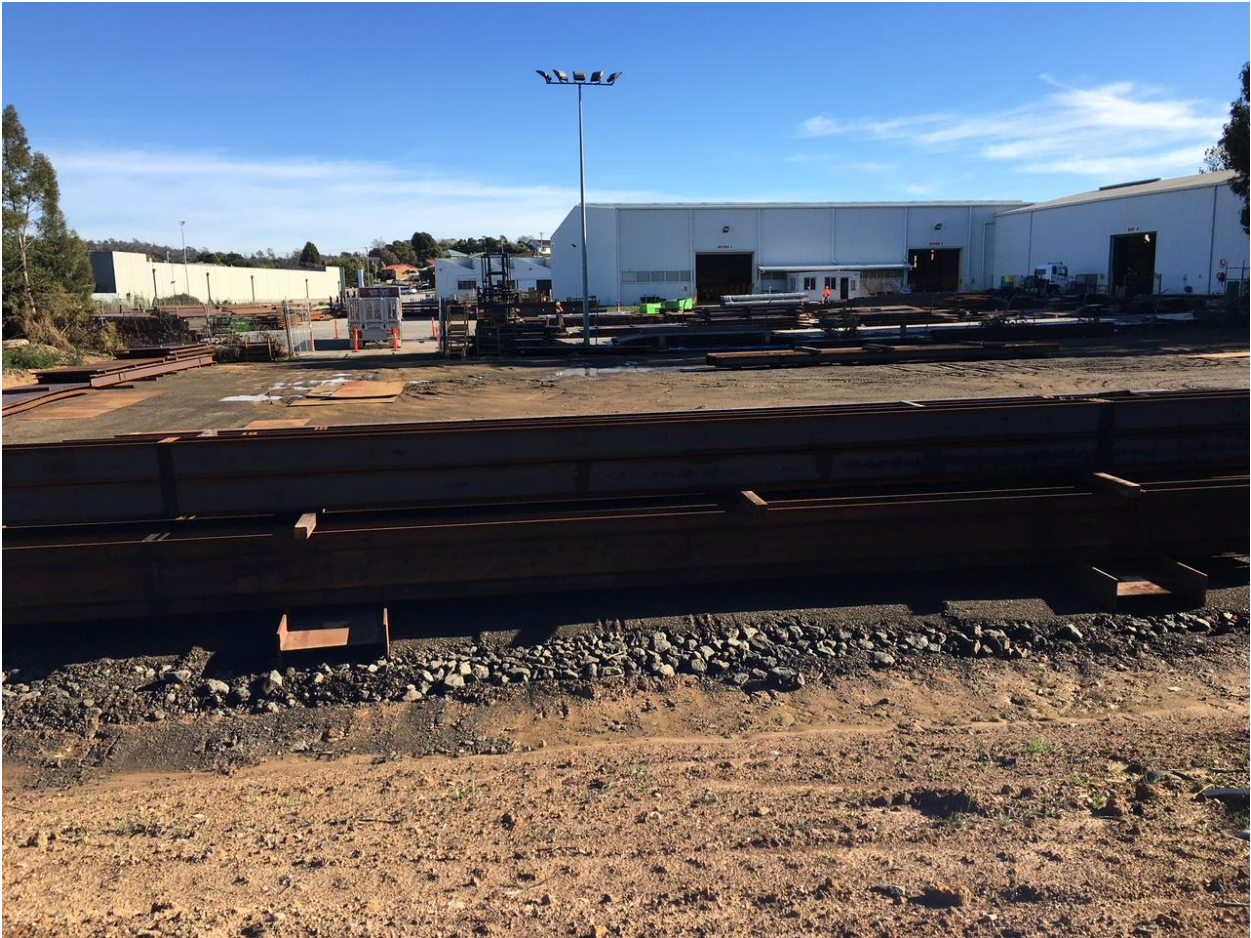
Figure 18: Lay-down area on Lot 1 with the workshop of Lot 2 in the background – looking west towards Hobart Road

ES&D representatives visited the site on the 5th of June 2018 to investigate potential sources of contamination in the proposed development area. There was no visible evidence of contamination at 341-349 Hobart Road, Youngtown 7249 (Figure 18 to Figure 20). Nearby properties were also investigated for the potential of offsite sources contaminating the property.
