Trees and redevelopment at Civic Square, Launceston.

Impact of proposed improvements.

Jerry Romanski
Arborist / Consultant
B.Sc (Hons), Ass. Dip. App. Sc. (Hort/Arb)

29 Winston Ave
SEVEN MILE BEACH TAS. 7170
m: 0419 363 011
e: arborist@jerryromanski.com
25/10/2016

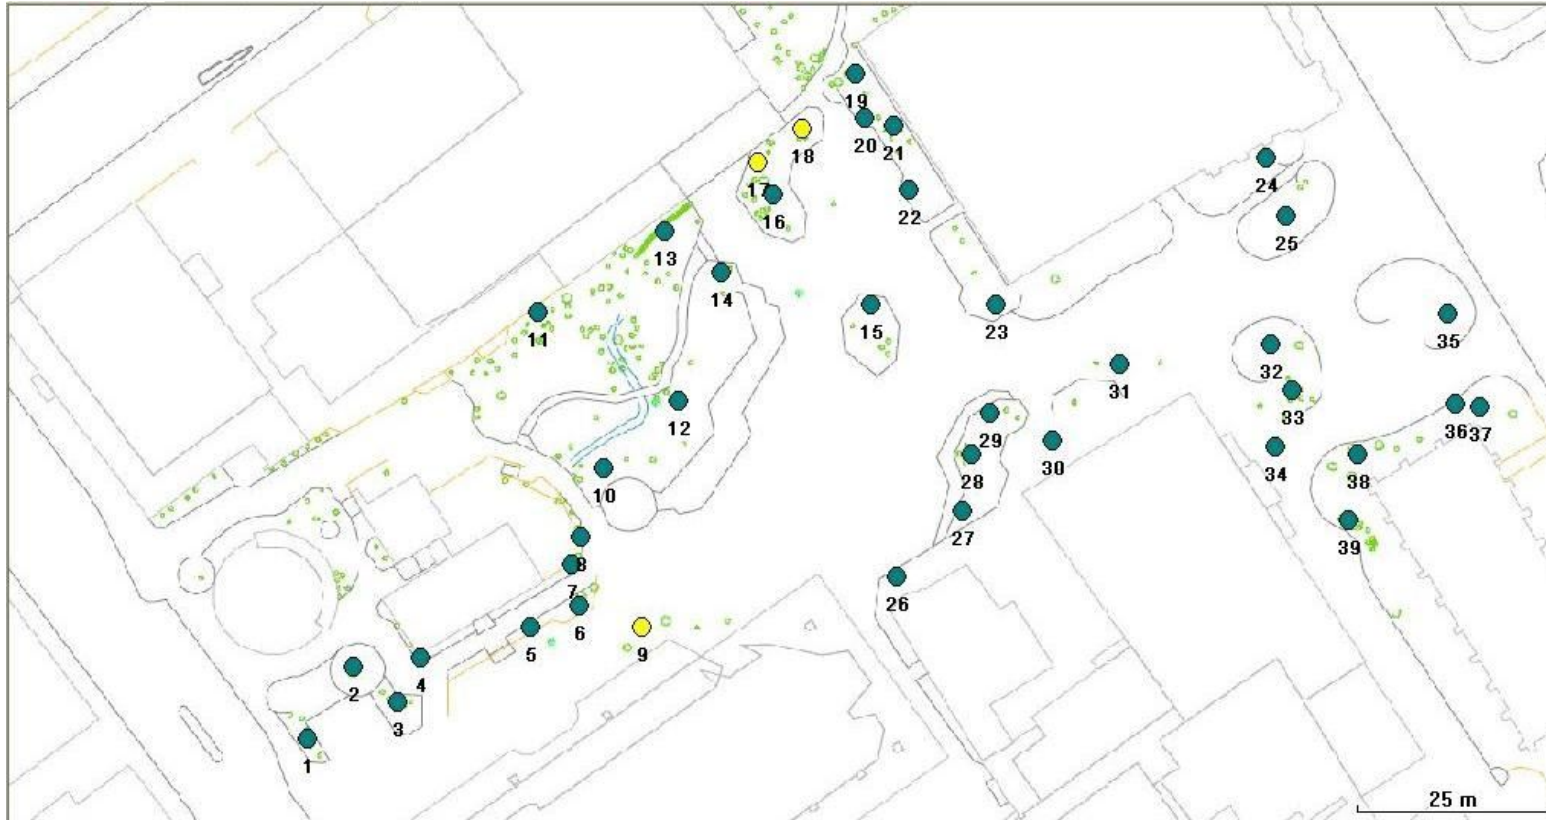
Tree Map

Plan of the Civic Square (LCC) marked with approximate location of the inspected trees.

- - Trees with a broadly acceptable risk of serious injury (>1 in 1 million)
- - Trees with a tolerable risk of serious injury (1 in 10,000 – 1 million, see Defects column in tree data tables below for individual assessment).

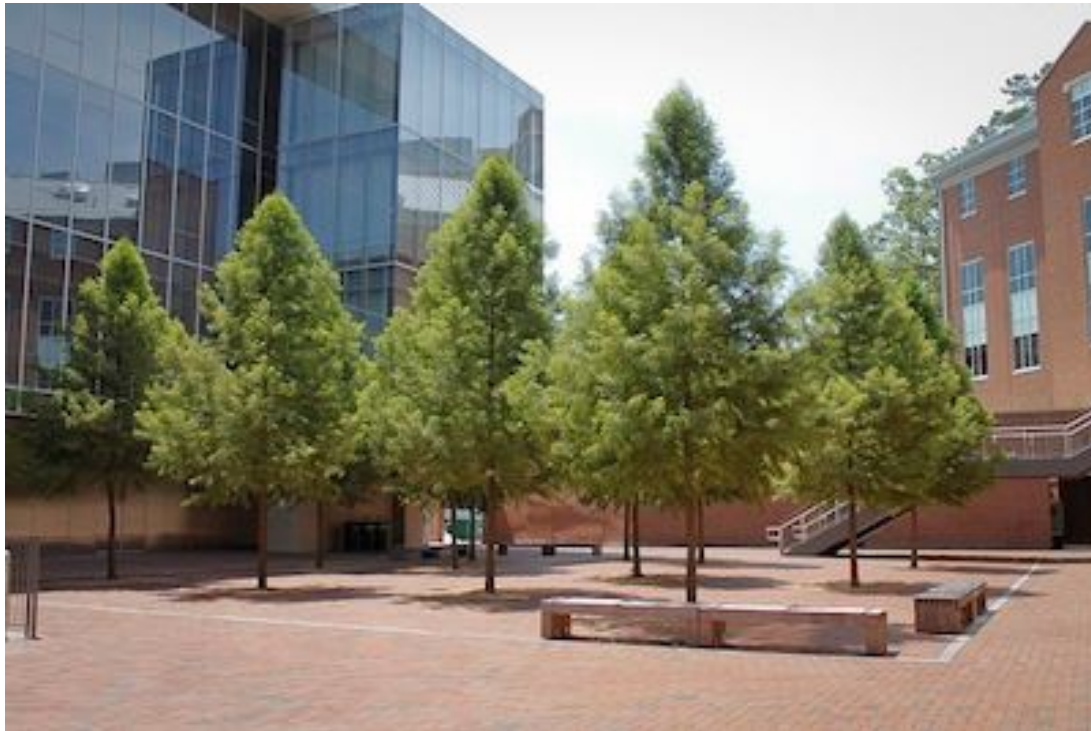
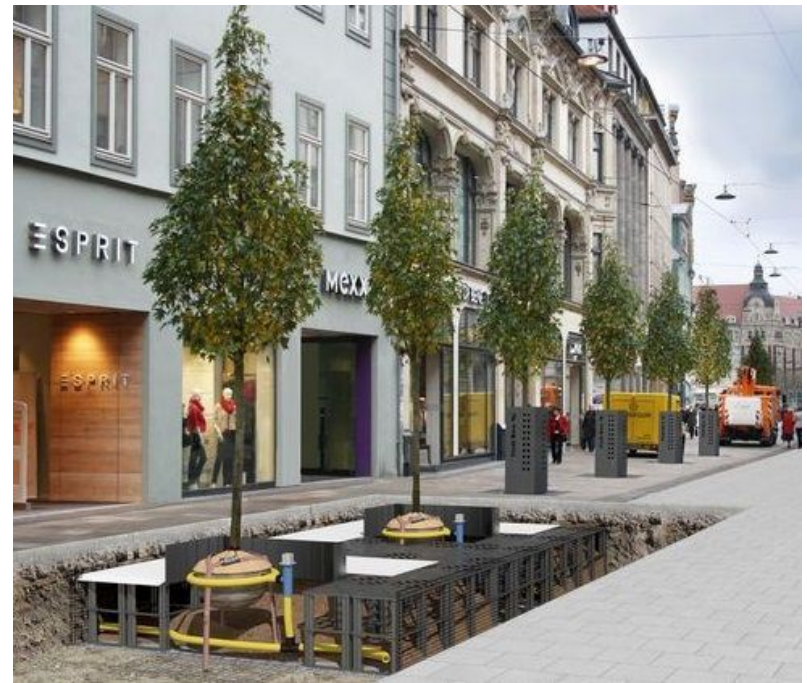
ID	SPECIES	TREES	HGT	DBH	H/S	DEFECTS	COMMENTS	LIFE	RET	WORKS
9	Corymbia maculata	3	20-24	45	G/G	Poor root structure; QTRA 1/300,000	Trees have been planted in concrete pipes. A large proportion of the roots are confined within the pipes, increasing the potential for wind throw.	10-25	N	Tree removal and replacement with new specimens planted in a medium supported by structural cells.

The gums could be replaced with new spotted gums (*Corymbia maculata*), dawn redwood (*Metasequoia glyptostroboides*) - a deciduous conifer - or beech trees (*Fagus sylvatica*) available in a range of cultivars with varying forms and leaf colours.
