Re: 9 Rose Lane, Launceston South

Landslide Risk Assessment

Geotechnical Site Review

Report No: 7390A

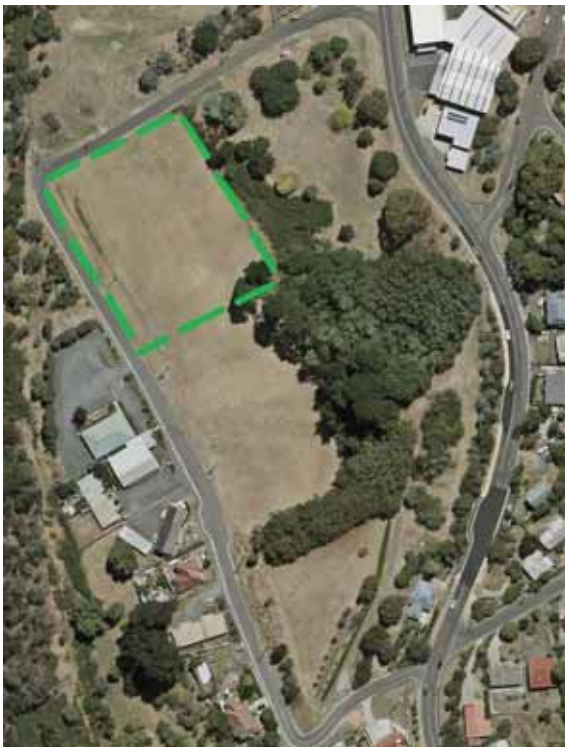
FIGURE 1 - PLAN VIEW OF DEVELOPMENT SITE

9 Rose Lane, Launceston South (Glen Dhu). JMC are proposing to construct 30 residential units on the site which is located at the north west corner on a large tract of west sloping vacant land that has reported landside issues. The location of the lots of land (green dashed rectangle) and nearby slopes are shown below:

The purpose of this review is to determine the level of risk to future development (landslide and stability) at the toe of the slopes.
