DRAWING INDEX DA000

Development Application Set : 02-06-2017

1625 Mah Residence
 76 Junction Street,
 Newstead
 Tasmania 7250

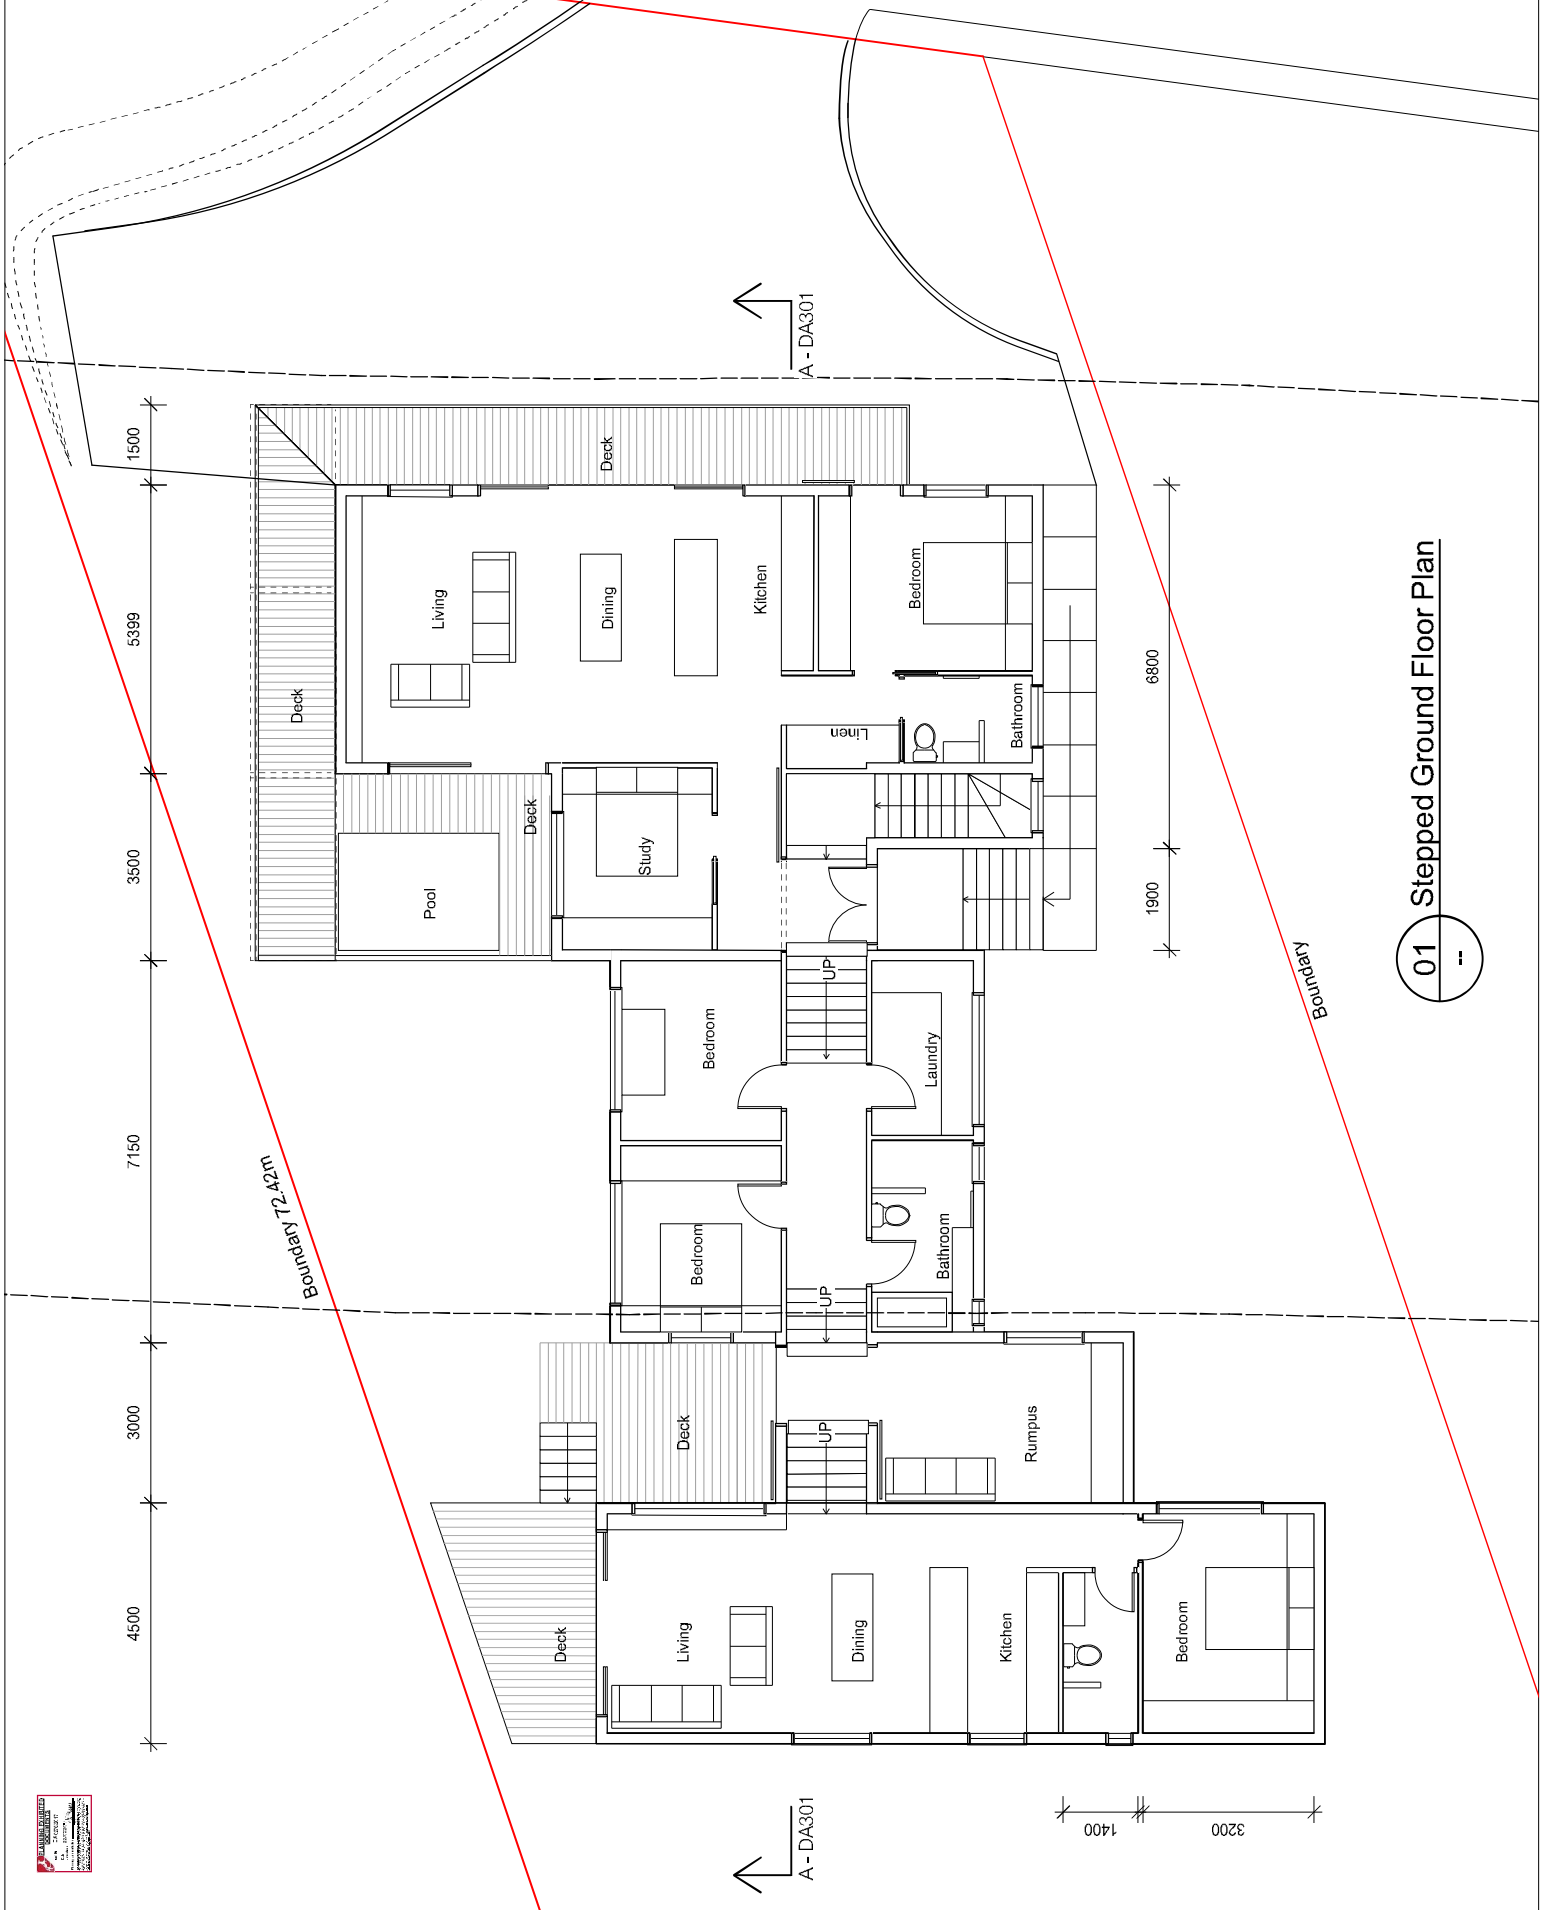
01 Stepped Ground Floor Plan

- SC Scyon Axon cladding - smooth 133mm vertical - paint finish colour to be selected
- GL Double glazed window - aluminium frame
- FC Fibre cement sheet - paint finish colour to be selected
- TD Timber decking
- GB Glass balustrade @ 1000H
