dale@douglasdesignanddrafting.com		Revision Rev A 28/09/2018	Project Address Client	Proposed Unit Development Lot 43, No.10, Cartiere Place, Newstead TAS 7250, SRK Developments Pty Ltd	Scale Date Issue	1:200 28/09/2018 PLANNING	Layout Drawing No.	A0.03 OF 17 Site Plan 180803
DOUGLAS DESIGN & DRAFTING PTY LTD		PH 0437 00 33 02						
© This drawing is the sole property of Douglas Design and Drafting Pty Ltd and may not be used in part or whole without written consent.		Acc No. CC7092 ABN 56 614 751 521

dale@douglasdesignanddrafting.com		Revision	Project	Scale	Layout
PH 0437 00 33 02		Rev A 28/09/2018	Address	1:100	A0.04 OF 17
Acc No. CC7092			Client	Date	Site Section - A
ABN 56 614 751 521			SRK Developments Pty Ltd	28/09/2018	Drawing No. 180803
				Issue	PLANNING

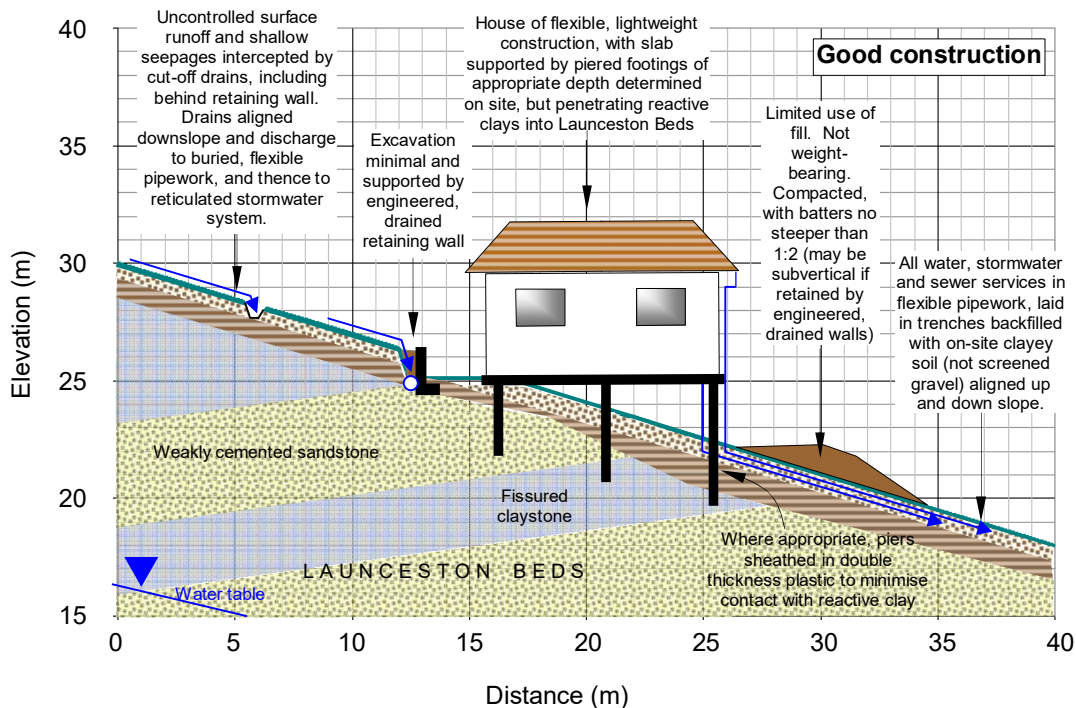
Generalised good and poor hillside construction practices on fill

Natural scale
