PROJECT: 2 LOT SUBMISSION

SUBJECT: 29 TALBOT ROAD SOUTH LAUNCESTON, 7249

DEVELOPMENT APPLICATION - 2-LOT SUBDIVISION AND VEGETATION REMOVAL - 29 TALBOT ROAD, SOUTH LAUNCESTON

Landslide Risk Assessment, 29 Talbot Road, South Launceston

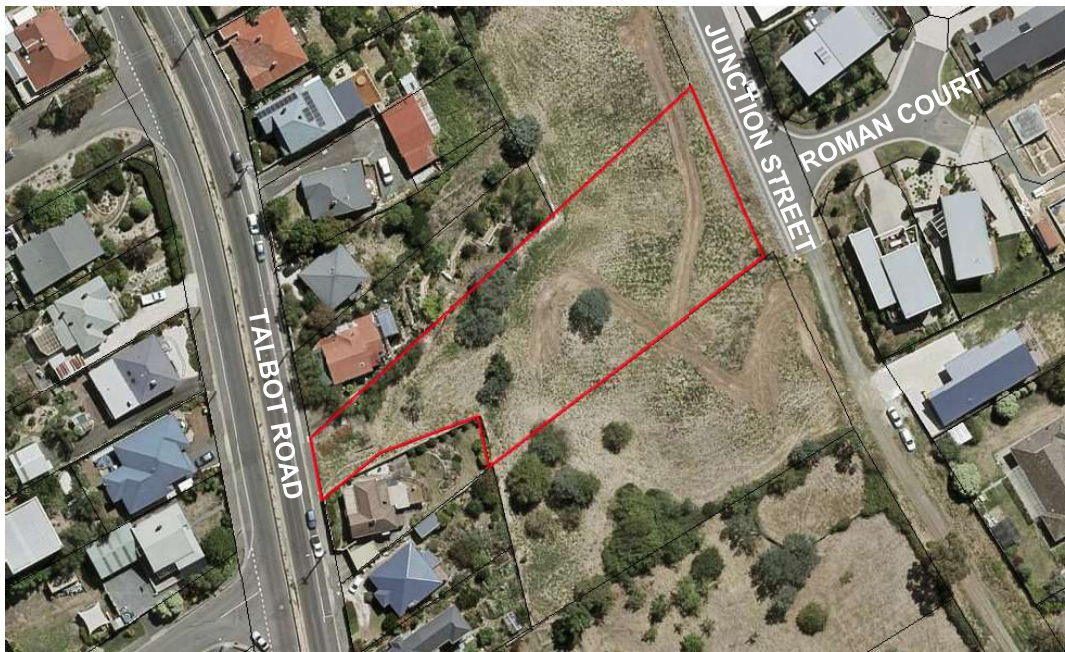
Figure 1 - aerial image of the site.

The site is addressed as 29 Talbot Road, South Launceston and is identified by Certificate of Title Volume 21380 Folio 1. It is illustrated in Figure 1 below.

The site is irregular in shape and has a long axis in a general north-east to south-west alignment. It has 13m of frontage to Talbot Road along its south-western boundary and 38.7m of frontage to Junction Street along its north-eastern boundary. Land contained within the lot falls away from Talbot Road at an average gradient of 16°.

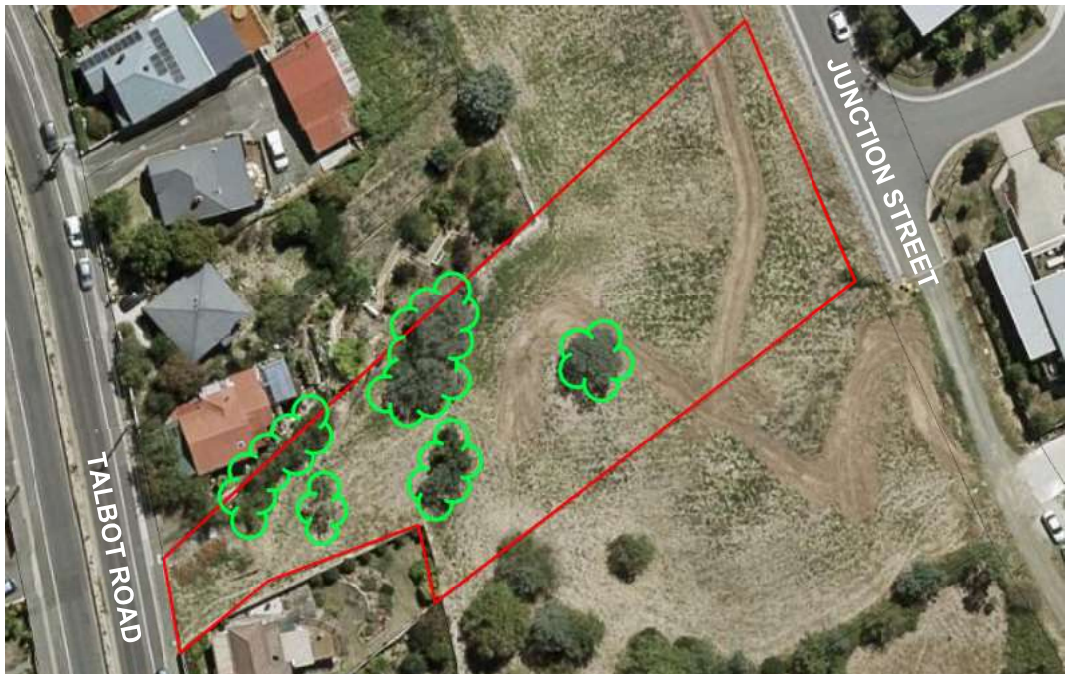
Figure 2 - aerial image identifying vegetation that is proposed to be removed.

It is proposed to remove some tree and shrub vegetation that is contained on the site. The extent of vegetation clearance is clouded in Figure 2 below where it is located on the site. The vegetation consists of a mixture of native and introduced species. The vegetation is required to be removed primarily to facilitate connections to service infrastructure and future development.

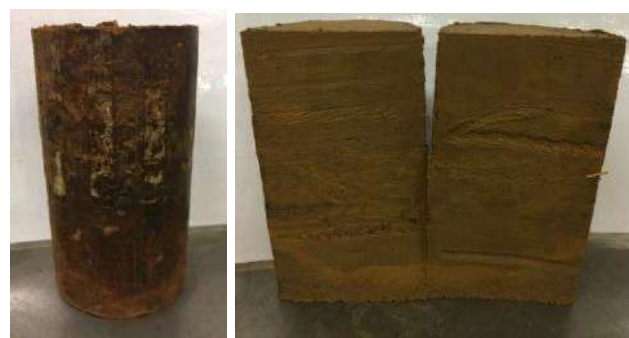
Photos After Test

Stage 1	Stage 2	Stage 3
Axial strain rate:	0.042	0.042	0.042
Strain at failure:	1.76	3.26	5.92
Minor stress σ_{3f} :	22	55	130
Major Stress σ_1 :	147	245	423
Corr Dev Stress	125	190	293

Effective Cohesion c': 30 Shear resistance Φ': 26	Mode of failure: Plastic Deformation Failure criteria: Principal Stress Ratio
---	--

Sample Description: sandy CLAY, Dark Brown, Medium Plasticity.

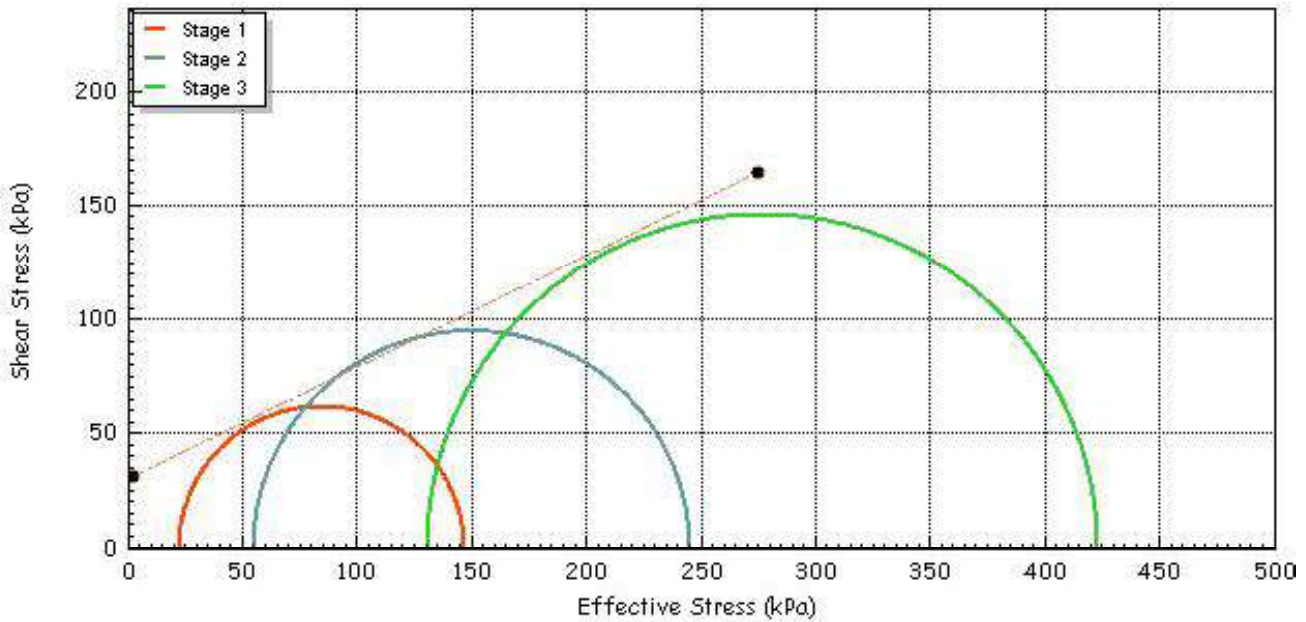
Shear Stage Plots

Effective Cohesion	c'	(kPa)	30.26
Effective Friction	ϕ'	(deg)	26.1

Total Cohesion	c	(kPa)	26.35
Total Friction	ϕ	(deg)	22.8

Test Method	AS1289.6.4.2 - 1998	Test Name	CUPP_05022	
	Database:	.\SQLEXPRESS \ chadgeotest2	Test Date	22/07/2019	
	Site Reference		Borehole	BH2 5.0 - 5.5m	
	Jobfile	TG18231 1100088	Sample	S19DS-05022	
	Client	Tasman Geotechnics	Depth		
	Operator	KPA	Checked	JLL	Approved

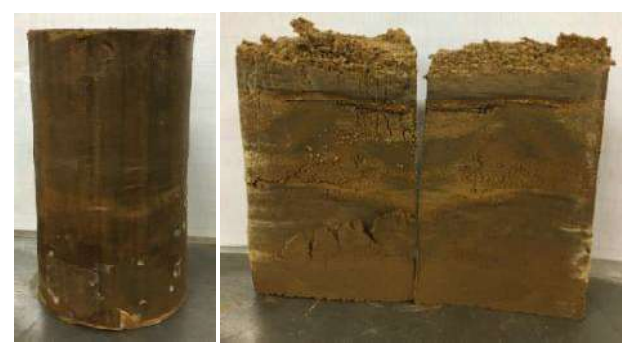
Photos After Test

Stage 1	Stage 2	Stage 3
Axial strain rate:	0.042	0.042	0.042
Strain at failure:	5.01	6.87	11.84
Minor stress σ_{3f} :	81	128	204
Major Stress σ_1 :	286	395	741
Corr Dev Stress	205	267	537

Effective Cohesion c' : 7
Shear resistance Φ' : 30

Mode of failure: Plastic Deformation
Failure criteria: Principal Stress Ratio
